Risk assessment and stability analysis of a recent landslide at Vishnuprayag on the Rishikesh–Badrinath highway, Uttarakhand, India

S. Sarkar*, Koushik Pandit, Mahesh Sharma and Ashish Pippal

CSIR-Central Building Research Institute, Roorkee 247 667, India

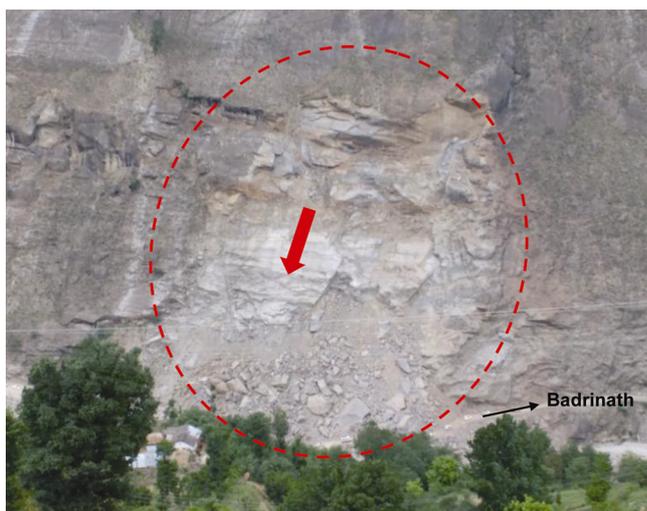
The hill slope is very steep with an average slope angle of 70° (Figure 2). The main escarpment along the failure plane, i.e. the outward-dipping joint plane was developed at a height of about 70 m above the road level. The toe of the slide at the river level below the road has a thick pile of boulders and debris. The landslide debris deposited on the road comprised of huge boulders and rock fragments (Figure 3). The maximum size of such boulders was about 2 m × 1 m × 1.5 m.

Figure 2. Panoramic view of the landslide.

The rainfall data during this period did not show any significant rain which could have triggered the slide. The slide may have been triggered due to the opening up of cracks present in the rock mass and probably aided by some water seepage through fractures as a few wet patches were observed on the upper part of the hill.

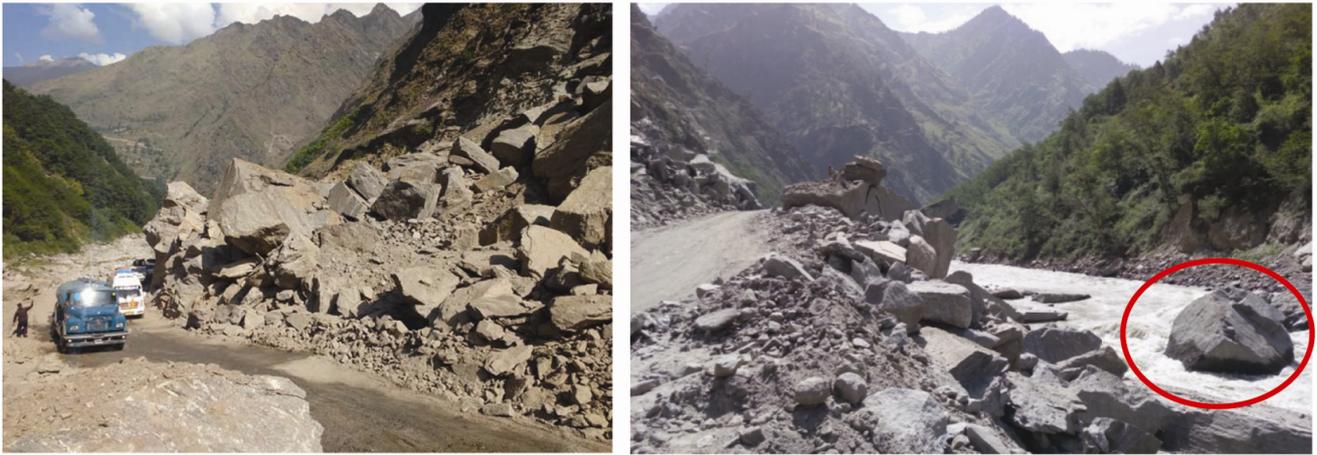
Figure 3. Landslide boulders and debris on the road and in the Alaknanda valley.

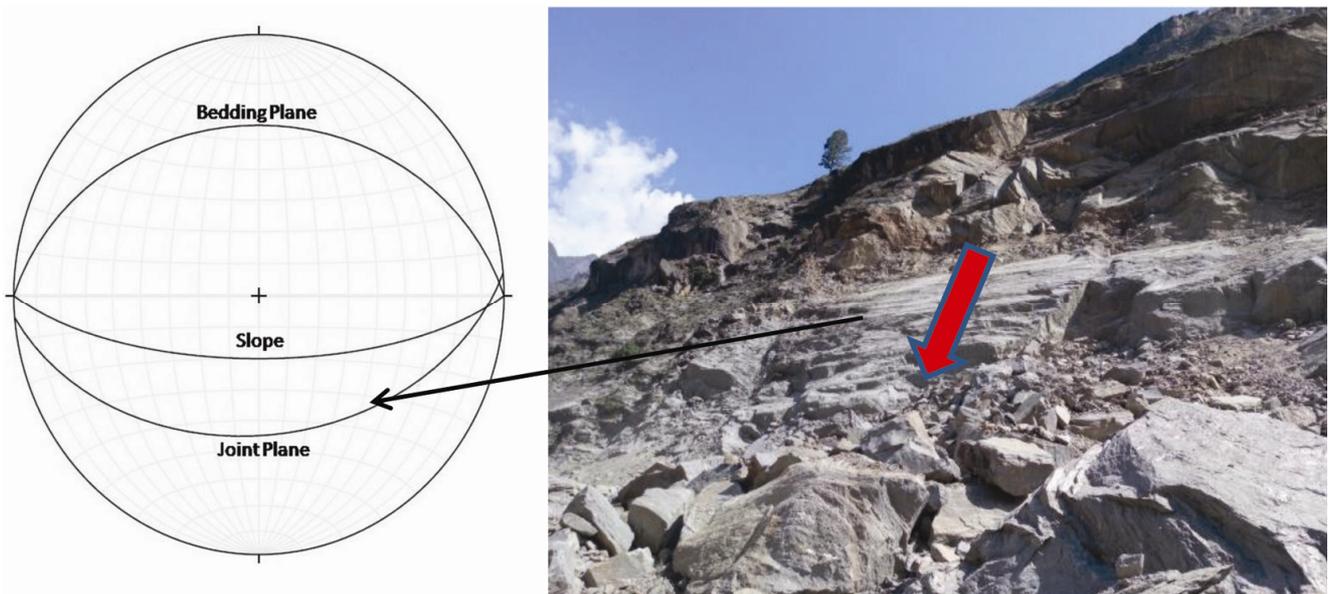
The Hathi Pahar hill is a landslide-prone zone as it contains two more landslide potential sites close to the present one. Two years ago, a similar landslide event occurred at the same spot on 29 April 2015. In fact, the present landslide could be considered as reactivation of the previous landslide, which had already weakened the rock mass and exposed the rock joints facilitating the sliding of the overhanging rock blocks. This time a huge rock block got detached from the hill and broke while rolling downhill. The resulting boulders and fragmented rocks blocked the road, and a few fell into the river. It was inferred from field studies that the slide has occurred as planar failure on the already existing discontinuity plane dipping parallel to the slope. Figure 4 is a stereo plot showing the unfavourable geological discontinuity causing planar failure.

Figure 4. Planar failure along the outwardly dipping joint.

As can be seen from Figure 6, the slope was modelled with two layers: (i) debris portion at the toe of the slope, and (ii) rock portion with two rock discontinuity sets in the rest of the slope. From field visits, it was observed that the landslide had taken place along the major discontinuity plane inclined at 45° at a spacing of 0.75 m (joint set 1) and was in the daylight of the slope face dipping. This prominent discontinuity plane caused the planar failure of the rock slope. The bedding joint set was in-

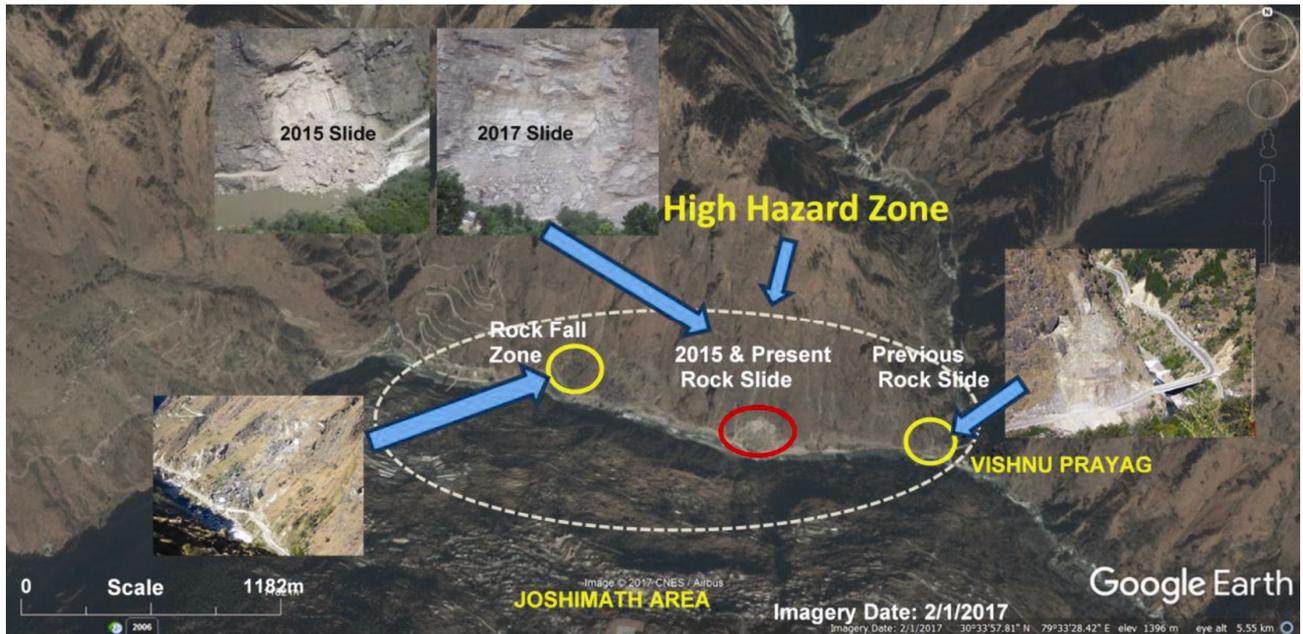
larly during rainy season. The landslide risk areas are highlighted in Figure 5 by combining the high hazard zone identified in an earlier study² and the landslide events that occurred in 2015 and 2017. Rockfall does not affect a large area, but can be fatal for the traffic entrapped in the rockfall zone. Sometimes the initiation of rockslide or rockfall goes unnoticed because of the steep hill and there is no time to give any warning.

Figure 5. Landslide risk areas of Hathi Pahar at Vishnuprayag on NH-58.

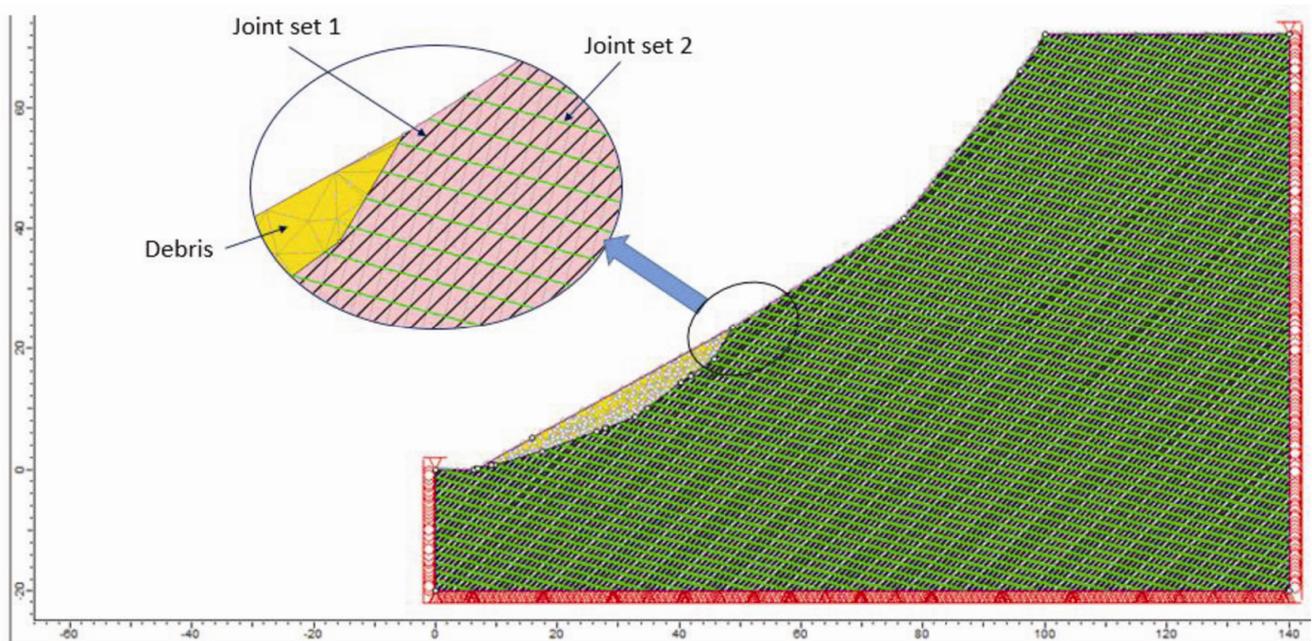
Figure 6. Geometry of the present slope.

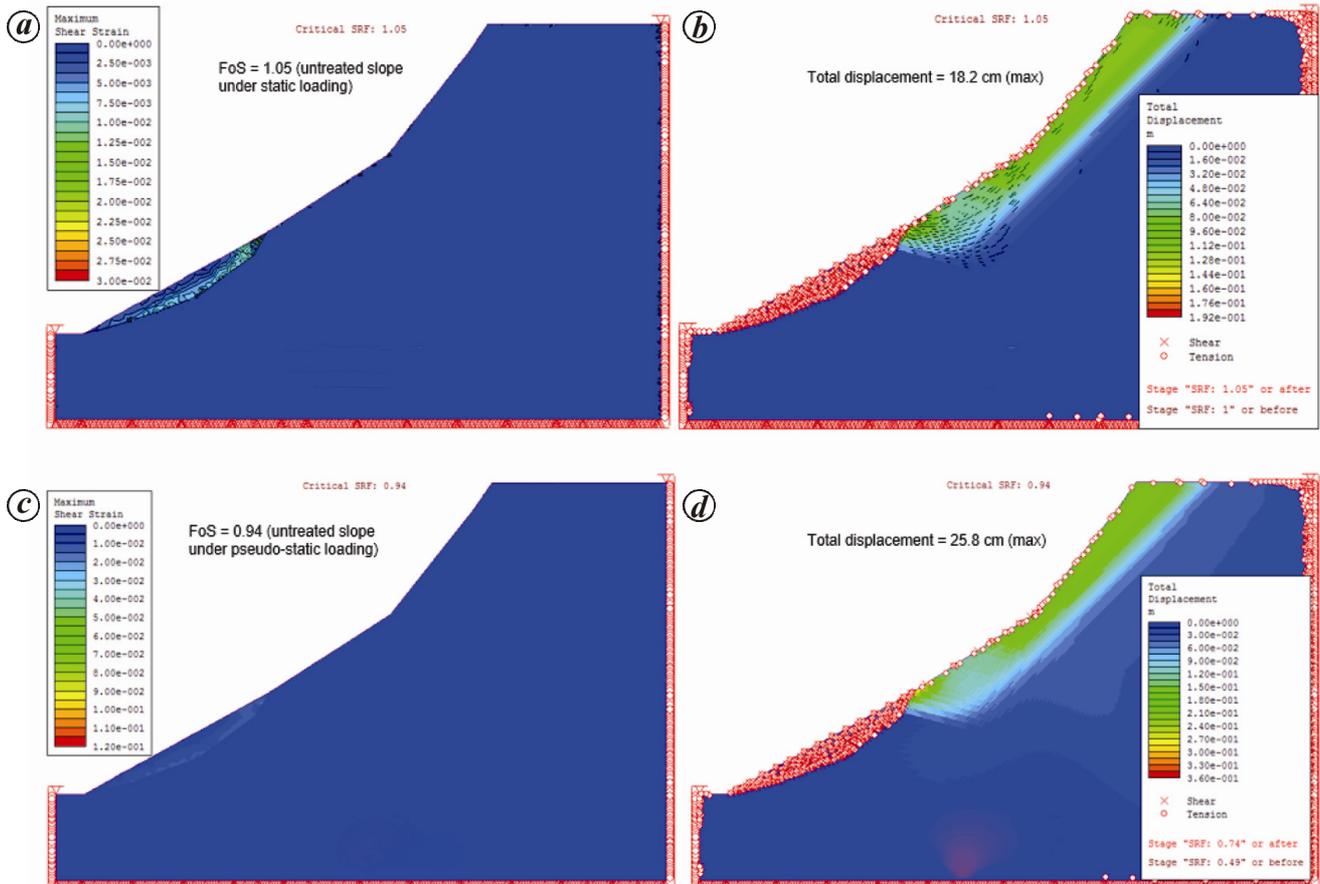
stability analyses suggest that the present slope if left untreated may fail – in future in the event of an intense rainfall or due to a strong vibration during earthquake in the area. The debris part has been found to be critical with a maximum total displacement of 18.2 cm in case of static loading and 25.8 cm in case of pseudo-static loading (Figure 7).

Figure 7. Slope stability analysis of the untreated present slope. (a, b) For static loading: (a) Maximum shear strain and (b) Maximum total displacement. (c, d) For pseudo-static loading: (c) Maximum shear strain and (d) Maximum total displacement.

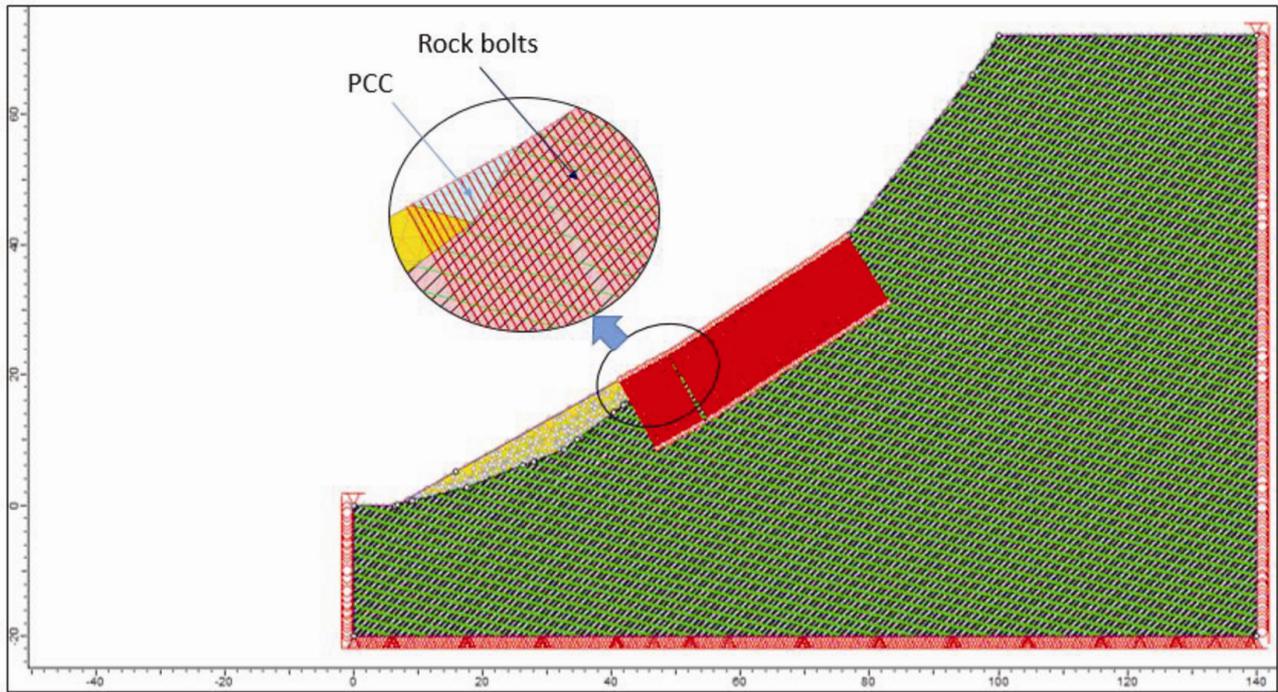
Figure 8. Slope geometry along with rock bolts and plain cement concrete (PCC) filling.

suited measures could be rock bolting and replacement of some parts of the debris using plain cement concrete (PCC) to arrest further sliding (Figure 8). Hence, slope stability analysis was performed with a small portion of debris being replaced by PCC (elastic modulus = 41 GPa, Poisson's ratio = 0.2, peak cohesion = 4.98 MPa, peak internal angle of friction = 37°, compressive strength = 20 MPa). In addition, fully grouted rock bolts (length = 12.0 m and diameter = 20 mm) may be installed normal

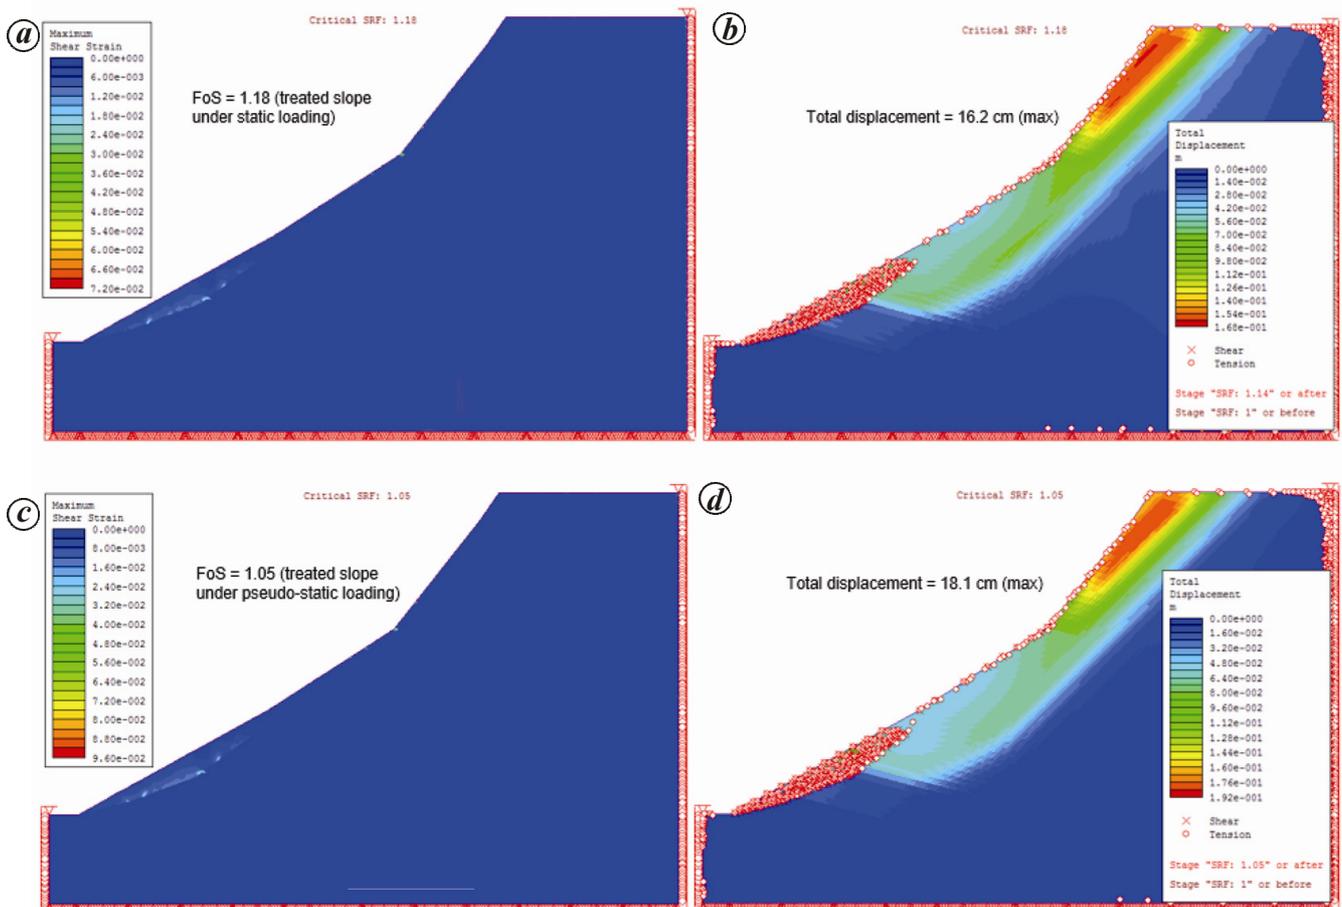
to the boundary section at a spacing of 0.5 m × 0.5 m, with mechanical properties such as elastic modulus of 200 GPa and tensile capacity of 100 kN. The analysis results were interpreted and the slope was observed to possess a global stability factor of 1.18 and 1.05 for static and pseudo-static loading respectively. On the other hand, the rock-bolted portion was found to have a minimum FoS of 3.17 and 2.64 for static and pseudo-static loading respectively. Hence, the slope treated with rock bolts and concreting can be considered as stable (Figure 9 a). The debris portion further needs wire-mesh netting, if possible, to arrest any rockfall probability in future,

since the maximum total displacement after rock bolting and PCC was determined to be 16.2 and 18.1 cm for static and pseudo-static loading respectively (Figure 9 b).

Figure 9. Slope stability analysis of the treated present slope. (a, b) for static loading: (a) Maximum shear strain and (b) Maximum total displacement. (c, d) For pseudo-static loading: (c) Maximum shear strain and (d) Maximum total displacement.
