Road widening along National Highway-58, Uttarakhand, India

T. Siddique and S. P. Pradhan

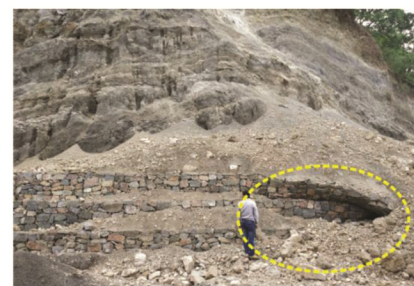
adverse practices are unendurable and violation of rules and regulations of the river ecosystem needs to be assessed. Such unscientific acts will not result in any development; rather they would trigger fatal events in the state. Similar activities in the upper reaches of Uttarakhand will cause siltation problem in major hydroelectric projects. Apart from problems pertaining to landslides and river ecosystem, the unique canopy of the region is also being affected. Such adversely executed activities are deteriorating the aesthetic environment of Uttarakhand. It was observed during a traverse along NH-58, from Rishikesh to Devprayag, that no preventive and stabilization measures were undertaken after excavation. However, in a few road-cut sections, gabion walls have been constructed for stabilization; but these walls are deformed due to inadequate stabilization measures and maintenance (Figure 1).

Figure 1. Deformed gabion wall along National Highway-58 near Rishikesh, Uttarakhand, India.

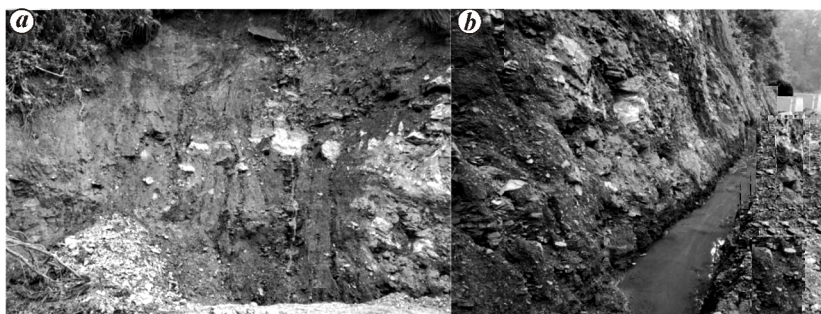
Figure 2. Photographs depicting adverse conditions along NH-58 near Rishikesh. **a**, Panoramic view showing continuous outflow of water. **b**, Cross-sectional view of cut slope showing stagnant water in the ditch hampering stability of the slope.

water from the slope was observed to be collected in a roadside ditch (Figure 2). Such careless practices are continuously hampering and endangering the health of sloped slopes and may give rise to large-scale

landslides. In the monsoon season of 2017, a talus-type of landslide was witnessed along NH-58 near Shivpuri (Figure 3). The landslide was triggered by the percolation of water through tension cracks between the debris and bedrock interface near the crown portion of the slope. The stagnant water on the slope may cause disturbance in the equilibrium conditions by increasing pore pressure and reducing shear strength of the material, thereby hampering stability to a great extent. So, proper outlet channels need to be constructed along the cut slopes.

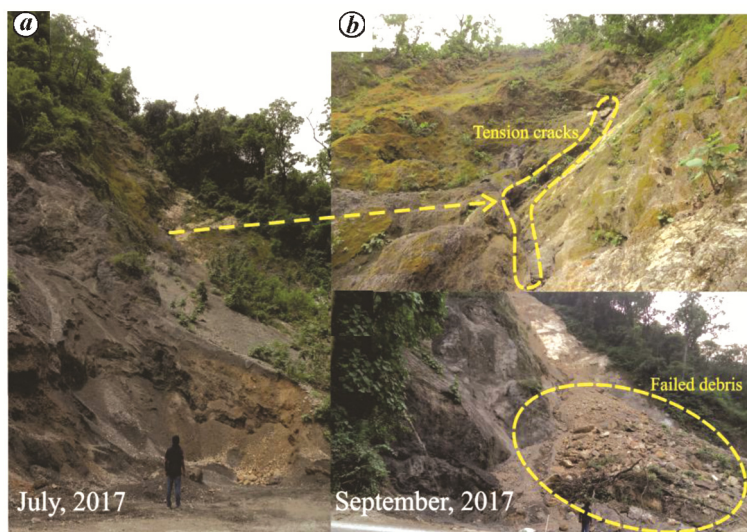
Figure 3. Talus-type slide along NH-58, Shivpuri. **a**, Pre-failure scenario in July 2017. **b**, (Inset) Image showing tension crack near crown portion. **c**, Post-failure condition in September 2017.

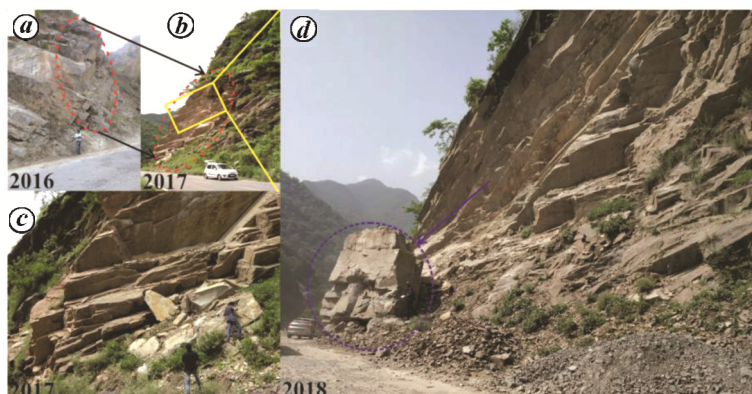
Figure 4. Recurring structurally controlled failure along NH-58 near Kaudiyala, Uttarakhand. **a**, Rock mass prone to planar and wedge failure. **b**, Block failure that occurred in 2017. **c**, (Inset) View of the failure depicting size of the block. **d**, Recurrent mass failure that occurred in 2018.
