Reliability assessment and system performance improvement of ORV *Sagar Nidhi* propulsion system

National Institute of Ocean Technology, Ministry of Earth Sciences, Chennai 600 100, India

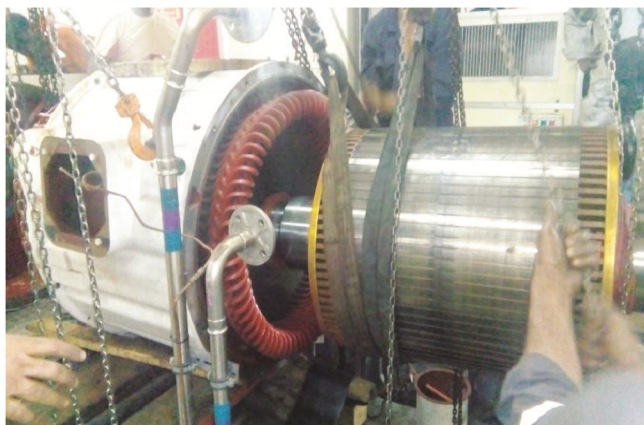
The failure of the motor is due to degradation of winding over nine years of continuous operation. Being a research vessel, *Sagar Nidhi* was kept in DP mode more frequently which resulted in sudden load change on motor. It was also observed that starboard thruster motor has more running hours compared to Port Azimuth motor. The root cause¹ and inference are mentioned below.

Figure 2. Loose coils in slot.

Cooler unit was dismantled and visual inspections were carried out. It was decided to dismantle the motor and accordingly rotor was removed for inspection. It was found that few wedges were missing in stator slot, which may have led to zero insulation in winding. It was inferred that the failure is due to degradation of winding². It was found that the lead time for supply of new motor is around ten months and three months for carrying out rewinding of stator. Damaged winding were taken out from the slots and special insulation tape was wrapped on the winding. New wedges were fixed on the slots wherever necessary. Complete re-varnishing was done in order to improve insulation of the winding. Megger test in 1000 V (ref. 3) mode was carried out and it was found that the insulation has improved to 6 Giga ohms.

After completion of standard repair procedure, the motor was re-assembled and it was tested under no load condition with 400 to 500 revolutions per minute (RPM) prior sea trials. The speed of motor gradually increased up to 810 RPM (ref. 4) and it was observed that all parameters were normal. Upon completion of no load test, the motor was assembled to thruster unit. Sea trial was carried out for 6 h with different speeds initially and at full speed for one hour. The above repair work and sea trials were conducted under the supervision of surveyors from Indian Registry of Shipping (IRS) and Det Norske Veritas (DNV). Though the work was completed successfully, the reliability of propulsion system remained the same

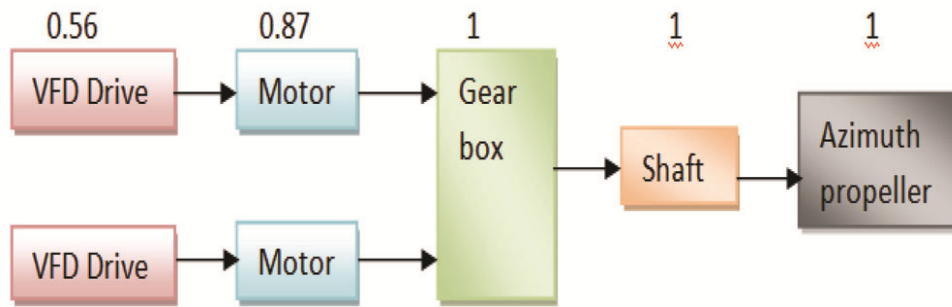
Figure 3. Proposed system reliability.

The reliability of proposed propulsion system which is shown in Figure 3, has increased to 94.7% which is helpful for *Sagar Nidhi* to accomplish the critical scientific and technology demonstration operations.

(a) Redundant motor and drive in parallel configurations resulted in increasing reliability to 94.7% from the current value of 22%.

(b) It is recommended to have a motor and drive in parallel configuration compared to series configuration and dual stator configurations which resulted in increase of reliability value.
