Field observations and lessons learnt from the 2018 landslide disasters in Idukki District, Kerala, India

Debi Prasanna Kanungo^{1,3}, Ravinder Singh² and Rajesh Kumar Dash^{3,*}

The landslide events, that occurred in August 2018 in the Idukki district Kerala, India were surveyed during 12–14 September 2018. Many landslides were studied through field observations to decipher their mechanism and mitigation measures have been recommended. Possible causative factors responsible for these slope failures have been discussed. This event was the most devastating disaster that affected millions of people and the second such event after the Kedarnath tragedy (2013) during this decade. The primary causes responsible for initiation of these landslides were unexpected intense rainfall, unplanned development and urbanization. This study on field observation-based interpretations will help academicians, researchers and field engineers to plan future initiatives for reconstruction planning and implementation in line with future disaster risk reduction.

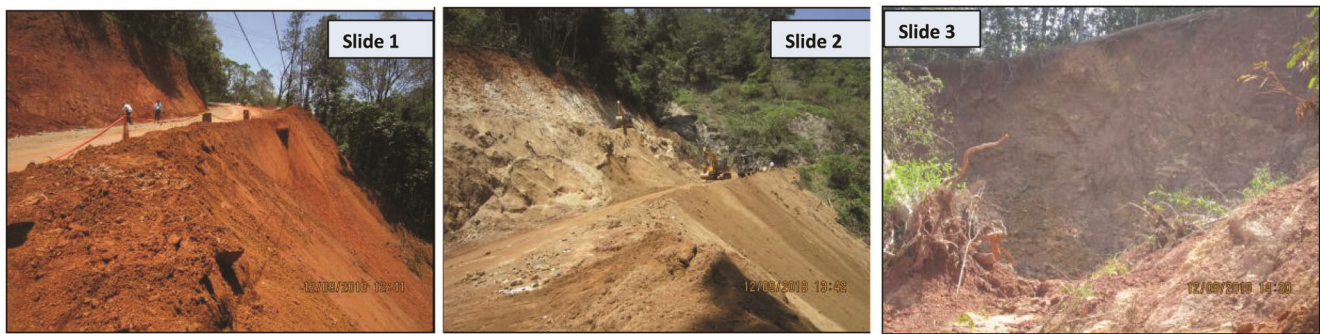
Figure 3. Landslides at Puliyanmala–Thodupuzha Road–Idukki and Arakkulam villages.

Slide 1: This landslide occurred below road level with collapse of the road which was unsupported (Figure 3). Thick cover of lateritic red soil was observed at the site. Above road level, the slope was moderate (30° – 40°) and straight in nature with terrace cultivation. Tension cracks and depression pits on the uphill slope above road level were observed. The possible causes for this landslide were: (i) toe-cutting during heavy water flow due to high-intensity rainfall by a perennial stream flowing at the base of the slope below the road level, and (ii) development of high water pressure in the lateritic soil with more clay content (sticky in nature and more water-retention capacity in comparison to water-draining capacity). It was also observed at the site that back-cutting of the road to maintain its width was being done after the occurrence of the landslide. However, the cut slope was left almost vertical without any retaining structure. The slope though, not too high, needs to be protected by proper retaining wall (gabion wall) with provision of catch water drain at the road level to discharge the surface water

Slide 2: This was a translational debris slide of the overburden material on the foliation plane of the highly weathered biotite gneiss (Figure 3). The road collapsed and was washed away with the debris slide. As informed, it is an old debris-flow area along a natural stream during every monsoon season. It was observed to be a water-logged area, as water was oozing out of *in situ* rock strata at many places (Figure 3). The possible cause may be due to the fact that the old debris slide/flow area was left unprotected at the road level as well as below it. Heavy water seepage had caused high-grade weathering to *in situ* rocks (biotite gneiss). Dip-slope relationship of the foliation plane facilitated translational (planar) mode of failure of the overlying debris and weathered rock mass. Back-cutting of the road to maintain its width was being done after the landslide. The *in situ* rocks are exposed due to excavation. It is proposed to protect the base of this cut-slope with a retaining wall and the exposed rock slope face with properly anchored wire-mesh to protect rockfall (fractured rock mass). Drainage measures along the existing natural stream along with properly designed culvert and catch-water drain at the road level need to be provided. The accumulated debris on the road dumped on the valley side needs to be protected with proper vegetation growth.

Slide 3: In this case, circular failure of overburden debris and highly weathered rock material had occurred (Figure 3). Foliation plane of biotite gneiss is in dip-slope relationship facilitating further sliding. Foliation plane along the slip surface has been exposed at the failure site (Figure 3). As in the case of slide 1, the lateritic soil with more clay content has much more water-retention capacity in comparison to water-draining capacity, and thereby high water pressure built-up within the slope material caused the failure. Therefore, it can be proposed to protect the base of this cut-slope with a retaining wall and the exposed rock slope face with properly anchored wire

properly to the nearby culvert. Retaining structures just below the road level and also at the stream level to avoid further toe-cutting need to be provided.

mesh to protect the rock slide and rockfall (fractured rock mass). The accumulated debris on the road dumped on the valley side needs to be protected with proper vegetation growth. Catch water drain at the road level has to be provided to channelize the surface water to the drainage culvert.

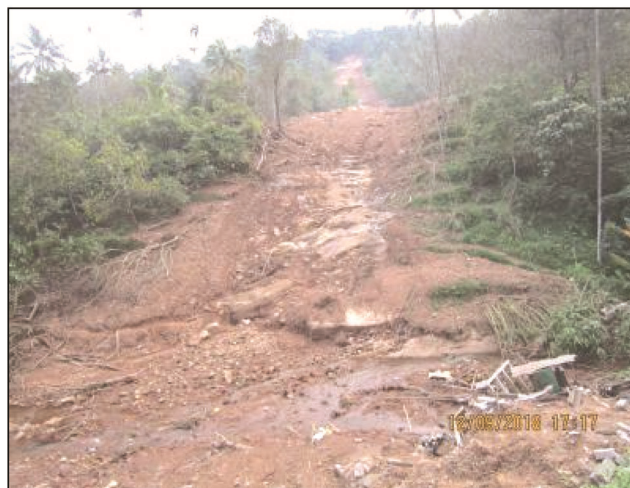
Figure 4. Landslide at Perumkala in Idukki Village.

A huge debris slide occurred at the crown of the slope on 15 August 2018 (Figure 4). A motorable road existing at the middle level of the slope and few houses on the slope below the road level were washed away with the slided debris material to the riverbed level (Figure 4). A huge accumulation of debris had occurred at the middle portion of the slope at the road level. The *in situ* rock of biotite gneiss was exposed at the crown in the zone of initiation of the debris slide showing inward dipping of the foliation plane. The possible causes for the occurrence of this slide may be attributed to huge debris cover on highly weathered strata on the slope, high-intensity rainfall triggering the process to the already saturated slope material and lack of earlier protection to the road cut-slope. Remedial measures in terms of retaining structures at the base of the slope at road level and at the riverbed level are to be properly designed and implemented. The residents still living in a building at the riverbed level should be evacuated immediately and rehabilitated.

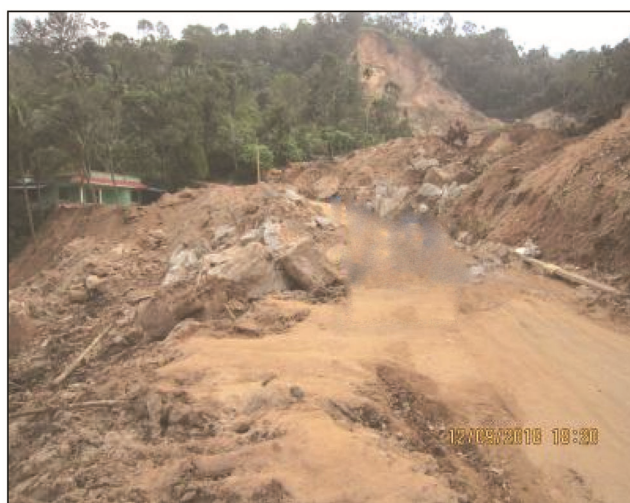
Figure 5. Landslide at Chittadikavala in Upputhodu Village.

A huge debris slide occurred on the side hill slope of a natural perennial stream on 17 August 2018 night (9:30 pm; Figure 5). As informed by local villagers and as observed at the site, the slide had occurred in three stages. A huge boulder got dislodged initially along the stream with huge water flow due to heavy rainfall during this period. The rolling of this huge boulder eroded soil mass from the toe of the slope with an initial debris slide. Subsequently, the soil overburden at the crown of the slope slid down due to removal of toe support. A huge amount of debris along with large boulders were transported along the stream flow and damaged the road, agricultural land and houses (one above and one below road level) around the affected area on both uphill and downhill sides of the road. At the zone of initiation of the slide, the gneissic rocks got exposed with foliation planes having dip-slope relationship. A huge accumulation of debris material, huge boulders and sand bed >1 m thick were observed above road level. The sand and clay are found as by-products of the highly weathered biotite gneiss. The sand got deposited in the form of a sand bed in the process of transportation by water. The clay got mixed with water and was transported to a farther distance down slope. The possible causes for this slide can

be listed as: (i) huge debris cover on highly weathered strata on the slope; (ii) high-intensity rainfall which triggered the dislodging of a huge boulder that eroded the toe of the debris slide on its path of rolling down stream, and (iii) no pre-existing protection measures for the road cut-slope. Proper remedial measures in terms of retaining structures need to be provided at the base of the slope and at the road level, both on the uphill and downhill sides. Removal of accumulated debris, sand and boulders on the drainage path above road level and using them in remedial and reconstruction works at this particular site are suggested. This will solve the problem of unloading the crown portion of the slope to control further sliding. A natural drainage path has to be made lined all along up to the valley side with provision for properly designed culvert at the road level according to the discharge capacity of the drain. Also a catch water drain at the road level can help channelize the surface water to the valley side.

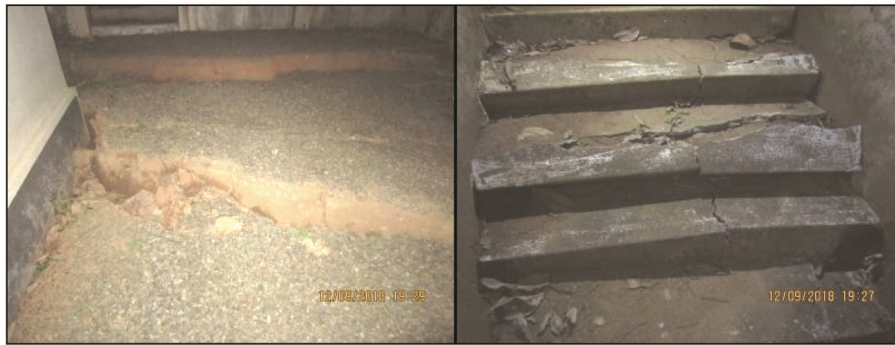
Figure 6. Damages in houses and surroundings due to landslide at Keerithodu in Kanjikkuzhy village.

This is an area shattered with slump failure by the development of numerous wide-open, long cracks all around. A lined flowing drain exists at the base of the slope. The ground around one existing reinforced cement concrete (RCC) building at the lower level of the slope and building itself have developed many wide-open cracks. The approach road and staircase to this building also show cracks, distress and damage (Figure 6). On one side of the building there is detachment of foundation from the ground and differential settlement to this portion of the building is also observed (Figure 6). A motorable road at a higher elevation of the slope has also developed cracks. Approximately 50 houses around this motorable road have experienced minor or no distress as of the time of site visit. However, there exists a greater risk to these houses due to subsidence and cracks as observed around the slope. Radial circular tension cracks all around the slope show creep and slump movements in the whole slope. Possible causes for this failure could be the following: (i) highly saturated slope with no proper drainage

measures; (ii) loading of the slope with many buildings on cut- and fill-ground with absolutely no protection measures at the uphill and downhill sides, and (iii) no protection at the toe of the slope as well as at the road level. Proper remedial measures in terms of retaining structures at the base of the slope, at the road level on both the uphill and downhill sides and at cut-slopes around the buildings need to be implemented. Suitable surface drainage measures also need to be planned for the whole slope. Crack-filling using local soil material with proper compaction and sealing with bentonite clay layer on the surface after filling are to be adopted. This site has to be taken on high-priority basis to protect rest of the 50 houses at higher elevation from damage.

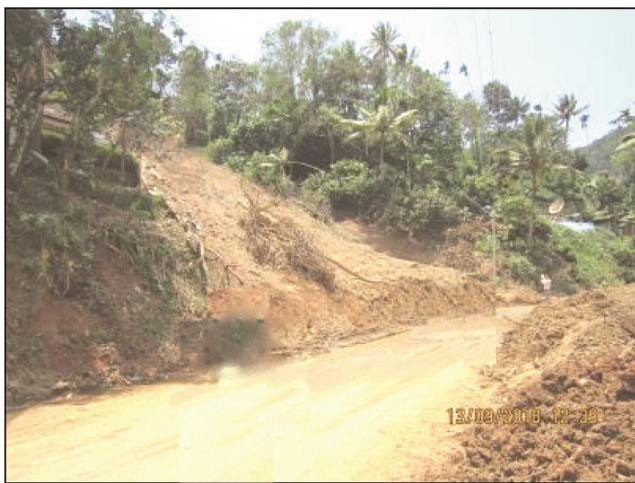
Figure 7. Landslide at Ponmudy S Valavu in Konnathady village.

This was a huge translational debris slide along the foliation plane at the zone of initiation. The debris flowed along the natural stream to the river valley and damaged houses on the slope as well as causing loss of lives (Figure 7). As observed, the slope comprised of huge soil/debris overburden on highly weathered gneissic rocks. After sliding, fresh gneissic rocks with the foliation plane having dip-slope relationship were exposed at the road level. The debris material comprised of finer materials like silt and clay that were lateritic in nature. A huge quantity of sand has been deposited in the area, which seems to be a product of highly weathered, coarse-grained biotite gneiss. Continuous water seepage along the foliation planes was observed at the site. Possible causes for this failure could be: (i) huge quantity of debris overburden on highly weathered gneissic rocks on the unprotected slope at the base at road level; (ii) highly saturated slope with no proper drainage measures; (iii) dip-slope relationship of foliation plane facilitating the translational debris slide charged with heavy water pressure, and (iv) high intensity rainfall triggering the sliding phenomenon. Proper remedial measures in terms of

retaining structures at the base of the slope at road level on both uphill and downhill sides need to be implemented. The exposed soil slope at the crown portion should be treated with soil nailing along with other bio-engineering measures to protect further soil erosion and sliding. Suitable drainage measures are to be planned for the whole slope. Local sand, soil and boulders should be used for reconstruction of the area.

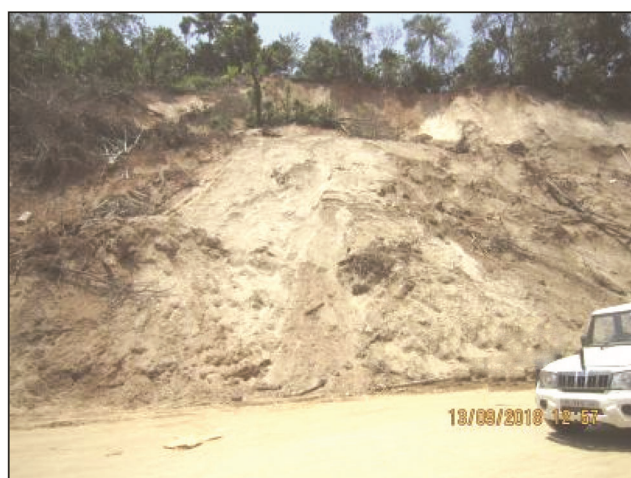
Figure 8. Landslide at Panniyarkutty in Konnathady village.

A huge debris slide (circular failure) damaged the nearby shopping complex and houses. It moved further downhill and blocked the river channel forming a dam (Figure 8). The heavy water flow in the river channel due to water release from Ponnudiy reservoir changed its course to the other side of the valley and washed away shops and houses on the opposite riverbank (Figure 8). Being identified as a potential landslide zone during heavy rainfall, the people were shifted to camps prior to the incidence; thereby avoiding loss of life. In this case, a huge quantity of debris overburden on highly weathered gneissic rocks was lying on the unprotected slope. The slope got highly saturated with monsoon precipitation and was devoid of proper drainage measures. High-intensity rainfall triggered the sliding phenomenon. Proper remedial measures in terms of retaining structures at the base of the slope at the road level on both the uphill and downhill sides need to be implemented. The exposed soil slope at the crown portion should be treated with soil nailing along with other bioengineering measures to protect further soil erosion and sliding. Suitable drainage measures need to be planned for the whole slope. Local sand, soil and boulders should be used for reconstruction of the area.

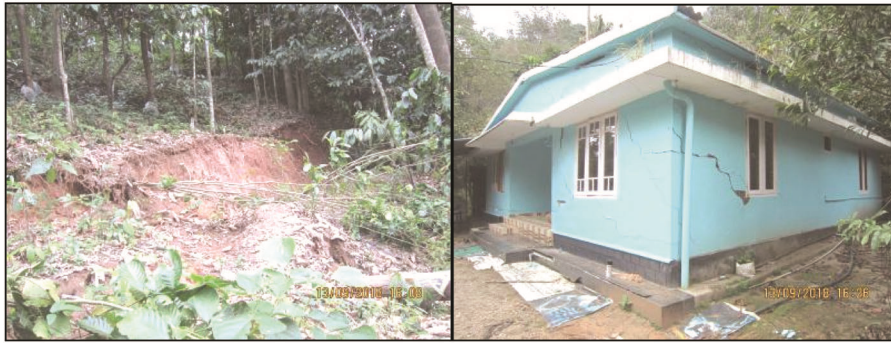
Figure 9. Creep movement in the agricultural land near Viswadeepthi School, Adimaly, Mannamkandom village.

This is an old creeping slope as witnessed by bent trees all around the agricultural land. The creep movement got triggered with high-intensity rainfall and developed huge, wide-open, radial and circular cracks all around the land at different levels from the toe up to the crown (Figure 9). Three houses at the toe of this huge agricultural land (5 acres) showed high intensity of distress in the form of ground cracks, structural damage to the building, etc. (Figure 9). The damaged houses should be abandoned and no one should be allowed to live in any part of this agricultural land. Crack-filling using local soil material with proper compaction and sealing with bentonite clay layer on the surface after filling need to be adopted. As this is an agricultural land without any habitation, the area with creep movement will be naturally stabilized with time. Vegetation growth in the form of trees and

shrubs with their roots creating an interlocking network can strengthen and stabilize the unconsolidated material naturally with time. Hence, this does not require any investment on remedial measures. However, buildings in the vicinity need to be strengthened with structural measures and slope protection walls, or the resettlement of these houses in the near vicinity of the creeping slope is recommended.

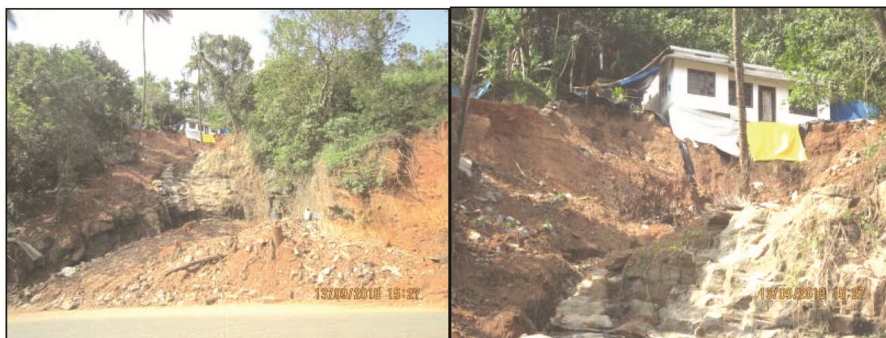
Figure 10. Landslide at Koompanpara, Mannamkandom village.

Debris slide and flow along an existing natural drainage had occurred here (Figure 10). *In situ* less-weathered gneissic rocks with sidewise gently dipping foliation plane got exposed after the sliding (Figure 10). Debris slide on the side slope blocked the path of the natural stream, and subsequent change in the flow path of the stream carrying debris damaged one of the buildings on the roadside slope causing loss of life and injury to the inhabitants (Figure 10). Though the retaining wall below the road level and culvert for natural drainage at the road level pre-existed, the road-cut slope was left unprotected. Buildings and the approach road have been constructed over unconsolidated debris overburden. Loading of the unprotected road-cut-slopes with buildings and human intervention in the natural drainage system is the primary cause for this sliding phenomenon. Retaining structure to the unprotected road-cut-slope with proper drainage alignment to the natural drainage to discharge water to the culvert needs to be provided. The exposed soil slope face after sliding should be treated with soil nailing with provision for suitable geo-grids and vegetation growth. Existing buildings at the crown of the slide area should be vacated and the residents should be relocated.

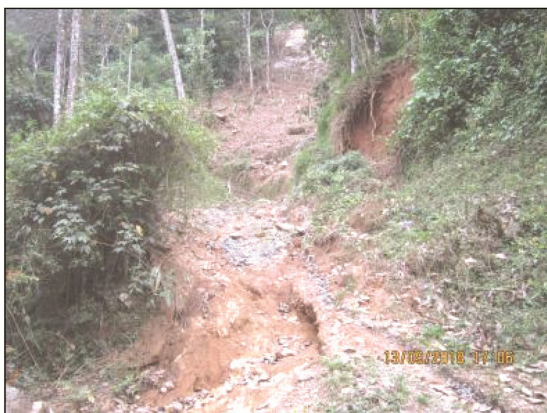
Figure 11. Debris slide damaging agricultural land at 60th mile in Anaviratty Village.

A minor debris slide had occurred with water flowing from higher elevations during heavy rainfall (Figure 11). The topsoil and debris overburden has slid down damaging the agricultural land above road level without affecting the road (Figure 11). The *in situ* rocks have been exposed after the sliding phenomenon. Dry stone masonry retaining wall exists at the roadside in this location. No remedial measure is required as the debris overburden has already slid exposing the bedrock.

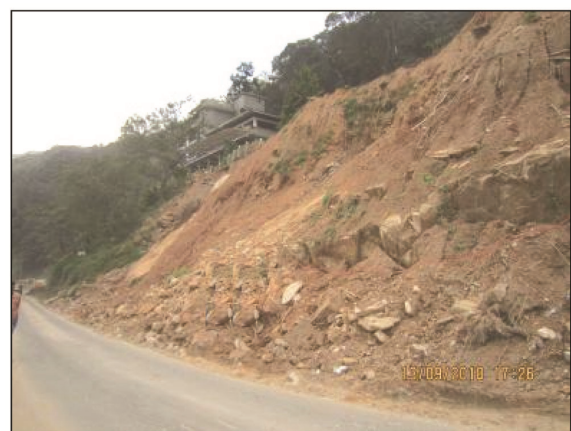
Figure 12. Landslide at 2nd mile in Pallivasal Village.

A huge debris slide above road level occurred affecting the tea gardens below and part of a huge resort above the slid area (Figure 12). The *in situ* fine-grained hornblende–biotite gneiss with inward dipping foliation plane and two sets of joints was overlain by a huge quantity of debris overburden. The road-cut-slope was left unprotected (Figure 12). Huge multistoried resorts have been allowed to be built on the huge debris cover by cut-and-fill method above the unprotected road-cut-slope (Figure 12). High-intensity prolonged rainfall triggered the saturated

debris overburden to slide. Heavy loading of the unprotected road-cut-slopes with buildings destabilized the saturated debris slope. Properly designed retaining structure with actual loading considerations to the unprotected road-cut-slope along with proper drainage measures need to be provided. The exposed soil slope face after sliding should be modified with proper terracing and then treated with soil nailing. Implementation of suitable geo-grids with provision of vegetation growth on the slope face is also suggested.

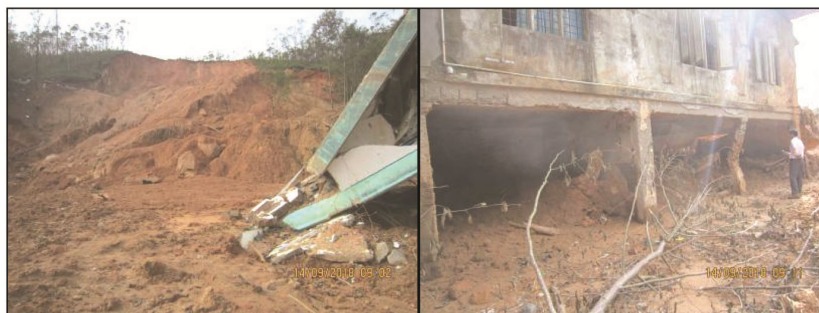
Figure 13. Landslide at Arts College Munnar.

Huge debris slide and flow occurred on 15 August 2018 night in the campus of Government Arts College, Munnar (Figure 13) totally damaging the newly constructed and unoccupied Boys' hostel building and partly damaging the classroom building. The administrative building was also affected by a debris slide behind it. The debris slide occurred at the crown of the slope and lateritic red soil flowed with water along the existing natural drain at the right flank of the landslide as mudflow. The mudflow also affected the highway below the college campus and found its way to the river down below. As informed, the college campus had experienced landslides in the past during 2005. It is an old and potential landslide area, which got reactivated this year due to high-intensity prolonged rainfall. Prior to the landslide during 15 August 2018, the District Hazard Analyst had surveyed the area in June 2018 and reported development of dis-

stress and cracks around this area. The area is covered by huge debris/soil overburden and is underlain by highly weathered, disintegrated, gneissic rock with outwardly dipping foliation plane. There have been several construction activities to build multistoried structures in the college campus in the recent past by the Public Works Department. No protection measure was witnessed on cut-slopes in the campus as well as on roadside. The triggering phenomenon of this failure may be attributed to reactivation of the potential old landslide zone with high-intensity prolonged precipitation. The primary cause of the slide is the overloading of unprotected hill slope with huge construction of multistoried buildings over debris overburden. No drainage measure was also provided to channelize the surface water and to prevent the slope from heavy water seepage. This landslide being a huge and active phenomenon needs to be studied in detail to prepare a detailed project report (DPR) for its mitigation. Only then can scientifically designed integrated control measures be implemented to achieve stability.

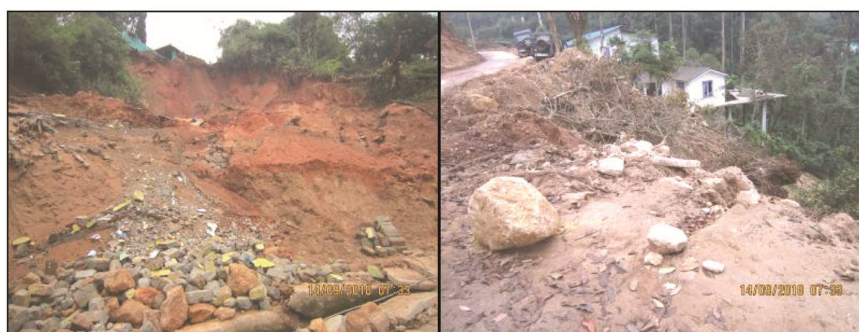
Figure 14. Landslide at Devikulam near Public Health Center (PHC) at Kannan Devan Hills (KDH).

This is a debris slide-cum-mudflow down the slope (Figure 14). There was presence of huge debris cover comprising lateritic red soil and boulders on the highly weathered gneissic rocks above the unprotected road-cut-slope. The debris slide flowed downstream with rainwater as a mudflow, damaging three houses at above and below

road level, with the loss of two lives. Human habitation exists all around this area. The Devikulam colony is located on the further downhill side of the landslide (Figure 14). The possible causes of this failure may be attributed to high-intensity prolonged rainfall triggering the saturated huge debris overburden to slide, unprotected road-cut-slope and lack of proper drainage measures along the road and around the inhabited area. The suggestive remedial measures for stability of this area are as follows: (i) retaining structure at the road level for providing toe support to the slope, and (ii) catch water drain at the road level and around the inhabited area to channelize surface water to the valley side.

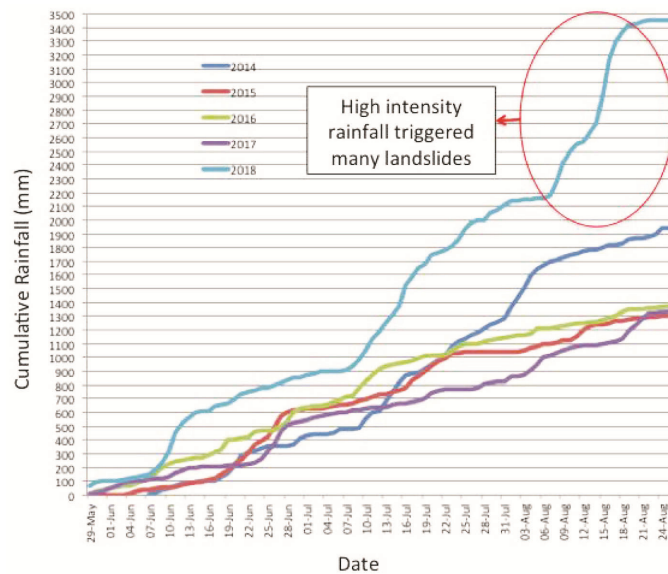
Figure 15. Cumulative rainfall during SW monsoon period (29 May to 26 August) of last 5 years (2014–2018) in Idukki District (Source: Taluk rain gauges).

- Toe-cutting by the perennial stream flowing at the base of the slope during heavy water flow due to high-intensity prolonged rainfall.
- High-intensity rainfall during August 2018 triggered landslides on the already saturated slope material (Figure 15).
