## Slope stability assessment of the recent Birik Dara landslide in the Kalimpong region of Darjeeling Himalaya, India

Suvam Das<sup>1,2</sup>, Prachi Chandna<sup>1,2</sup>,  
Shantanu Sarkar<sup>1,2,\*</sup> and  
Debi Prasanna Kanungo<sup>1,2</sup>

**The Birik Dara landslide occurred at around 10 pm local time (GMT+5:30) on 20 October 2021 on National Highway-10 in the Kalimpong region of Darjeeling Himalaya, India, and disrupted traffic for more than a week. This study presents an overview of the landslide and reveals the present stability status of the slope. The slope stability assessment was carried out using data collected from the field during a site visit in the second week of November 2021. The findings of this study indicate that the landslide occurred on a critically unstable slope and it may be triggered again in the near future with more damage. Therefore, immediate attention is required regarding slope stabilization measures to avoid future threats.**

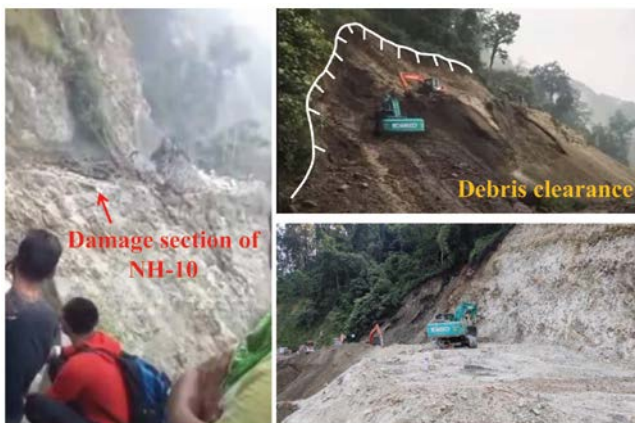
The Birik Dara landslide occurred around 10 pm local time (GMT+5:30) on 20 October 2021, at 26°58'1.91"N and 88°25'38.92"E between Rambhi and Kalijhora, at an elevation of about 304 m amsl, with slope direction N316° (Figure 1). Figure 2 shows photographs of the road condition after the hazard, while Figure 3 shows field photographs of the landslide. In 2021, the main scarp of this landslide was positioned over a convex slope of height around 50 m above road level with a slope inclination of 76°. The site visit revealed that this landslide was typically characterized as a rock-cum-debris slide with a visible head scarp and flanks on the upper slope section. Above the crown, vegetation cover was present with a thin soil layer of about 1.5 m. The displaced materials accumulated below the road are mainly comprised of boulders and rock fragments with soil mass (Figure 3). The crown and toe of this landslide were at a distance of about 200 m with an elevation of 360 and 223 m respectively. The depth ( $D_d$ ), width ( $W_d$ ) and length ( $L_d$ ) of the displaced mass were approximately 3, 60 and 150 m respectively. After initiation, the landslide damaged NH-10 and moved downhill towards the Teesta River. On the right flank, a small drainage channel was found, that may have increased the relative erosion rate and in turn the volume of debris during sliding. The estimated volume of the entire landslide body ( $\pi \times L_d \times D_d \times W_d/6$ ) was roughly 14,137 m<sup>3</sup> (ref. 1). The temporal Google Earth images depict the shifting and enlargement of this landslide body from its actual path during 2016–2020 (Figure 4 a) and indicates high temporal recurrence probability. The exact date of events prior to 2021 is unavailable in the historical database and by interviewing the local residents it was learned that past events at this location did not cause any damages. On 20 October 2021, this landslide was re-activated by consecutive heavy rainfall events for a few days. A spatial comparison of this landslide based on Google Earth images reveals that the main scarp was located below the road level having a total length of about 140 m during 2020, and thereafter, the slope above the road failed in 2021. Such recurrence with uphill expansion emphasizes the retrogressive nature of the Birik Dara landslide. Figure 4 b shows the schematic cross-sectional representation of this landslide and advocates that its position is the most dominating aspect regarding its risk.

**Figure 2.** Road condition after the landslide. (Source: Fastest Fast Sikkim YouTube channel and *East Mojo* newspaper.)

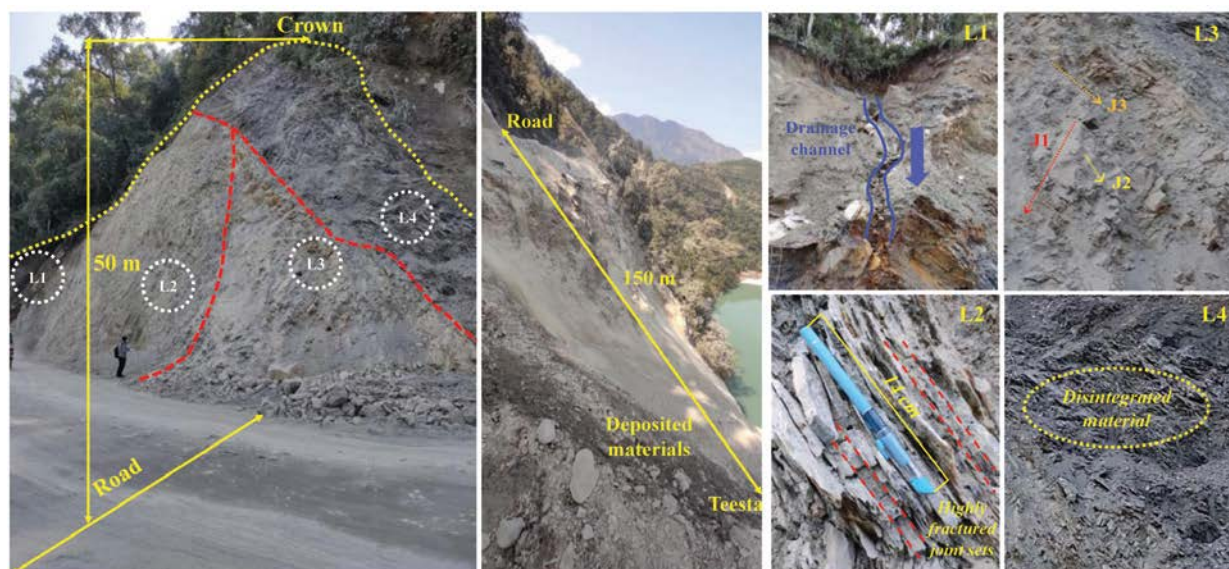
Geologically, the study area is underlain by the Daling series rock types, including meta-greywacke, slate, chlorite quartz schist and phyllite rocks (Figure 1)<sup>2</sup>. The site visit also revealed the presence of similar rock types in this area. The terrain consisted of rugged mountains running in all directions, separated by drainage valleys. Site inspection of this landslide indicated that the failure area mainly extended along a small folded ridge with steep terrain in the southeast and low in the northwest directions towards Teesta River. The typical association of different rock strata in the sliding zone reveals the complex geological attribute of this area and its proximity to the MBT (Main Boundary Thrust) also strengthens the seismic vulnerability. Phyllite and slate are the dominant rock types present in the sliding zone (Figure 3). These rocks are highly weathered and shea-

red, and easily disintegrated by hand. Considering the degree of rock mass weathering proposed by Goel *et al.*<sup>3</sup>, the identified rocks were categorized as grade IV to grade V classes. Discontinuities and closely spaced joint sets were visible in the main scarp area (Figure 3). The general dip direction of the prominent joint set was towards the northwest (N302°) with a dip of 68°. Table 1 presents a detailed description of the slope and joints. The geological evaluation reveals that the present study area has been subjected to intense tectonic activities in the geologic past and endorses the fact that the area is highly susceptible to landslides. Therefore, geological characteristics are considered one of the major preparatory factors for landslide occurrences in this area. During the field survey, representative rock samples were collected from the sliding surface, namely locations L1–L4 (Figure 3) for characterizing the engineering and physical properties.

**Figure 3.** Field photographs of Birik Dara landslide. L1–L4 represent locations from where rock samples were collected for laboratory testing.

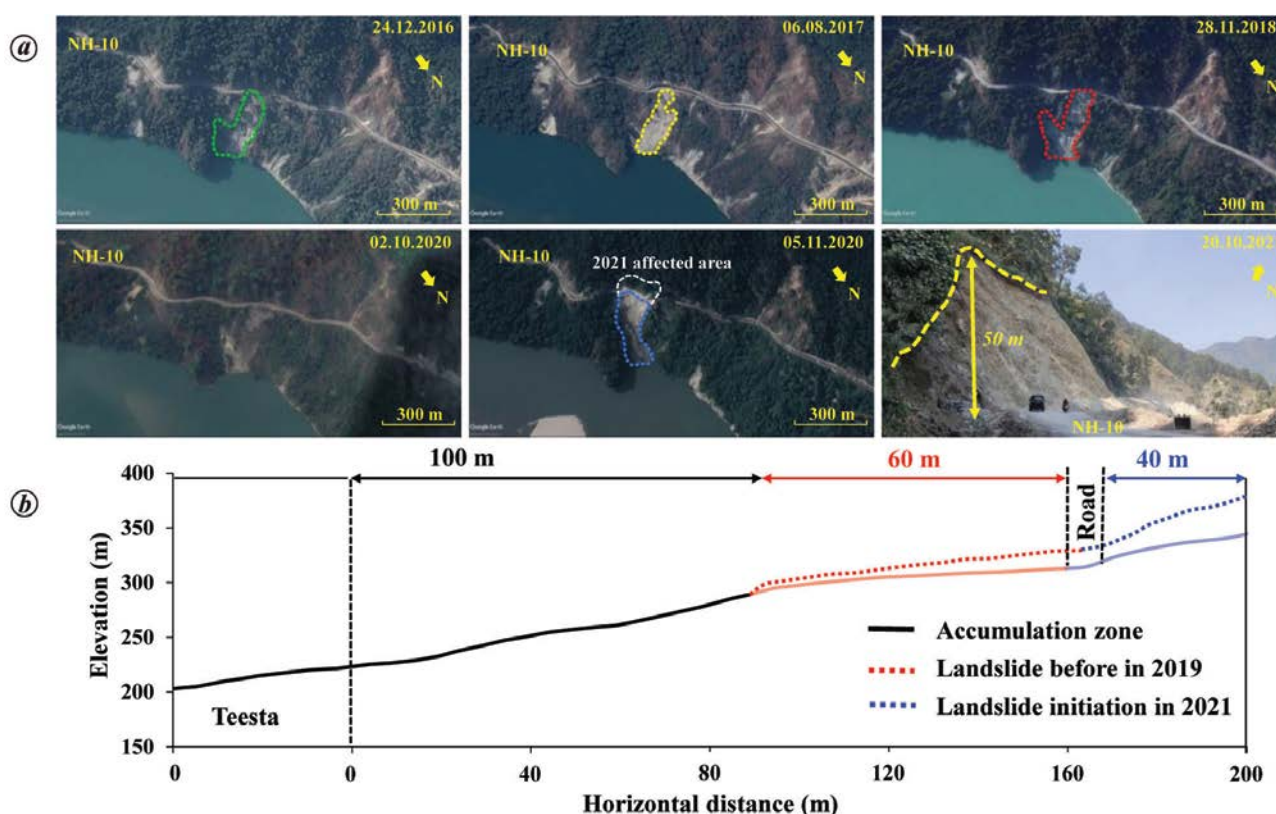
This landslide was characterized as a shallow retrogressive rock-cum-debris slide and witnessed frequent occurrences in a short period. In 2021, the active portion of this landslide had extended towards the Teesta River and is now progressing retrogressively to the uphill slope section above the road. This landslide requires special attention because of its disastrous effect on NH-10 and the associated economic loss to the affected area. In this regard, the present study aims to describe the factors responsible for the Birik Dara landslide and estimates the stability coefficient of the present slope based on the data collected during the field survey.

**Figure 4.** *a*, Temporal Google Earth (© Google Inc.) images of Birik Dara landslide. *b*, Schematic cross-sectional representation of the landslide.

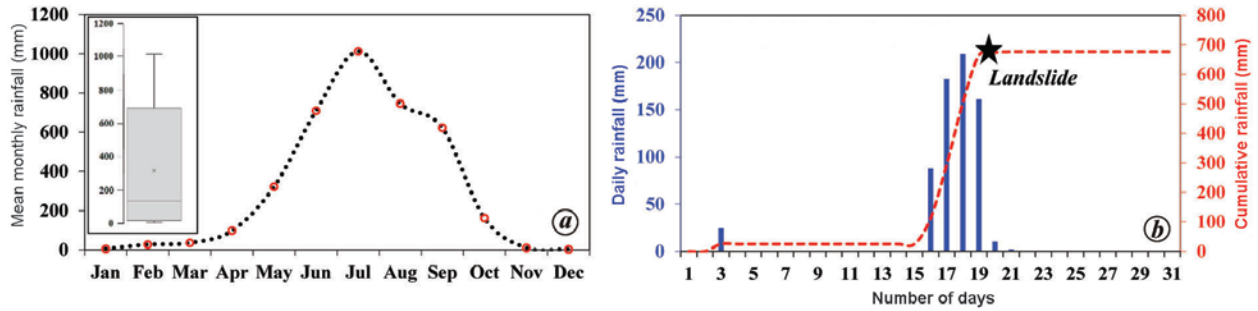
In the present study, daily rainfall data (mm/day) during the past 20 years (3 November 2002–2021) were collected from TLD-IV PS, located about 5 km southeast of the landslide site (Figure 1). The data show that the area received an average annual rainfall of about 3748.86 mm, with a unimodal peak during June–August (Figure 5 *a*). Figure 5 *b* shows rainfall data in October 2021. Critical analysis of the date of initiation in relation to the period of rainfall revealed that delayed monsoon rainfall had a pronounced effect on this landslide. On 20 October 2021, the landslide was triggered after an episode of extreme rainfall events for four days (87.6, 182.4, 209.2 and 160.8 mm of rainfall on 16, 17, 18 and 19 October 2021 respectively) that may have developed successive wetting fronts as well as increased pore pressure, thereby decreasing the shear strength of the highly weathered slope materials. Thus, it indicates that

high-intensity rainfall was responsible for triggering the Birik Dara landslide.

Figure 5. a, Mean monthly rainfall for the past 20 years (3 November 2002–2021). b, Daily recorded rainfall during October 2021.

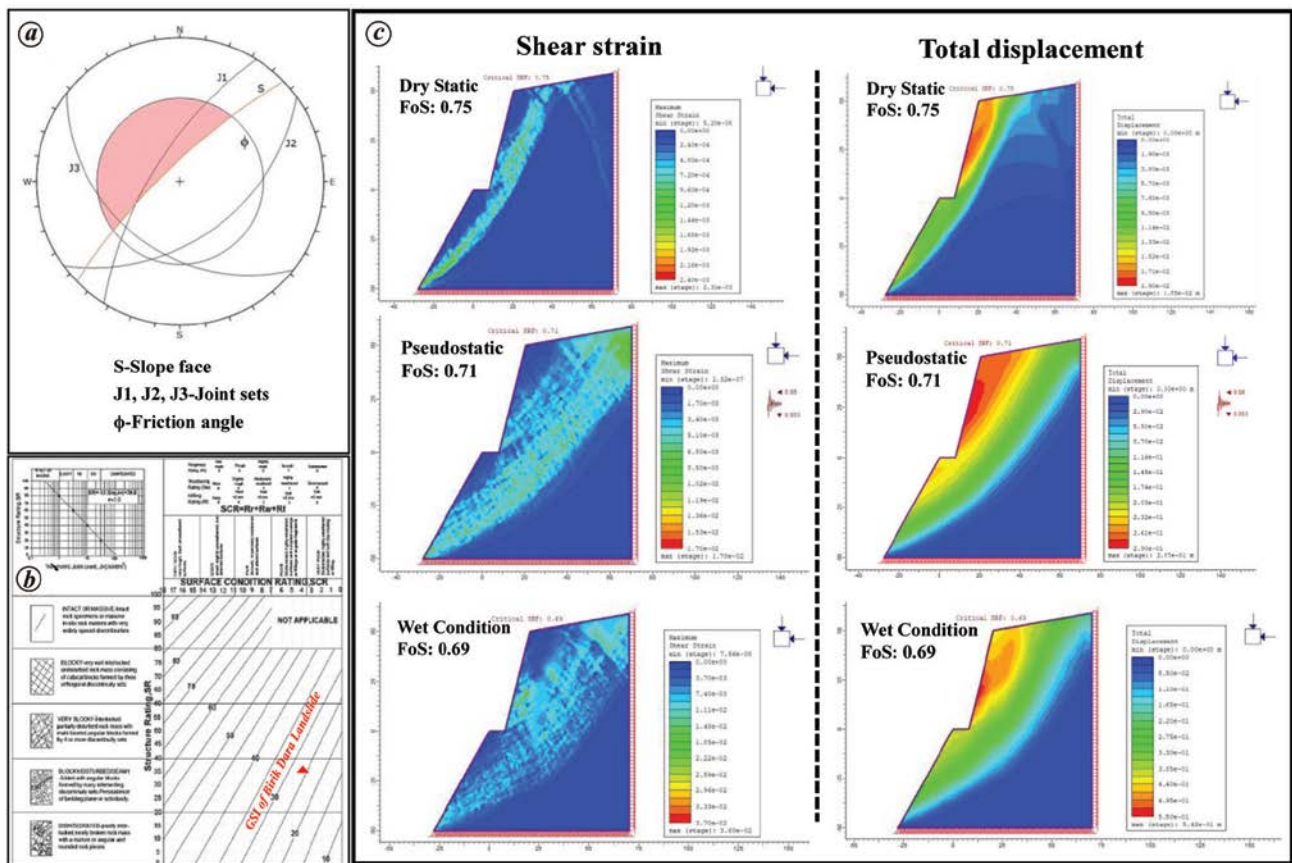
Figure 6. a, Kinematic analysis showing the joints–slope relationship. b, GSI chart showing the quantified GSI value of the studied slope (after Sonmez and Ulusay<sup>10</sup>). c, FEM-based stability analysis of the slope section.

Kinematic analysis was carried out using the Markland’s test described by Hoek and Bray<sup>4</sup> to interpret the slope–joints relationship. Table 1 presents the geometric orientation of the slope face (S) and the three identified joint sets (J1–J3) and in Figure 6 a, these are plotted in a stereographic projection. Notably, the structural orientation of J1 and slope face satisfies the conditions of a critical plane (dip direction  $\pm 20^\circ$ ) and justifies J1 offering a planar mode of failure for the landslide that occurred in 2021.

where  $J_v$  is the volumetric joint count ( $J_v = 1/S_1 + 1/S_2 + 1/S_3 \dots + 1/S_n$ , where  $S_1, S_2, S_3$  and  $S_n$  are the average joint spacing). The SR and SCR values obtained were 32.41 and 4 respectively (Table 2). Thus, the GSI value obtained for the studied slope was 27 (Figure 6 b). The low value of GSI indicates that the rock mass quality of the slope is poor and such slopes are often susceptible to landslides.

In this study, we also incorporated the pore water pressure ( $R_u$ ) coefficient to simulate different water saturation conditions by assuming constant moisture levels at different depths. The obtained FoS values were 0.75, 0.71 and 0.69 for dry static, pseudo-static and wet conditions respectively (Figure 6 c) and thereby supporting a precarious slope.

This study describes the causative factors and failure mechanism responsible for triggering the Birik Dara landslide and also analyses the stability of the slope using diverse methods. A side-by-side comparison of the applied rock mass classification techniques, including kinematic analysis, reveals that the slope section is critically unstable, which has been further strengthened by FEM analysis (FoS  $\leq 1$ ). Although this landslide does not pose any direct risk to the settlements, it has a strong propensity to damage NH-10 and may affect the traffic. After the 2021 incident, the road was cleared for transportation, but it may be damaged again due to future rainfall/earthquake events. Considering the strategic significance of NH-10 as the only route for the people of Sikkim and Kalimpong to connect with the rest of India, it is imperative to develop appropriate stability measures to avoid future disastrous situations. The rationale behind this study is to ensure safe operation in this area, and also provide guidance to the decision-makers for landslide hazard mitigation and environmental remediation.
