Performance of residential buildings during the M 7.8 Gorkha (Nepal) earthquake of 25 April 2015

Durgesh C. Rai*, Vaibhav Singhal, S. Bhushan Raj and S. Lalit Sagar

Department of Civil Engineering, Indian Institute of Technology Kanpur, Kanpur, India

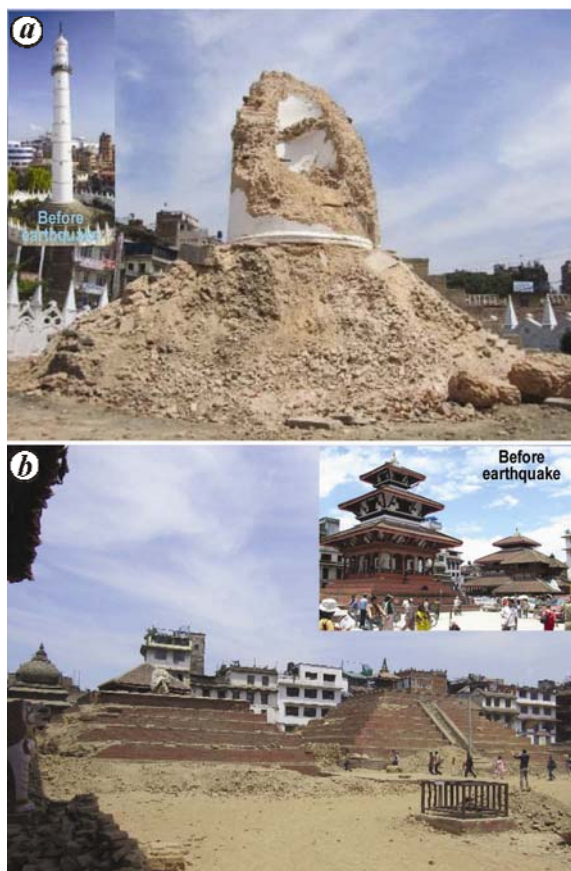
ing of seismic waves. There could be other factors which have resulted in concentrated damage, but due to the lack of sufficient number of ground motion records, the soil amplification and focusing effect cannot be proven currently. The cultural heritage structures suffered extensive damage during this earthquake. Especially the historical temples and palaces in the urban centres of Kathmandu, Bhaktapur and Patan suffered severe damage (Figure 4).

Figure 4. (a) Collapse of Dharhara tower in Sundhara, Kathmandu ($27^{\circ}42'3''$, $85^{\circ}18'42''$). (Inset) Before earthquake (photo: Corbis Ian Trower). (b) Collapse of temples in Hanuman Dhoka, Kathmandu ($27^{\circ}42'14''$, $85^{\circ}18'29''$). (Inset) Before earthquake (photo: Andrej Pauš).

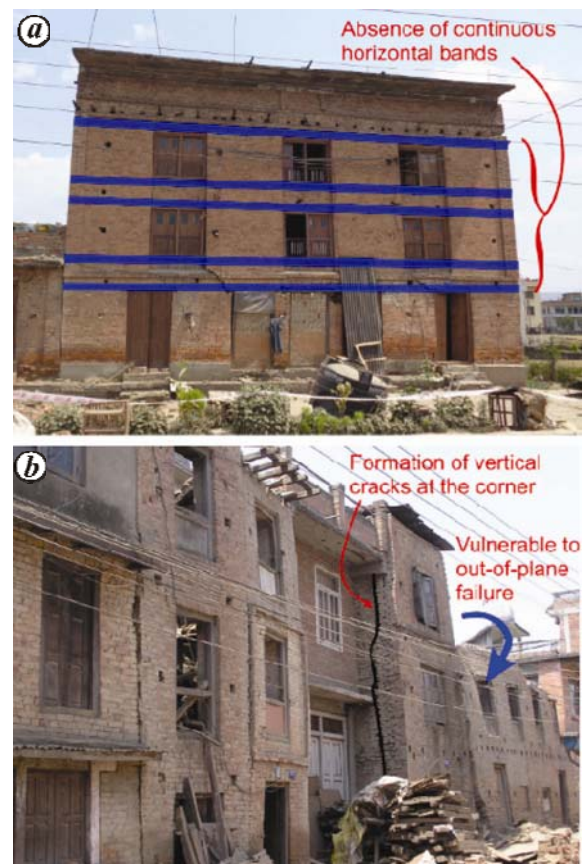
Figure 5. Typical URM construction in Nikosera ($27^{\circ}40'45''$, $85^{\circ}24'10''$): (a) Absence of continuous horizontal bands, and (b) formation of vertical cracks at the corner which resulted in the separation of cross wall from the main wall.

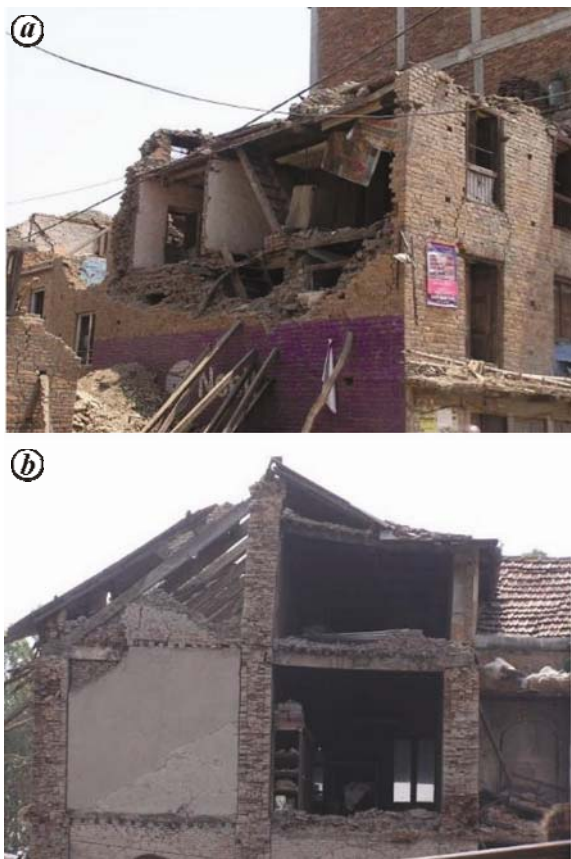
Figure 7. Typical out-of-plane failure of unreinforced masonry walls: (a) Failure due to absence of positive connection between the cross wall and main wall in Nikosera (27°40'45", 85°24'10"), and (b) failure due to proper connection between floor/roof diaphragms and walls.

forcement in the form of timber or steel should be provided to integrate the box action for the peripheral walls (Figure 6). Due to the absence of positive connection between the walls at the corners and at T-junctions, these behave as free-standing slender walls subjected to large out-of-plane seismic forces due to their heavy mass which often exceeded their capacity. Thus these separated walls were vulnerable to out-of-plane collapse and many failed during the shaking (Figure 7).

The floor and roof diaphragms were made of timber joists with timber planks and were embedded in the masonry (Figure 7 a). Wooden pegs were generally used to prevent the dislodgement of the roof from the wall in the Newari buildings as shown in Figure 6 c. However, as observed in Figure 7 b, the timber joists were simply embedded into masonry walls without provision of pegs. Consequently, they were incapable of holding the walls together resulting in tall, free-standing wall sections vulnerable to out-of-plane collapse. Some old masonry buildings, especially heritage structures which survived during this earthquake, were provided with the continuous timber bands at each storey levels. In addition, wide timber bands were provided on the top of openings, which acted as lintels for carrying the loads from the upper storeys (Figure 8 a). The roof was connected to the walls by means of wooden pegs which enhanced the box action of the building (Figure 8 b). The sloping/overhanging timber roof was supported by aesthetically carved timber struts, which also acted as structural members enhancing the rigidity of the floor/roof (Figure 8 b). However, it seems that this knowledge of earthquake-resistant features in unreinforced masonry was somehow lost during the last few decades leading to the poor seismic performance of these unreinforced masonry buildings. The lack of earthquake-resistant features in these masonry structures could also be due to high cost and non-availability of structural timber in the Himalayan region. The use of materials other than timber, such as precast RC and steel members, for confining masonry should be investigated for wider application²².

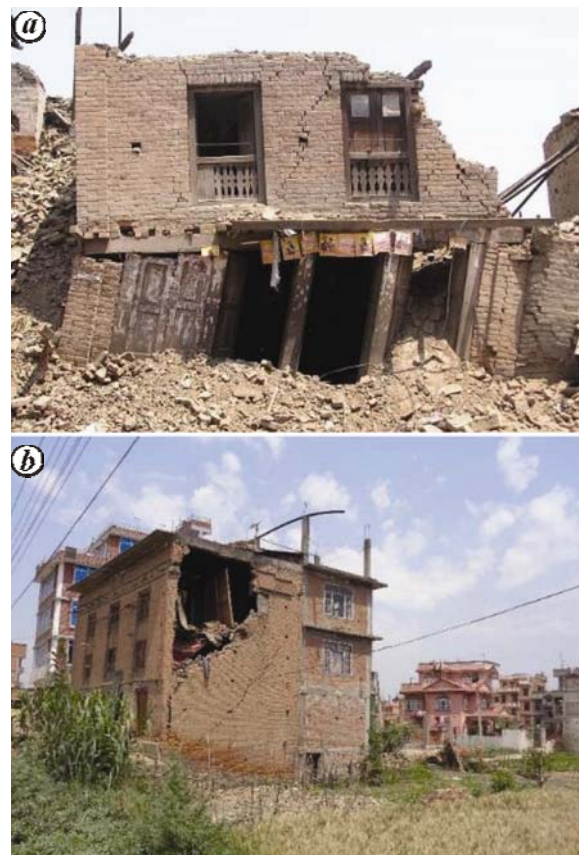
damage by step-type diagonal cracks in masonry walls extending to the full storey height was also observed, which further reduced the out-of-plane strength of walls and increased the risk of out-of-plane collapse (Figure 9a). From the failure pattern of building shown in Figure 9b it can be observed that in-plane damage was followed by out-of-plane collapse.

Figure 9. URM buildings failures in Nikosera ($27^{\circ}40'45''$, $85^{\circ}24'10''$): (a) Collapse of three-storey unreinforced masonry building, and (b) combined in-plane and out-of-plane failure of the wall.

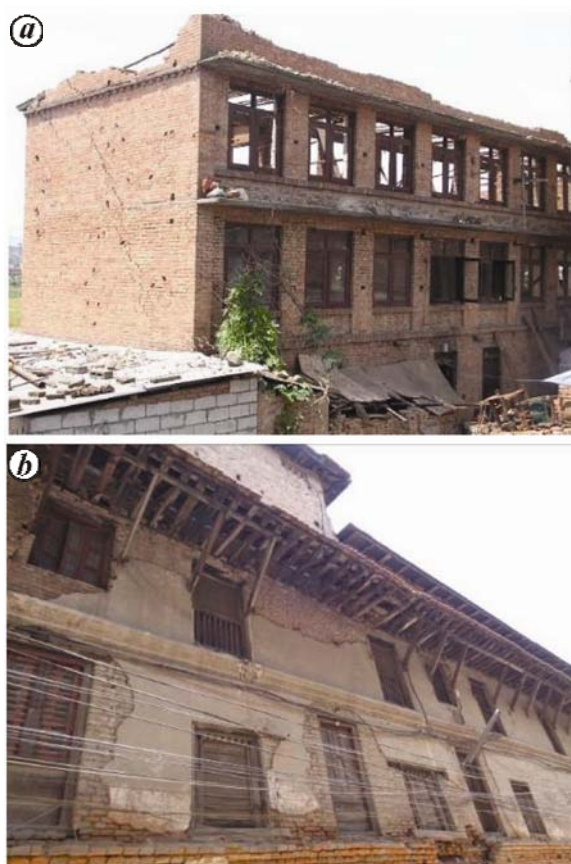
Figure 10. *a*, Partial collapse of URM building with large openings in Nikosera ($27^{\circ}40'45''$, $85^{\circ}24'10''$). *b*, Typical view of the residential building with too many openings placed haphazardly near Kathmandu Durbar Square ($27^{\circ}42'14''$, $85^{\circ}18'29''$).

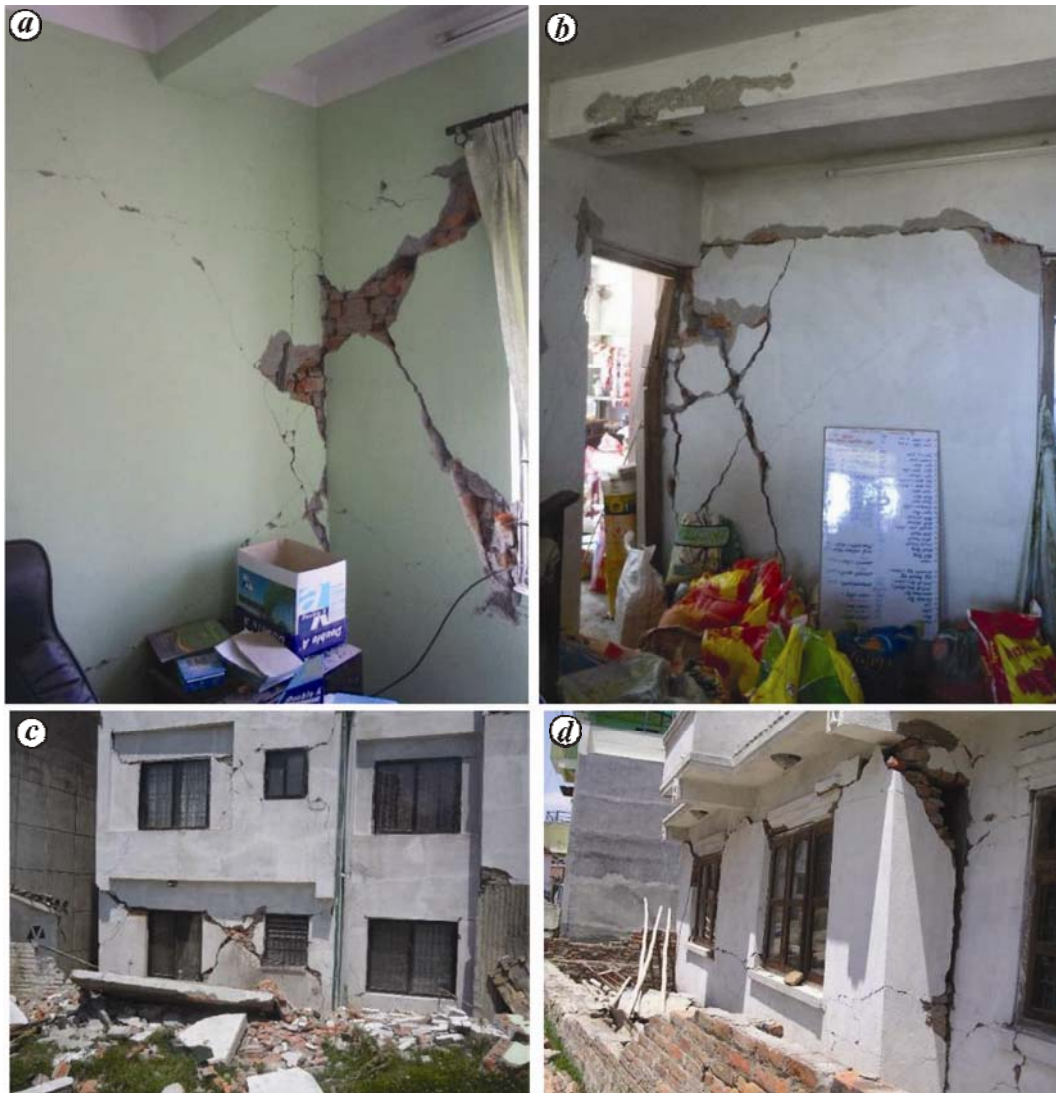
Figure 11. Various structural defects in newly constructed residential buildings in Kadhka Gaon ($27^{\circ}41'43''$, $85^{\circ}15'53''$): (a) Absence of column at the intersection of two walls. (b, c) Damage to the wall panel due to absence of confinement all around the openings. (d) Projection of masonry wall beyond the column grid line.

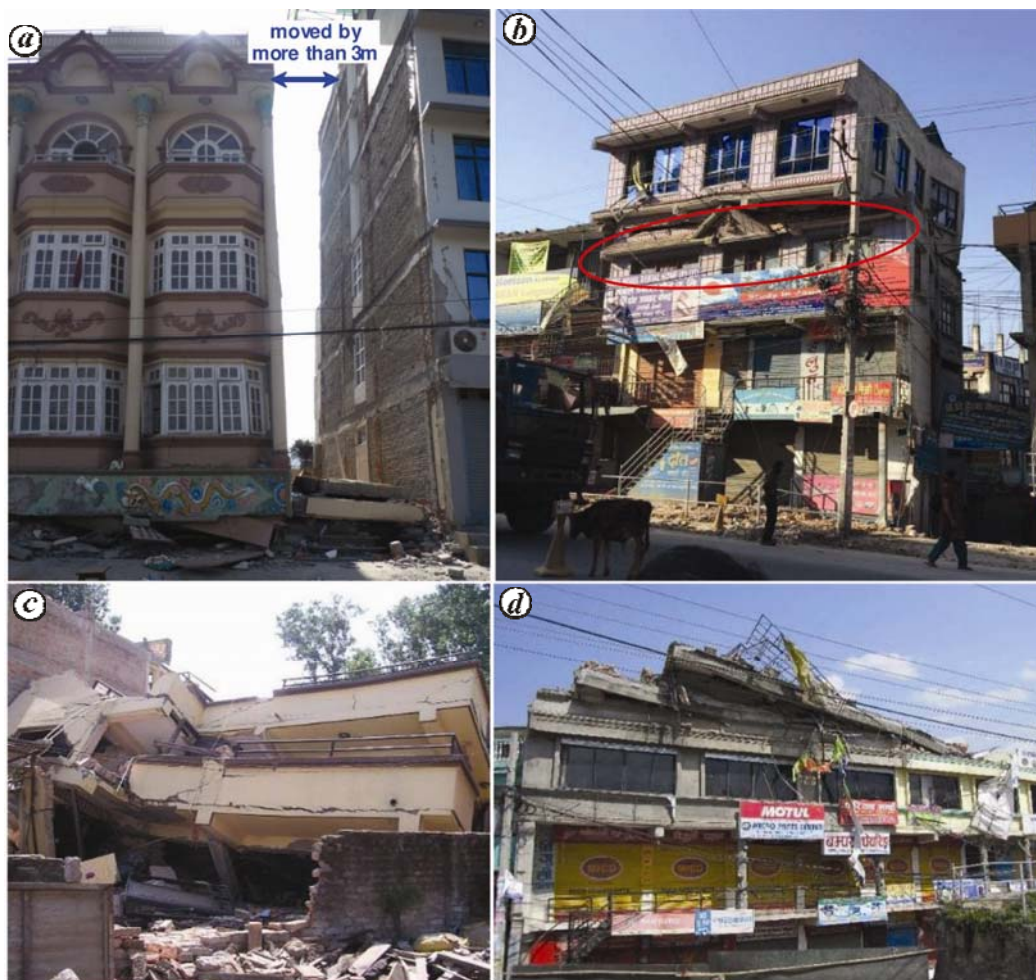
Buildings with open ground storey are notorious for their poor behaviour during the past earthquakes and this event was no exception. Many open ground-storey buildings collapsed completely due to soft/weak storey mechanism. A residential building with open ground-storey in Sitapaila, Kathmandu which stood immediately adjacent to another building collapsed due to plastic hinge formation in the ground-storey columns and moved away laterally by about 3 m from the adjacent building (Figure 12 *a*). Buildings which were partly used for commercial purposes collapsed, often with pancaking of floor slabs, due to open ground and intermediate storeys in the absence of infills (Figure 12). The collapse of these buildings was primarily triggered by the formation of soft/weak storey mechanism due to the inadequate wall area, small size of RC frame members and poor reinforcement detailing at critical locations.

Figure 12. *a*, Open ground storey failure of four-storey building in Sitapaila, Kathmandu, ($27^{\circ}42'42''$, $85^{\circ}16'58''$) and (*b-d*), pancake collapse of single and multiple floors of commercial and residential buildings (*b*, Machha Pokhari – $27^{\circ}44'06''$, $85^{\circ}18'20''$; *c*, Sitapaila – $27^{\circ}42'36''$, $85^{\circ}16'59''$; *d*, Kalanki Bus Stop – $27^{\circ}41'47''$, $85^{\circ}16'54''$).

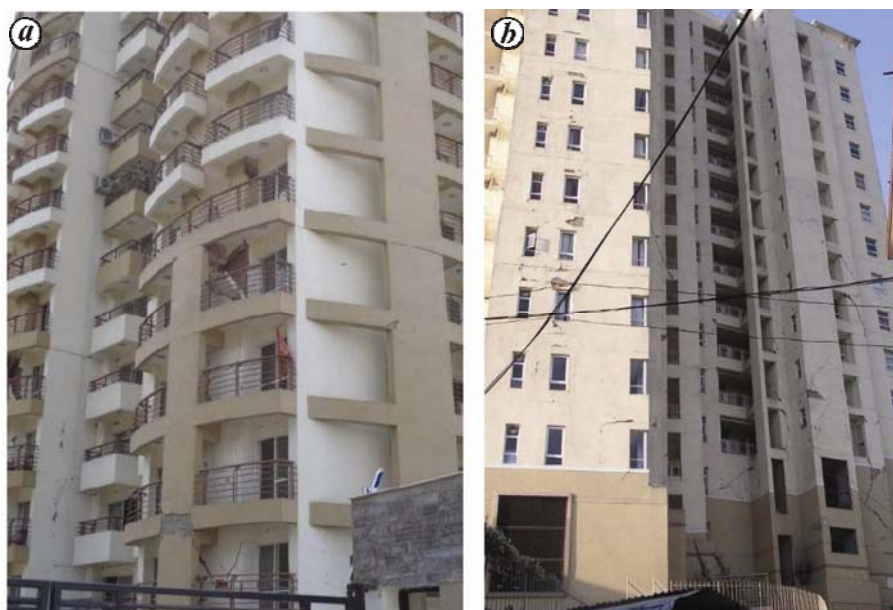
Large multi-storey commercial buildings and residential apartments which were supposed to be built under professional guidance also suffered extensive damage, though they did not collapse completely. Damage to the masonry infill walls such as large diagonal cracks in masonry panels and at the frame–masonry interface was common in these high-rise structures (Figure 13). The projection of walls outside the framing elements is widely prevalent in the rapidly urbanizing valley region driven by the need to utilize space to the maximum. However, these slender projecting walls when not positively connected or integrated, with the building frame become extremely vulnerable to collapse along both in-plane and out-of-plane directions, as observed in the 15+ storey buildings in Kathmandu and Lalitpur. Moreover, such high-rise buildings weakened by the damage to infills, posed serious danger to neighbouring buildings in densely built areas in the event of a strong aftershock ground motion. Diagonal shear cracks in masonry piers near openings were commonly observed in the wall panels where the continuous horizontal RC bands were not provided (Figure 13 *a* and *b*). Poor monitoring of the urban

Figure 13. Typical damage to masonry infill in tall RC frame buildings: (*a*) 17-storey apartment building in Patan ($27^{\circ}39'02''$, $85^{\circ}19'55''$) and (*b*) 14-storey building in Kathmandu ($27^{\circ}44'21''$, $85^{\circ}19'27''$).

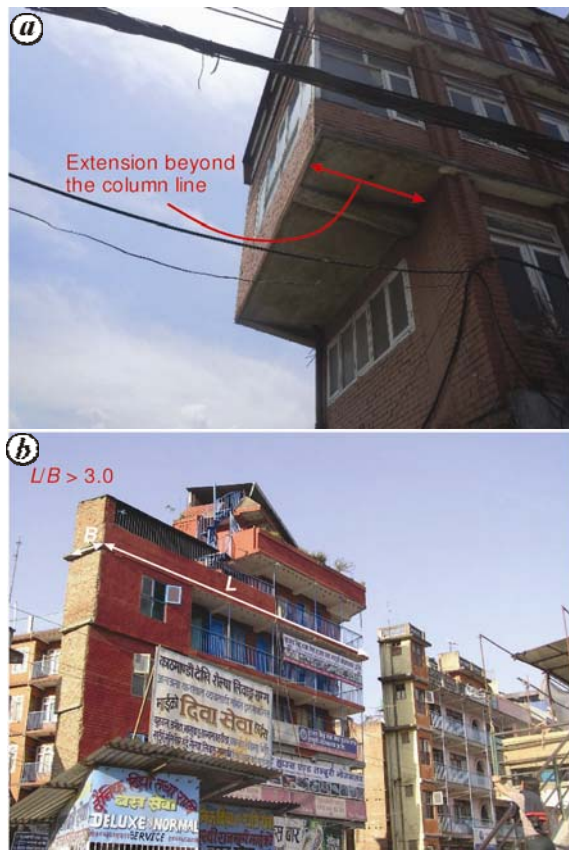
Figure 14. (a) An example of RC building with upper storeys supported on long cantilever slab or beam, and (b) a building with very large length to width ratio (L/B).
