## **Evaluation of Failures and Design Practices of River Diversion Structures for Irrigation: A Revisit of Two SSI Schemes in Ethiopia**

**Abstract:** In this paper, the design practices and failure mechanisms of two small scale irrigation (SSI) schemes (Awushoana and Kecha) in Ethiopia were evaluated. An attempt was made to understand the design problems with respect to hydrologic, hydraulic and structural design aspects. The main constraints that contributed to the malfunctioning of the irrigation system in the schemes associated with planning, institutional, social, operational and economic parameters were also assessed. The main problems observed in Kecha scheme were sedimentation at the headwork, damage of intakes and sluice gates, clogging of intakes, damages of distribution systems and ram body. Whereas accumulation of boulders, structural failures of diversion weir, damages of the intake gates, main canals, and absence of the under sluice were observed in Awushoana scheme. Some of the problems attributed to the institutional, social and operational problems due to lack of adequate community participation, the absence of Water Users Associations (WUA's), proper handing ove

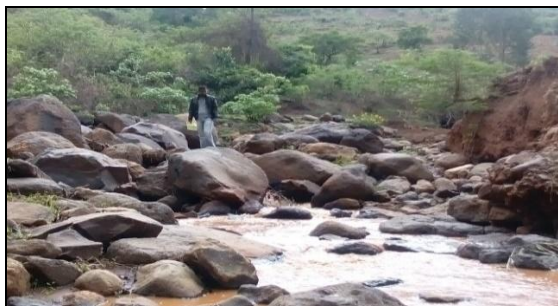
**3.1.4 Upstream flooding:** The field study indicates that the siltation of headwork in both of the schemes, and damages of the main canal and weir proper in Awushoana SSI scheme (Fig. 4). The field survey was also revealed that Awushoana river basin having

mountainous, undulating to rolling, steep to very steep slopes. This characteristic supplemented with the meandering of river terrain insisted to high runoff which results flooding with silt and sediments deposition at river course. In addition, the main causes of weir failure were found weir site foundation problem and instability of the side banks at the upstream of the weir.

**Fig. 4:** Accumulation of boulders upstream of weir of Awushoana

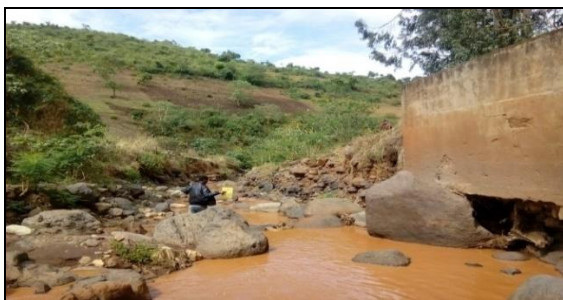
There was no proper design of downstream protection works like a downstream impervious apron, cut-off wall, downstream block protection, launching apron and a downstream sheet of piles and their length and thickness were not properly designed. This results in failure of downstream work in the case of Awushoana scheme (Fig. 5). The improper hydraulic design arises from poor knowledge of energy dissipation and impact of sediment on the structure (Baban [19]; Novak et al. [20]). The impervious floor is designed in all cases to reduce surface flow action that causes scouring due to unbalanced pressure in the hydraulic jump tough. The stilling basin is seldom designed to confine the entire length of a free hydraulic jump on the paved apron because such a basin would be too expensive. The main purpose of such control is to shorten the range within which the jump will take place and thus to reduce the size and the cost of stilling basin (Hoffmans and Verheij [21]).

**Fig. 5:** Damages on downstream protection work at Awushoana SSI scheme

The observations indicate that water is flowing beneath the foundation of the structure results total failure of the scheme. Also, it was found the absence of upstream and downstream sheet piles to control the sub-surface flow which induces failure due to uplift pressure or piping.

**3.3.3 Downstream scouring and damage of downstream apron:** From the hydraulic analysis, Awushoana weir indicated that failure corresponds to the position of the hydraulic jump due to variation occurring in the bed of the river. The proposed solution to this problem is to create a stable hydraulic jump within the limited stilling basin. It is useful means of dissipating energy in the supercritical flow.

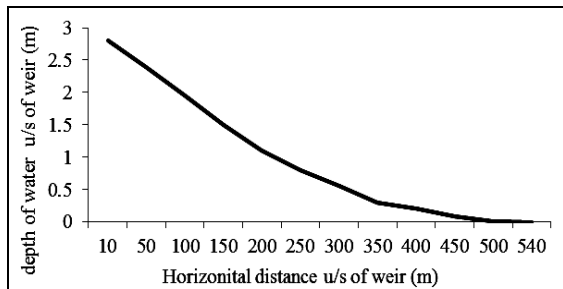
The water profile of the weir at the upstream and downstream for the Awushoana scheme should be determined which can be used in the design of energy dissipating structures of the weir and fixing the dimensions of these structures. The backwater effect due to the construction of the weir is required to determine the level of the water surface at different length upstream of the weir (Fig. 8). This computation is needed to determine whether the flood over tops the river bank and to provide protection measures. In this particular site, river bank is more than the depth created during the design floods, there is an effect on the river banks. Therefore, protection work should be provided. Construction of the weir increases the total energy level and this energy has to be dissipated before the flow reaches the river channel. Since the flow over the weir is supercritical, the energy can be dissipated by the formation of the hydraulic jump. Therefore, this jump must be constructed at the downstream of the Awushoana weir section to prevent the surface flow damages.

Fig. 8: The backwater curves upstream of the Awushoana scheme

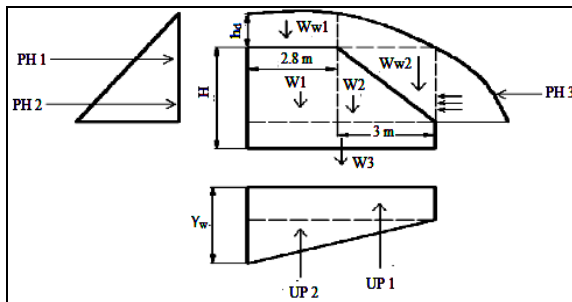
**Stability analysis of the weir under dynamic condition involves the following forces (Fig. 9):**

In the case of Awushoana diversion weir structure, this criterion is analyzed and the result implied that the stabilizing moment ( $\Sigma M_R=1562.45$ ) is greater than a destabilizing moment ( $\Sigma M_O=265.87$ ) for the high flood condition (Table 8). The factor of safety against overturning for the weir section is 4.136 ( $F_O=\Sigma M_R/M_O=1562.45/265.87 =5.87>1.5$  OK) which is between the recommended values (i.e. 1.5-2.0). This implies that the structure is safe against overturning. It is also necessary to keep the summation of vertical forces greater than the summation of the horizontal forces. In this case, the factor of safety against sliding for the weir section is 0.06 which implies that the structure is safe against sliding ( $F_s=\Sigma H/\Sigma V = 20368.2 =0.05$ ).

Fig. 9: The forces acting upon weir wall of Awushoana scheme
