## **Analysis on the Earthquake Damages Characteristics of Tunnel through Fault Zone**

**Abstract:** The factors and types of earthquake damages to tunnel through fault zone are analyzed and concluded based on the research on earthquake damage data of tunnel through fault zone in previous great earthquakes. The results indicate that tunnels through fault zone with complex geological conditions, high geo-stress and poor surrounding rock quality are main earthquake damage parts and controlling areas. The main factors which affect tunnel earthquake damage consist of seismic intensity, seismic fortification code, and construction quality of tunnel and activity of fault zone, all of which jointly affect the extent of earthquake damage to tunnel. Ductility lining structure which shall be adopted to fault zone and extended section of tunnel to avoid tunnel entire collapse; The types of earthquake damage to tunnel through fault zone at fractured zone mainly consist of dislocation of tunnel lining, longitudinal/transverse cracking of lining, chipping or peeling of lining, bulging of floor, and entire collapse of lining and surrounding rocks. The research results mentioned plays an importan

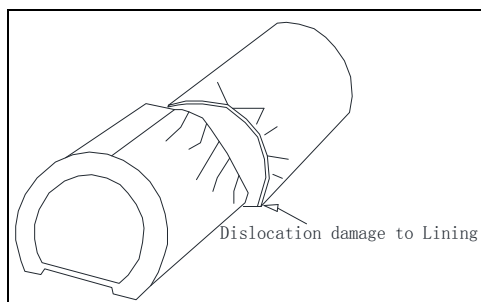
The tunnel structure of tunnel through fault zone has apparent dislocation at the fault fractured zone due to the apparent relative displacement difference of surrounding rocks during earthquake caused by apparently sudden change of preferable surrounding rocks and surrounding rock rigidity of tunnel through fault zone, and the lining has shear damage under fault zone. The followings are typical dislocation damage in earthquakes: the earthquake in San Francisco, US in 1906 caused dislocation damage to Tunnel Wright No. 1, and the horizontal dislocation was up to 1.37m; the earthquake in Izu, Japan in 1930 led to a horizontal dislocation of 2.39m and a vertical dislocation of 0.6m in Tanna Tunnel through fault zone of Tanna mountain, and the dislocation damage was severe; the earthquake in Hanshin, Japan in 1995 resulted in an apparent earthquake shear dislocation damage to the tunnel structure of Shanyang Shinkansen Malacca Tunnel after earthquake because of transversely passing through Malacca fault system; the fault zone had apparent dislocation damage along the construction joint and non-construction joint near F8 fault in Longxi Tunnel on Du-Wen expressway, the largest dislocation was up to 60cm, please see the damage type and damage to Longxi Tunnel in graphs 3-4.

**Figure 3** Damage to Tunnel Lining caused by Shear Dislocation of Surrounding Rock

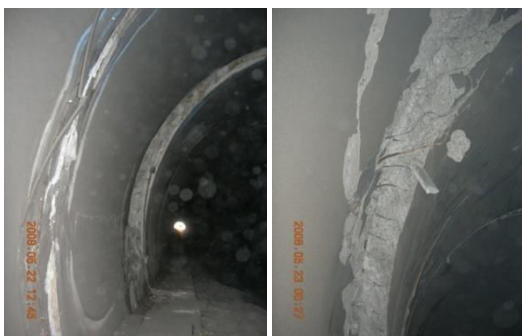
**Figure 4** Dislocation of Secondary Lining to Tunnel

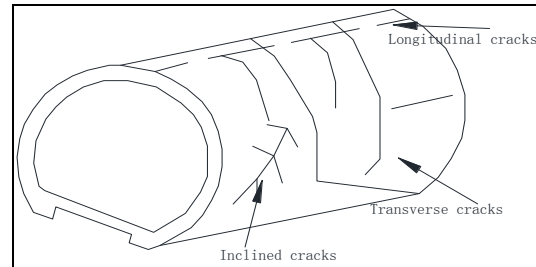
damages during the fault dislocation, and the cracks of lining mainly include longitudinal cracks, transverse cracks and inclined cracks. The apparent earthquake damage characteristics are mainly in Longchi Tunnel, Longxi Tunnel, Longdongzi Tunnel and Jiujiaya Tunnel in Wenchuan earthquake, Sanyi Tunnel in Chi-chi earthquake, and the damage types are shown in graphs 5-8.

**Figure 5** Cracking damage to lining of tunnel through fault zone

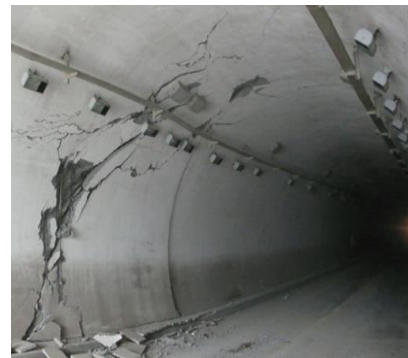
**Figure 6** Damage to Side Wall of Longchi Tunnel

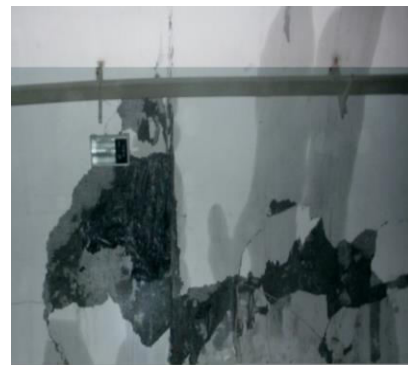
**Figure 7** Side Wall Damage in Hole of Longchi Tunnel

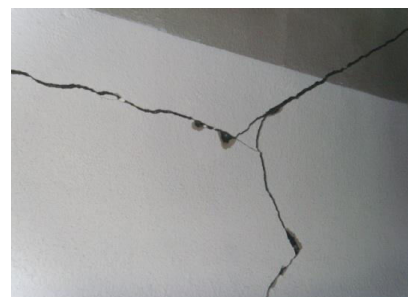
**Figure 8** Side Wall Cracks in Longchi Tunnel

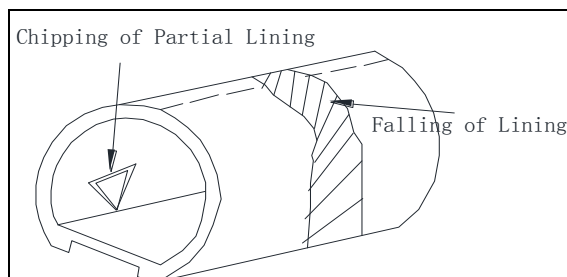
By the influence of concentrated high stress of fault zone, collapse of both lining and surrounding rocks or falling of secondary lining happened during earthquake in tunnel through fault zone, heavy collapse of surrounding rocks generally leads to the sealing of tunnel portal, which is one of the most severe earthquake damage to tunnel, and please see graphs 9-12 for damage features. Entrance portal of Longxi Tunnel had tunnel collapse in poor surrounding rocks, and the collapse caused serious sealing of tunnel; and secondary lining at the upper side wall of tunnel body section of 1 LongdongziZuoxian tunnel was collapsed, which led to severe damage to tunnel.

**Figure 9** Partial and Entire Falling Damage of Lining Arch Ring

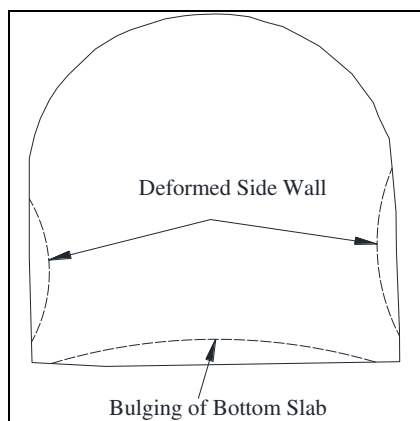
**Figure10** Bulging of Inverted Arch and Side Wall Damage of Lining

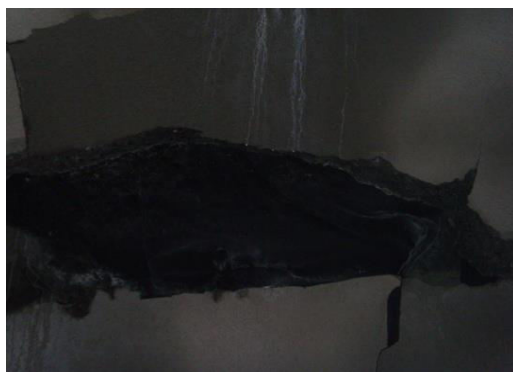
**Figure11** Collapse and Leakage of Lining at Zuoxian Tunnel Body Section

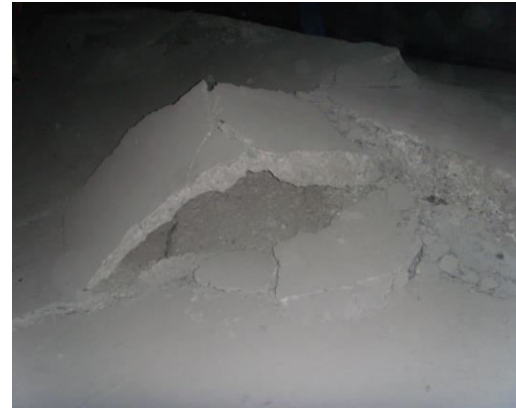
**Figure 12** Bulging and Cracking of Bottom Slab at Tunnel Body Section
