A Bizarre Scenario during Lung Isolation Due to Interchanged Double-lumen Tube Connectors

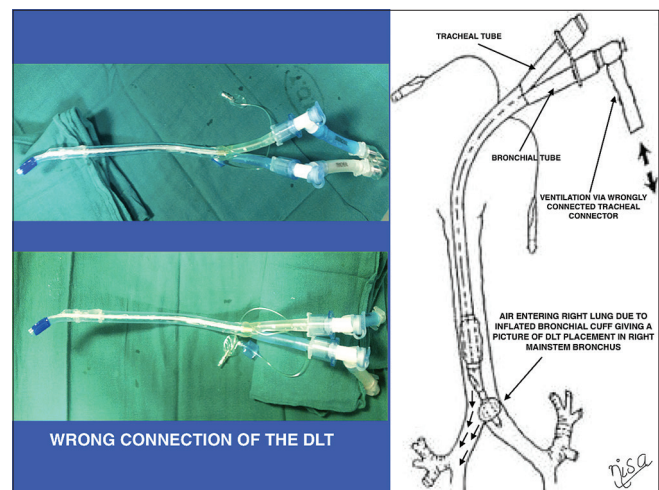
The initial scenario where the connectors were interchanged resulted in two situation. First, when the tracheal cuff was inflated, and ventilation was done through tracheal tube after clamping bronchial tube; where in reality ventilation was

occurring through the bronchial tube, as the bronchial cuff was not inflated, right lung was getting ventilated due to air leakage from the bronchial tube and a picture of bilateral air entry was felt and the tracheal tube appeared to be in its desired position above the carina.

Second, when the bronchial cuff was inflated, and the tracheal tube was clamped and ventilation was done through bronchial tube; where in reality, ventilation was occurring through tracheal tube, airflow was completely prevented from entering the left lung as the bronchial cuff was inflated, and air entry was heard only in the right lung. This gave a wrong impression that the left-sided DLT was accidentally placed in RMB [Figures 1 and 2].

Figure 1: Interchanging of connectors and mechanism of the right lung isolation

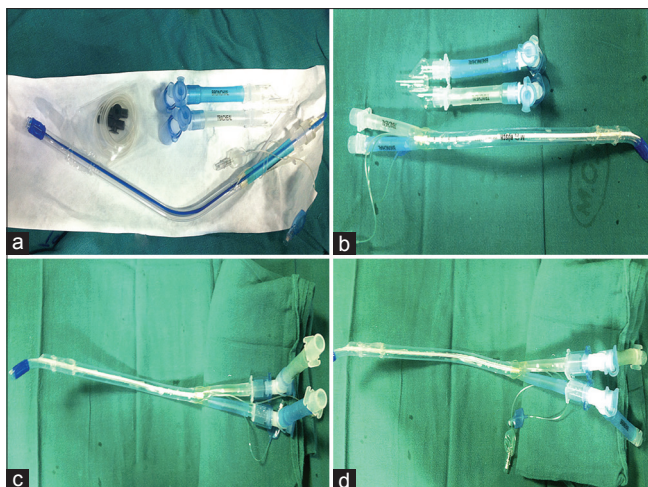
This was a case where lung isolation failure was presumed although DLT was correctly placed due to technical error. DLT are frequently used by the authors and routinely PVC Robertshaw tubes are used. Manufacturer coats the bronchial aspect of the DLT with a blue-colored cuff, balloon, and connector [Figure 2] for safety measure but was completely overlooked in our case and lead to a bizarre yet interesting clinical scenario.

Figure 2: Rusch Bronchopart Robertshaw double-lumen tube and its Parts (2a-2b) showing correct assemble (2c-2d).

using DLT. The suction port of both segments of the tube (both blue in this case) should also be color coded apart from blue-colored cuff, balloon, and connector as additional safety feature. A preformed connector assembly can also avoid this situation so that connectors of DLT not be interchanged during equipment setup.
