# Failure of Cold Drawn Steel Wires due to Formation of Friction Martensite

## Abstract

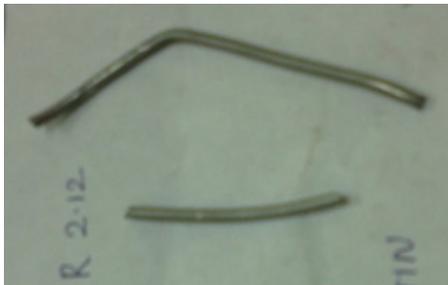
**Figure 1.** Cold drawn wire (R 2-12).

The investigation was carried out on two different shaped wire samples (R-12 and L-10) which failed during wire drawing operation at M/s Usha Martin Ltd (Figure 1 & 2). Additionally, tests were also conducted on similar samples which failed during service of the rope made of the cold drawn steel

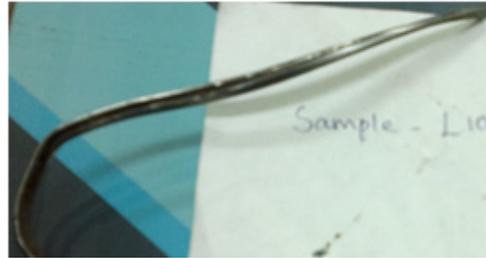
**Figure 2.** Cold drawn wire (L-10).

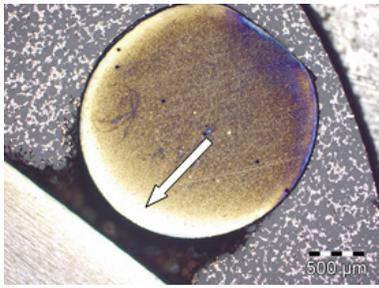
**Figure 3(a).** Cross section of R-12 wire sample at low magnification.

The microstructure of both the wires was observed under optical microscope after etching the polished specimens with 2% nital solution. Microphotographs were taken at low magnification as well as at 1000x for revealing the structures/ features present across the diameter which are shown in Figs. 3 & 4. On examining the microstructures it was revealed that the wires, in general, contained ferrite-pearlite microconstituents across the cross section (Figure 3b-c & Figure 4b-c). However, near to the surface/ edges a white layer (arrow marked) of fine microstructure was found to exist (Figure 3a & 4a).

Taking a closer view of these layers it was revealed that the morphology resembles with that of a low carbon martensitic microstructure, which most probably might have been transformed during wire drawing operation. Similarly, during service the industrial cables come across the un-lubricated pulleys and/or other parts of assembly, which causes friction and get heated upto austenitizing temperatures resulting in transformation of friction martensite.

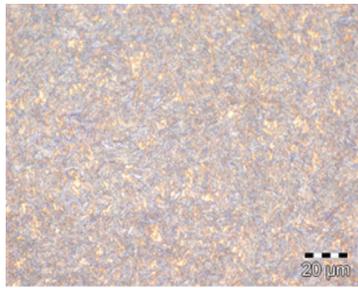
**Figure 3(b).** Fine pearlite & ferrite in transverse direction at 1000x.

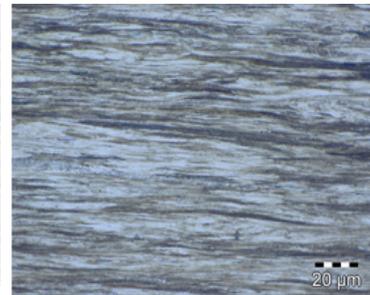
**Figure 3(c).** Fine pearlite & ferrite in longitudinal direction at 1000x

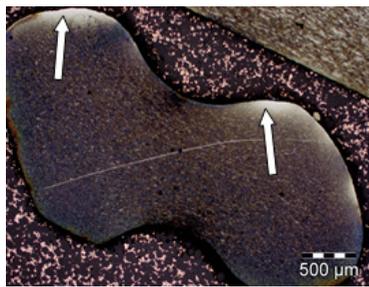
**Figure 4(a).** Cross section of R-10 wire sample at low magnification.

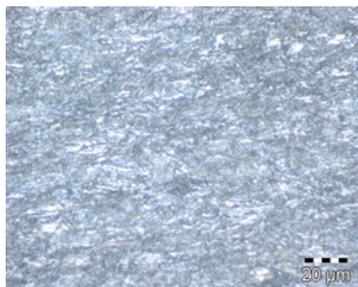
**Figure 4(b).** Fine pearlite & ferrite in transverse direction at 1000x.

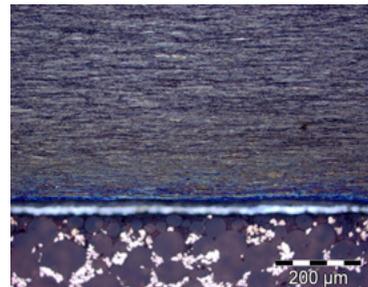
**Figure 4(c).** Fine pearlite & ferrite in longitudinal direction at 200x.

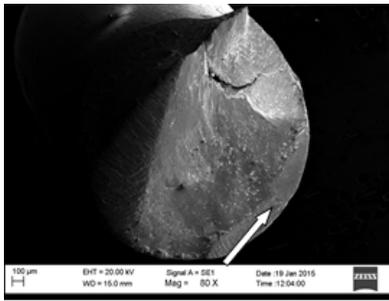
Scanning electron microscopy was conducted on the fractured surfaces of both the wire samples to identify the mode of fracture in the central parts as well as in the white layered regions. Photographs depicting the fractured surfaces of R-12 and L-10 samples are shown in Figure 7 and 8 respectively. It may be observed from these figures that the central parts of wires have experienced dimpled ductile fracture (Figure 7c & 8c), while the white layered regions have undergone shining brittle fractures (Figure 7b & 8b). This, in fact confirms the presence of harder phase (martensite) in the white layers as identified through optical microscopy as well as the micro-hardness measurements.

**Figure 7(a).** Broken surface of R-12 sample at low magnification.

The results obtained through optical microscopy, scanning electron microscopy, micro-hardness measurements and tensile testing of both the sample helped in inferring that the wires failed due to initiation of crack in the harder phase known as the friction martensite. There is evidence in the literature<sup>2</sup> that during wire drawing operation excessive wear/friction takes place due to high speeds and abusive operating conditions of improper lubrication. As a result, under the sliding wear conditions a large

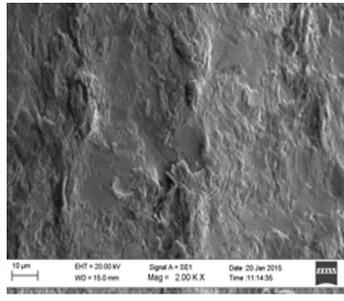
**Figure 7(b).** Shining brittle fractured surface at the edge (2000x).

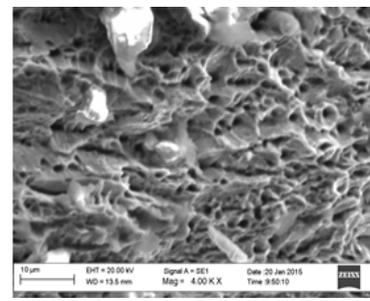
**Figure 7(c).** Dimpled ductile fracture surface in centre (4000x).

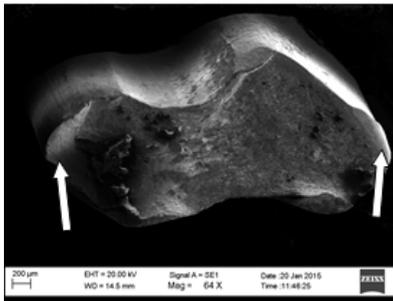
**Figure 8(a).** Broken surface of L-10 sample at low magnification.

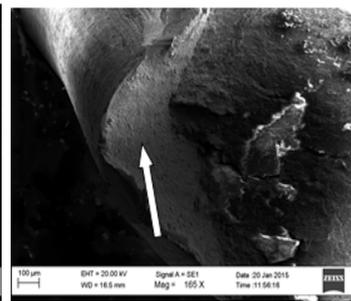
**Figure 8(b).** Shining brittle fractured surface at the edge.

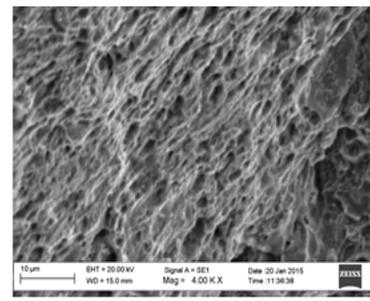
**Figure 8(c).** Dimpled ductile fracture surface in centre (4000x).
