# Seismic vulnerability of monastery temples of stone masonry in Sikkim Himalaya

**Buddhist monasteries in the Sikkim region have conserved and portrayed the art of Tibetan and Chinese architectural style through centuries. These historic structures have sustained varied degrees of damage due to earlier earthquakes. Their performance in the recent Sikkim earthquake of  $M$  6.9 on 18 September 2011 shows their high seismic vulnerability. A quick seismic assessment using certain simplified indices suggests higher vulnerability of damage for these heritage structures. A post-earthquake ambient vibration test established these monastery temples as short-period structures with fundamental period of 0.23 to 0.37 s. A finite element analysis of one of these temples has been done to study its dynamic behaviour. The response spectrum and static nonlinear pushover analysis highlighted vulnerable portions of stone masonry walls and provided useful insights for proper retrofitting to mitigate damage in future earthquakes.**

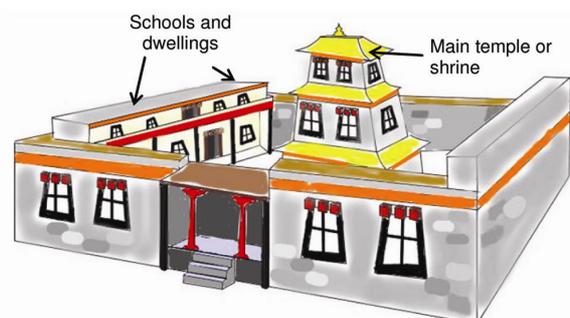
**Figure 1.** Layout of a typical monastery showing the courtyard, main temple and school.

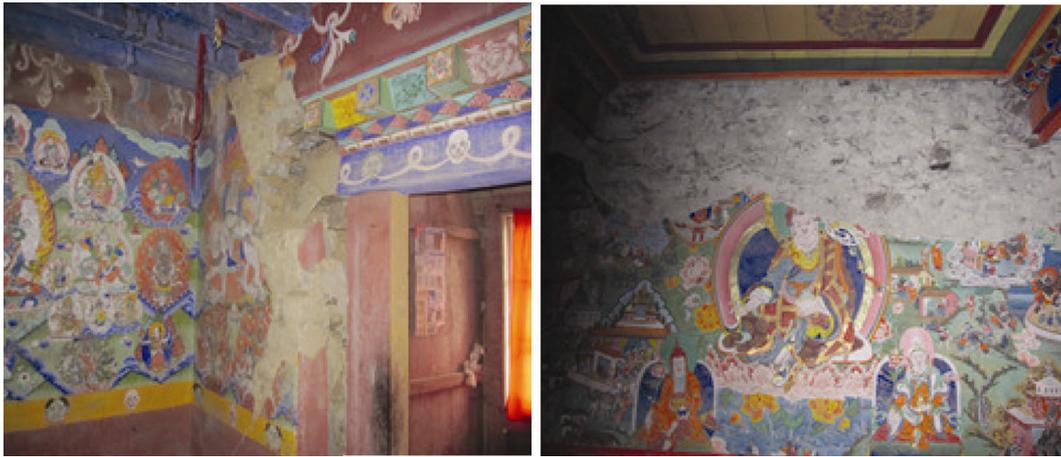
Figure 2. Damage caused to the frescos during the 18 September 2011 earthquake.

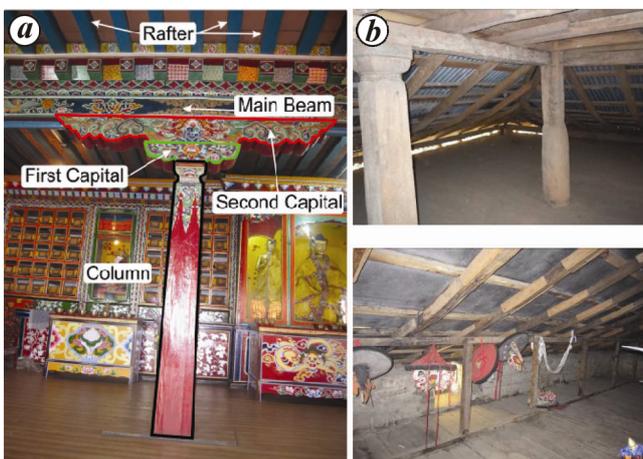
**Figure 4.** Typical details: *a*, Wooden timber frame and floor diaphragm supported on rafters; *b*, hipped roof construction.

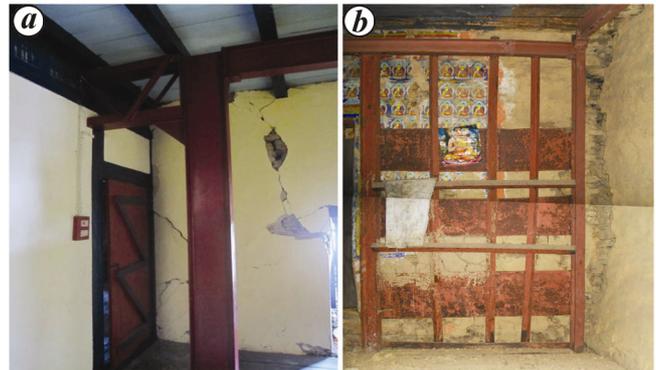
**Figure 5.** *a*, Steel frame in Labrang monastery for retrofitting, which proved ineffective during the September 2011 earthquake event. *b*, Walls damaged by supporting steel structure, Old Ngadak Gompa, Namchi, South Sikkim<sup>4</sup>.

In many monasteries certain appendages such as pavilions and extended prayer halls are built to accommodate the expanding congregation, for example, in Phodong monastery. Also, the unprofessional and unsystematic retrofitting on various occasions introduces RC, block/brick masonry or RC components in several monasteries. Most of the times, these interventions prove ineffective (Figure 5 *a*), and sometimes may even be detrimental to the structure as well as the artefacts (Figure 5 *b*)<sup>4</sup>.

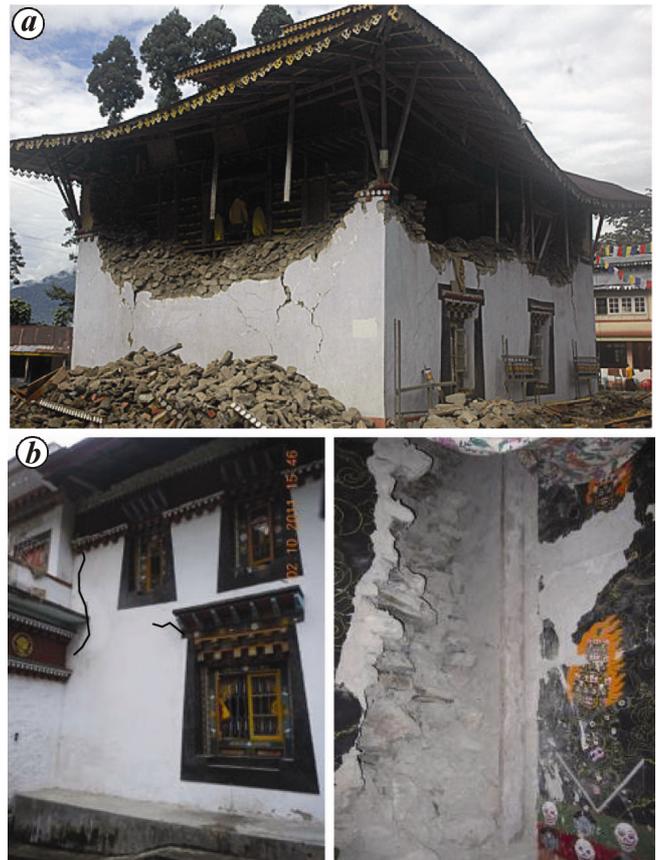
**Figure 6.** Common types of damages observed during the earthquake: *a*, Partial collapse of wall of Ringhem Choling monastery; *b*, Shear cracks and delaminated wall painting at Samten Choling monastery.

imposed on them. During the 18 September 2011 event, several monasteries suffered varying degrees of damage ranging from cracked walls to total collapse. Heavy damages were observed to exterior walls at several monasteries, e.g. total collapse of a village temple at Lachung, partial collapse in Ringhem Choling at Mangan (Figure 6 *a*), delamination of walls and cracks in Samten Choling temple, Lachung (Figure 6 *b*).

Figure 17 shows the contour plots of maximum in-plane stresses in both the  $x$ - and  $y$ -directions at the CP drift limit in masonry walls with compressive strength of 0.5 MPa (positive and negative stresses denote tensile and compressive stresses respectively). The tensile stresses observed at the corners of the openings exceed the lower-bound cracking value of 0.05 MPa, making them the most damage-prone areas of the structure (Figure 17). The locations of maximum stresses were the same as those of damages observed during the 2011 earthquake (Figure 7). The compressive stresses are maximum near the base of the structure and at corners the stresses are higher than the compressive strength. Regions of concentrated tensile stress are seen near the floor levels, which compare well with the observed damage at the connection between the diaphragm and walls. The high tensile regions in the upper storeys indicate the possibility of out-of-plane damage, similar to those observed in other monasteries, such as Ringhem Choling in Mangan (Figure 6a).

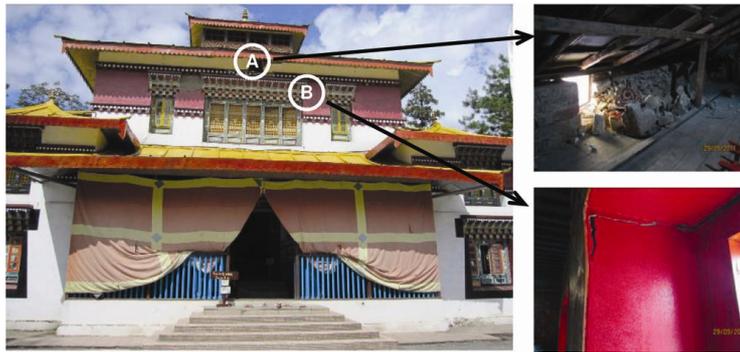
**Figure 7.** Damage observed on the front wall of the third storey at Enchey monastery.

Moderate damage was seen in many monasteries, including Enchey, one of the most important monasteries, built in 1909 near Gangtok. It was retrofitted after the 2006 Sikkim earthquake, but suffered moderate damages during the 2011 event<sup>5</sup>. The out-of-plane failure around the opening was observed in the unretrofitted portion of the third-storey wall (Figure 7), which is similar to the damage observed to the exterior wall built in stone laminates at Labrang monastery (Figures 5a and 8). The Labrang monastery was built in 1826 on a hilltop near the village of Tumlong and retrofitted after the 2006 earthquake<sup>3</sup>. The collapsed bamboo roof was replaced by a truss roofing system supported on steel columns erected around the shrine room. Steel joists connected to columns were also inserted below the timber floor to relieve the load on the timber beams and walls.

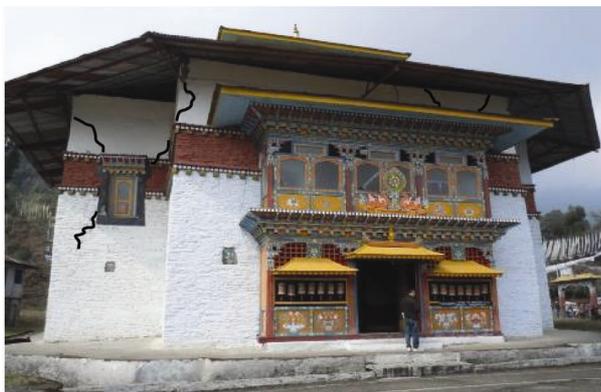
**Figure 8.** Cracks on the exterior wall of Labrang monastery.

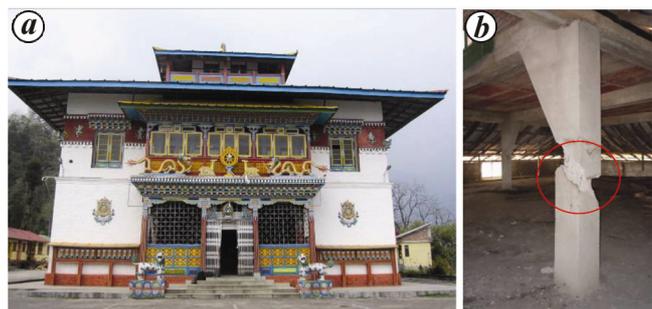
**Figure 9.** a, Phodong monastery, interior RC frame with exterior stone masonry wall. b, Damaged column due to short-column effect induced by the presence of deep haunches.

The Phodong monastery, built in the early 18th century and retrofitted later, is a mixed construction of RC frames and load-bearing masonry walls. These load-bearing exterior walls did not suffer damage during the recent earthquake (Figure 9a). However, the RC columns were severely affected because of the short-column effect due to the presence of deep haunches at the beam-column junctions (Figure 9b). The haunches were supposedly provided to increase the lateral load resisting capacity of the frame, which in turn created a short-column effect causing the brittle shear failure of the columns.

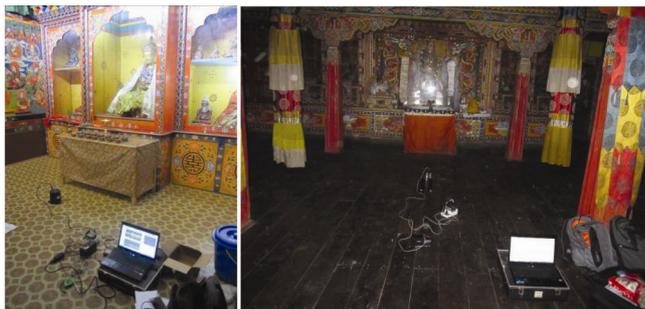
**Figure 10.** Experimental set-up consisting of seismometer and data acquisition system at Enchey and Labrang monasteries.**Table 2.** Frequency measurement of the ambient vibration test

vibrations caused due to wind, and various local random and periodic sources (traffic and human activity). The vibration measurements were made in two directions, i.e. parallel to the main entrance (*x*-direction) and perpendicular to the main entrance (*y*-direction) using the seismometer. Figure 10 shows the experimental set-up of sensors and data acquisition system at Enchey and Labrang monasteries.
