Deserted nineteenth century Paliwal villages around Jaisalmer, western Rajasthan, India: historical evidence of palaeoseismicity

A. B. Roy^{1*}, Harsh Bhu², Pankaj Sharma² and Kishan Vaishnav²

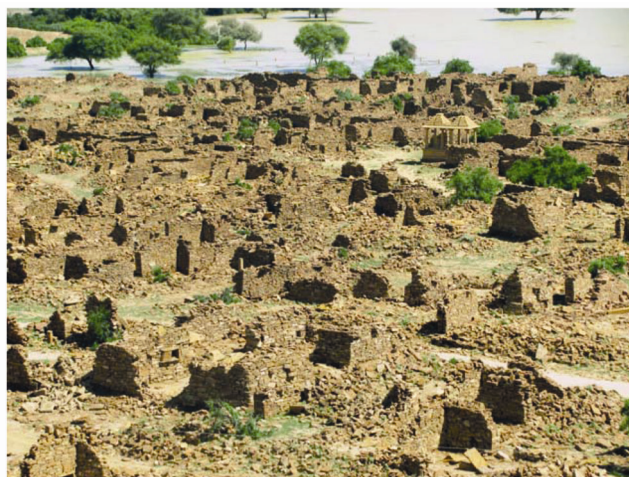
Figure 1. Part of the devastated village of Khabha near Jaisalmer, Rajasthan. Renovations are restricted to temple and ‘chhatra’ (canopy usually made to demarcate funerary sites). Rainwater has accumulated in the narrow depression in the background, which is a fault-bounded valley area (graben).

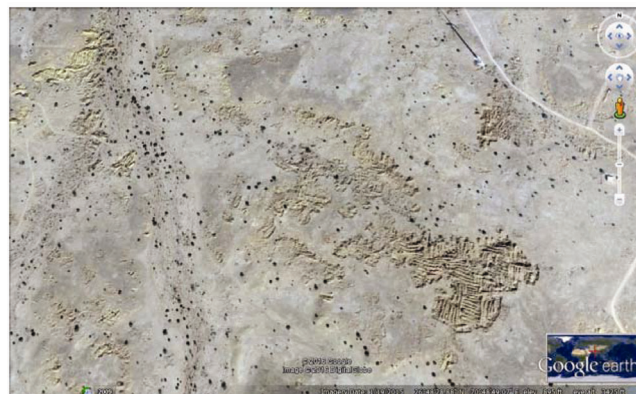
Figure 2. Google Earth imagery showing a general overview of destroyed houses near Kuldhra, Jaisalmer.

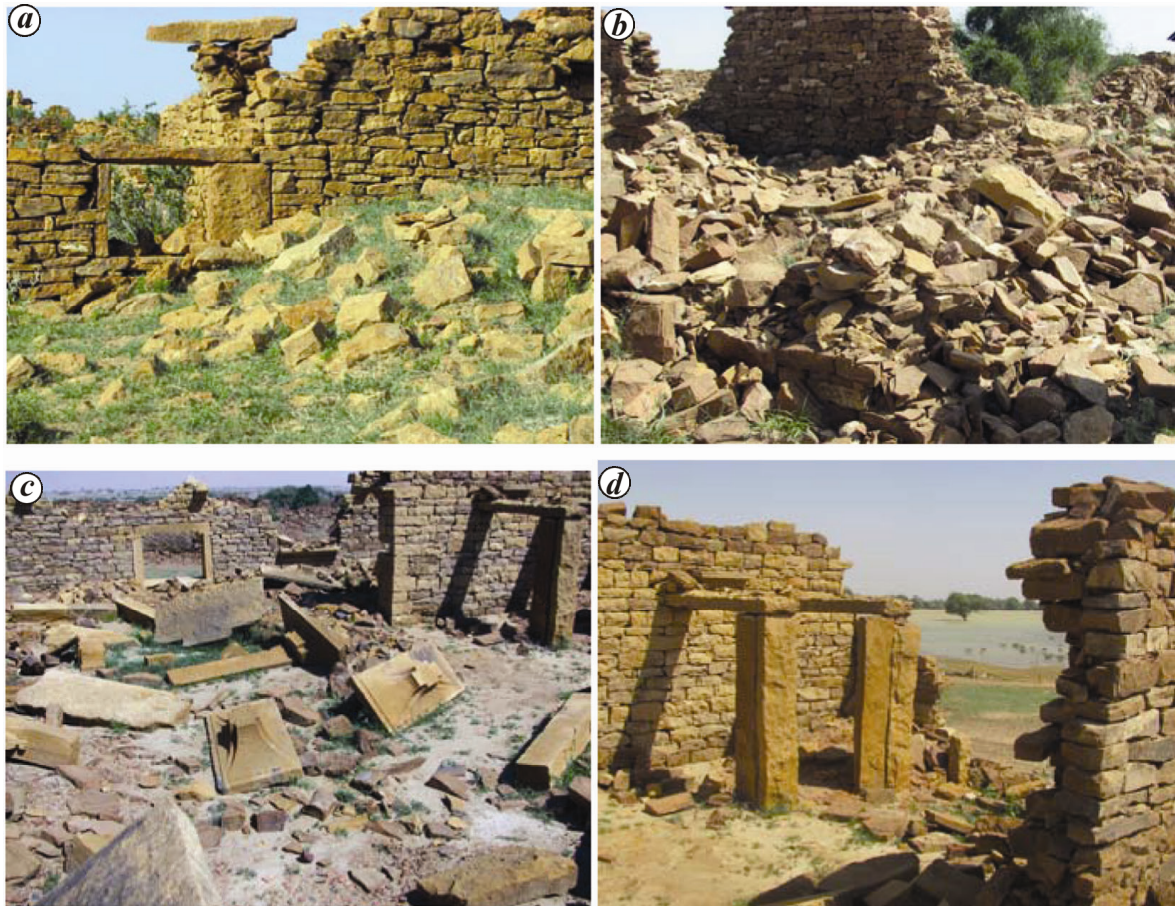
Figure 3 a-d. Collapsed walls and scattered dressed stones along with evidences of fallen joists, lintels and pillars strewn inside the houses. Some collapsed houses turned into heaps of rubble.

stones along with evidence of fallen joists, lintels and pillars provide tell-tale evidence of devastation in all the houses (Figure 3). Some houses are damaged to such an extent that they look like rubbles of scattered stones. Destruction of such scale and complexity is generally not

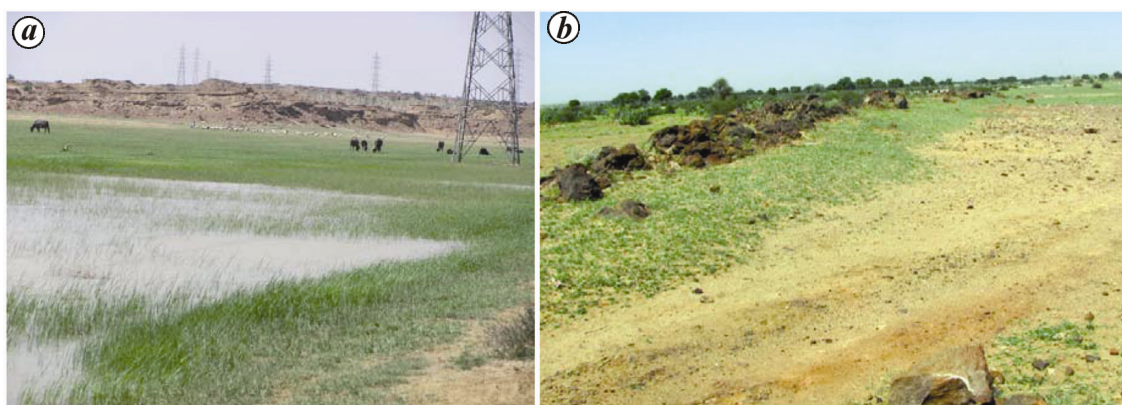
Figure 5. *a*, Waterlogged graben bounded by ENE-WSW trending horsts on either side. *b*, Flat-lying horst marked by narrow uplifted ridge separating the graben on the northwestern side.

The major faults that pass through the area have NNW-SSE trend. Most of these faults are traceable through geomorphic features such as narrow, flat linear valleys (grabens) bounded between flat ridges (horsts). There are also several cross faults that trend in the ENE-WSW direction. One such is the Fatehgarh Fault that runs south of Jaisalmer⁴ (Figure 4). The geomorphology of the terrain is broadly controlled by the two major NNW-SSE trending faults: Kanoi Fault in the west and Manpiya Ramgarh Fault in the east⁸. A depression between the two faults marks a graben, which itself is segmented by a number of sub-parallel fault systems bounding horsts and grabens (Figure 5). Because of development of such fault systems, the major graben is dissected into a series of narrow (between 250 and 300 m wide) valleys (graben) separated by a narrow, elevated upland (horst). The ENE-WSW faults though not so prominent like major faults, appear to have effectively controlled the drainage pattern. The drainage disorganization, especially of the NE-SW trending ephemeral drainage systems in the Jaisalmer area turned them into saline lakes^{9,10} (Ranns) (Figure 6).

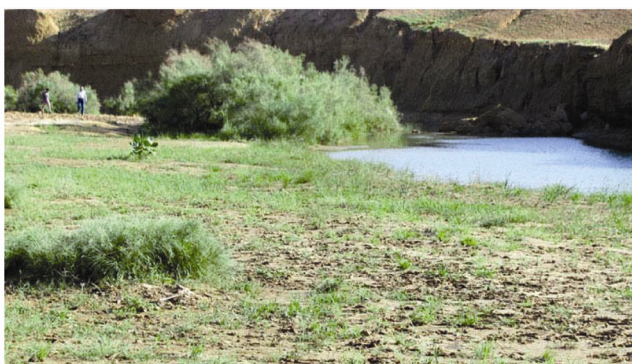
Figure 7. Three levels of terraced structure formed indicating gradual uplift of the Kuldhar village (on the left side).

Apart from the segmentation of stream channels, the intersection of two sets of faults has also resulted in the formation of rhombic blocks of different sizes. Some Paliwal villages (Khabha and Kuldhar in particular) show successive terraced structure formed during the gradual subsidence (causing depression) or uplift (shallow uplands) in the individual blocks on the one side, with corresponding degree of uplift on the other. A classic example is seen on the eastern side of Kuldhar (Figure 7), where the village ends at the water body bounded on one side by a steep scarp surface.
