# Tremors and built environment of Hyderabad, Telangana, India: safety of buildings using recorded ground motions

Although the city of Hyderabad in Telangana, India lies in seismic zone II, low to medium intensity tremors that pose a serious concern towards safety of the built environment are not uncommon. One such series of tremors occurred during 13–20 October 2020, in the financial district of Hyderabad and created a panic situation due to perceivable shaking and jolts with loud sounds associated with hydro-seismicity. To understand the safety of the city's built environment, a study was conducted on low, medium and tall buildings using ground motions recorded at the International Institute of Information Technology (IIIT), Hyderabad, which is 2.3 km from the epicentre. The amplification of ground motion on the second floor of the Nilgiri Building in IIIT, Hyderabad was 1.2–2.3. The vibrations recorded on the ground floor of the Nilgiri Building were used to develop a site-specific response spectrum. This was further used to obtain the peak responses of the considered buildings through response spectrum analysis. The present study suggests that the low-rise buildings, mid-rise

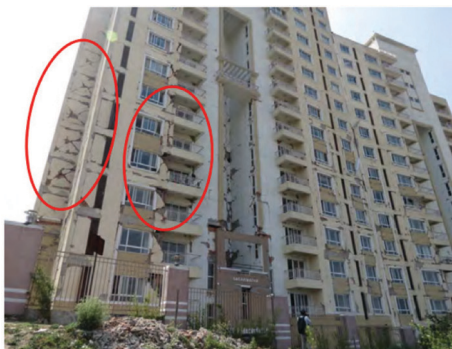
**Figure 5.** In-plane and out-of-plane damage in a high-rise building during the 2015 Gorkha earthquake, Nepal (image courtesy: Lizundia *et al.*<sup>10</sup>).

are few cases that highlight the poor performance of NSEs. Figure 5 depicts the damage to masonry infill walls of Parkview horizon complex, Kathmandu, Nepal<sup>10</sup>. In addition, it has been observed that the locations close to the epicentre are subjected to ground motions which contain short-period pulses that are potentially dangerous to NSEs in high-rise buildings. The study of the performance of NSEs in India and the world is still in its nascent stage and beyond the scope of this work.

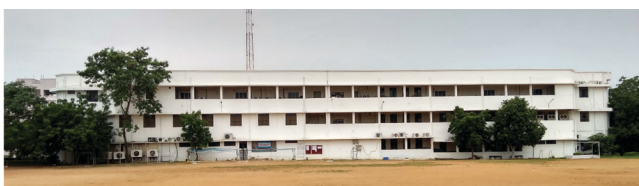
**Figure 6.** Photograph of Nilgiri Building, International Institute of Information Technology (IIIT), Hyderabad.

The engineering characteristics of tremors observed in the last week of October in Hyderabad were studied using building vibration sensors installed at IIIT, Hyderabad (Figure 6). The epicentre has been reported at 17.4337°N, 78.3322°E located near ‘My Home Vihanga’ residential complex<sup>1</sup>. The instrument was located at IIIT Hyderabad at a distance of 2.3 km. The structural health of the Nilgiri Building was monitored using the building vibration sensors installed (Figure 7). Since the established epicenter of the tremors was near the building under study, the ground vibrations obtained on the building ground floor

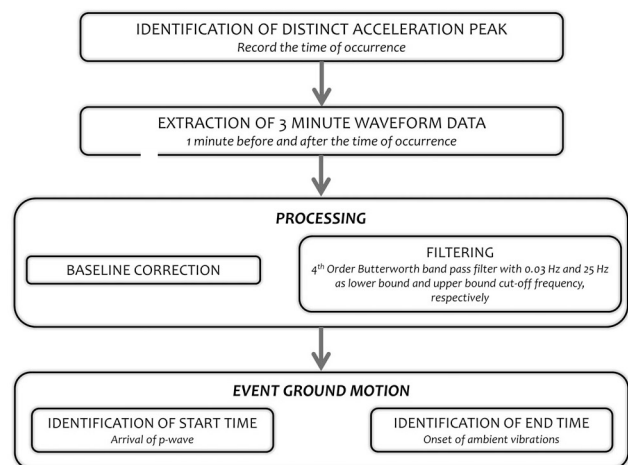
**Figure 9.** Flow chart of data processing.

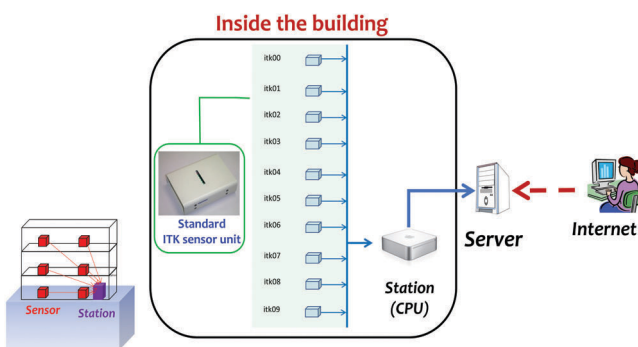
**Figure 8.** System configuration and the set of installed sensors.

The sensors were installed with a permanent network set-up and connected to a server. Figure 8 shows the system configuration and installation. The ambient vibration response of the building was recorded continuously. Data were acquired at a sampling rate of 100 and frequency of 0–50 Hz in the north–south (NS), east–west (EW) and up–down (UD) directions. The sensors include network-connected seismometers developed and standardized at the IT Kyoshin Consortium, Japan. The NS and EW components of sensors were oriented along shorter and longer dimensions of the building respectively.

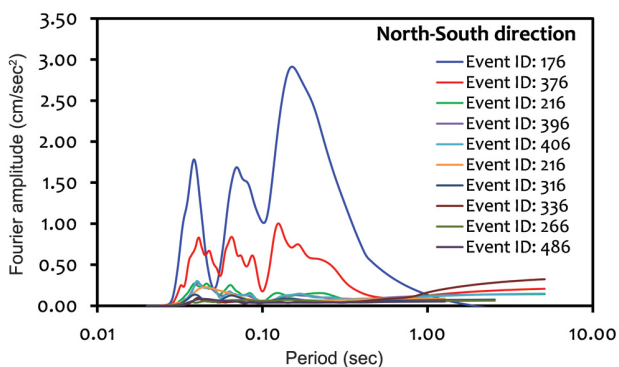
**Figure 11.** Fourier amplitude spectra of ground motions along north-south direction.

Figures 11 and 12 show the Fourier amplitude spectra of all the ground motions recorded during tremors in the NS and EW directions respectively. The maximum value of Fourier amplitude from ground motions in the NS direction was  $2.91 \text{ cm/sec}^2$  and in the EW direction it was  $3.18 \text{ cm/sec}^2$ . From the definition of half-power bandwidth, the value of  $1/\sqrt{2}$  times maximum Fourier amplitude is  $2.06 \text{ cm/sec}^2$  in the NS direction and  $2.25 \text{ cm/sec}^2$  in the EW direction. Likewise, the predominant period range of the top events is located at 0.05–0.20 sec. This observation also indicates that the ground motions are critical for

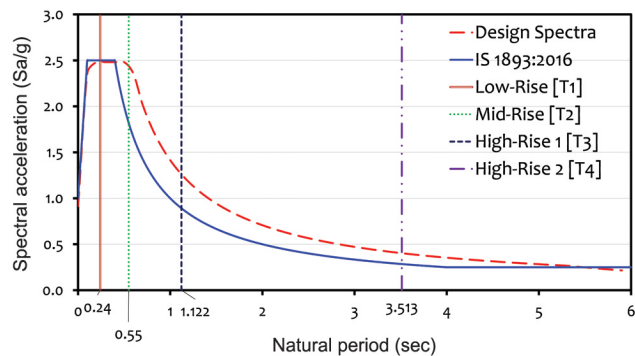
**Figure 13.** Comparison of 5% damped design spectrum specified in IS 1893: 2016 and that developed from the observed ground motions for the location under consideration.

A site-specific design spectrum indicates the effect of tremors on the existing building stock in the city. The design spectrum was developed using the standard procedure<sup>12</sup>. Figure 13 shows the design spectrum obtained from ground motion data observed during the recent tremors compared to the design spectrum specified by the standard code IS 1893 (Part 1): 2016. The generated spectra were used to determine the response of different categories of buildings in the preceding section.

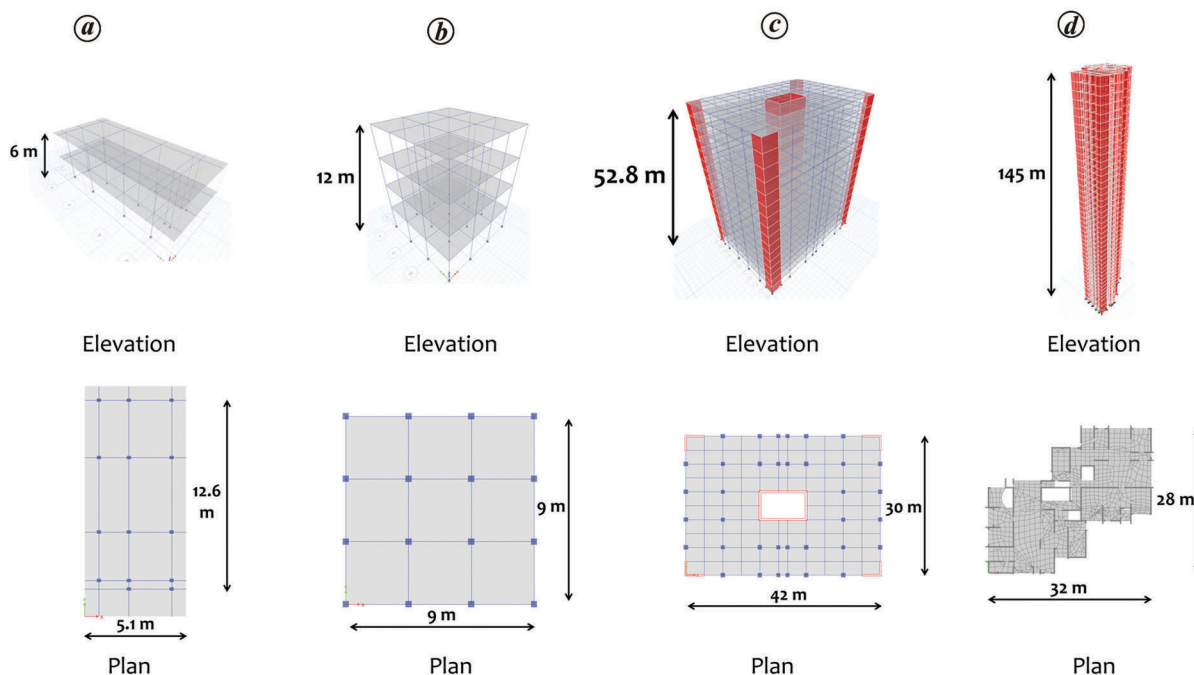
Figure 17. Plan and elevation of buildings under consideration: (a) G + 1; (b) G + 3, (c) G + 16, (d) B + G + 40 (G, ground; B, basement).

since details of this building are well known. The instrumented Block II of the Niligiri Building is the (G + 2) RC structure used for academic purpose. Further, to determine the effect of tremors on the existing building stock in Hyderabad, four more RC buildings representing the typical architectural and structural feature were modelled and analysed using the commercial Finite Element Modelling (FEM) software ETABS (version 18.1.1). To ensure diversification, buildings were selected such that they cover low-rise (up to two storeys), mid-rise (<18 m) and tall (>50 m) structures. Among the four RC representative buildings, two represent low- and mid-rise residential buildings respectively. Out of the remaining two, one represents a commercial building used as an office having a simple rectangular plan. The other represents a tall residential buildings to be constructed in the Cyberabad region. Table 6 provides the basic details of all the five buildings considered in this study. Figures 16 and 17 show the plan and elevation of these buildings.
