Unstable slopes and threatened livelihoods of the historical Joshimath town, Uttarakhand Himalaya, India

S. P. Sati, Maria Asim, Y. P. Sundriyal, Naresh Rana, Vijay Bahuguna and Shubhra Sharma*

This study analyses the causes and consequences of slope instability around the historical Himalayan town of Joshimath, Uttarakhand, India. The town is in the Higher Himalaya near the Main Central Thrust. The lithology constitutes fissile, shattered and sheared gneiss. Consequently, the slopes are prone to land subsidence and mass wasting. In the last few decades rise in population has led to a surge of infrastructure development, thus causing immense pressure on the finite resources and limited accommodation space on precariously balanced vulnerable slopes. Particularly, the unplanned infrastructure development, lack of adequate drainage and excavation of roads through unstable debris slopes are some of the reasons that seem to have accelerated the ongoing slope instability and land subsidence.

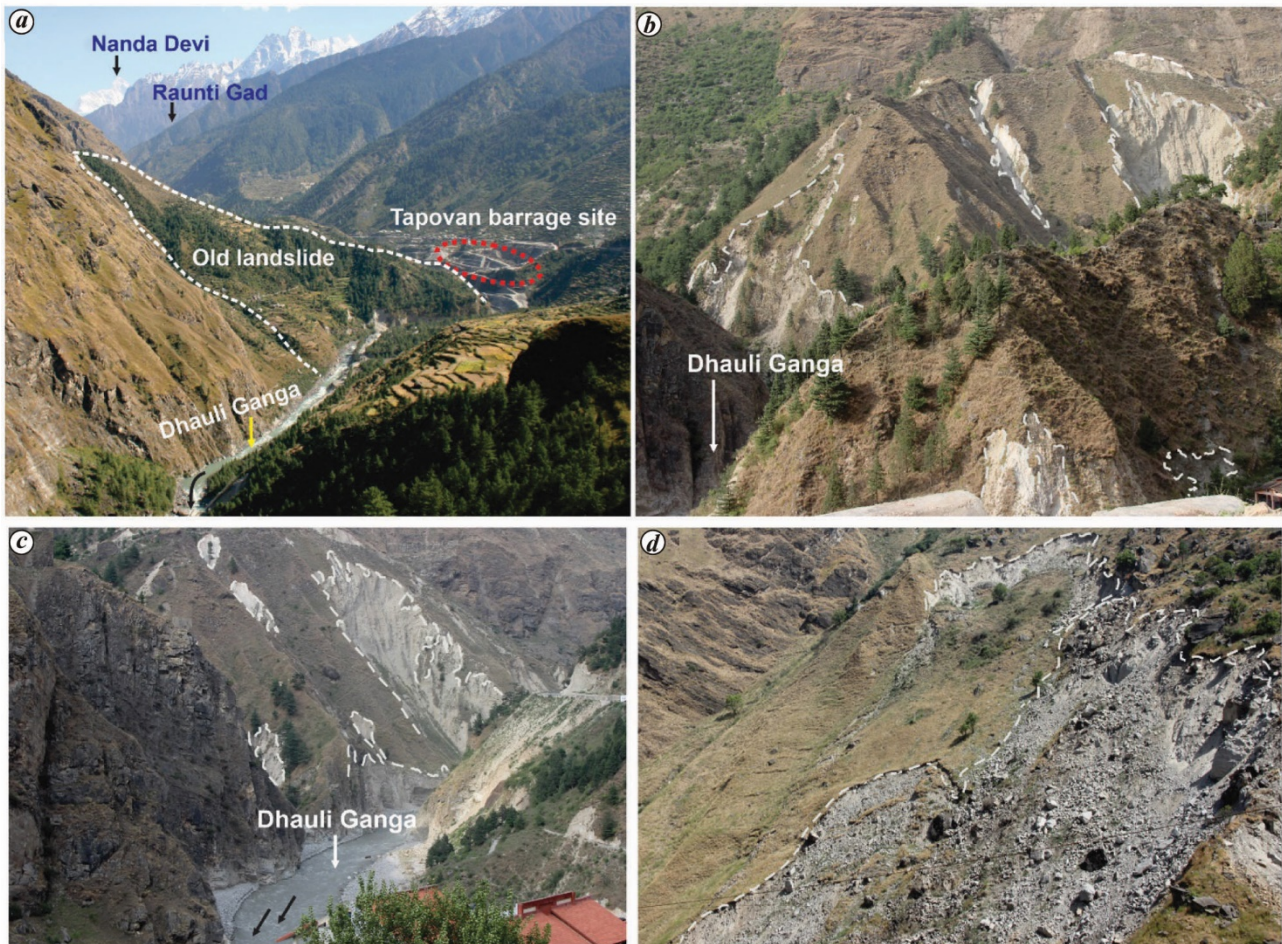
Figure 2. *a*, Panoramic view of Dhauli Ganga (facing east) taken in 2010. Nanda Devi forms the eastern boundary of the Rishi Ganga catchment. The location of Raunti Gad is shown which was responsible for triggering the February 2021 Rishi Ganga flood. Note the old landslide deposit along the right flank opposite the Tapovan barrage site (red dotted ellipsoid). *b–d*, Upstream from the barrage site at Tapovan, the reactivated landslides (white dotted line) after February 2021 flash flood are shown.

has high stream power due to the combination of discharge and over-steepened river gradient³⁰. It was observed during the recent February 2021 Rishi Ganga disaster that multiple debris-laden stabilized slopes (old landslide deposits) were reactivated between Reni and Marwari (Figure 2 *b–d*).

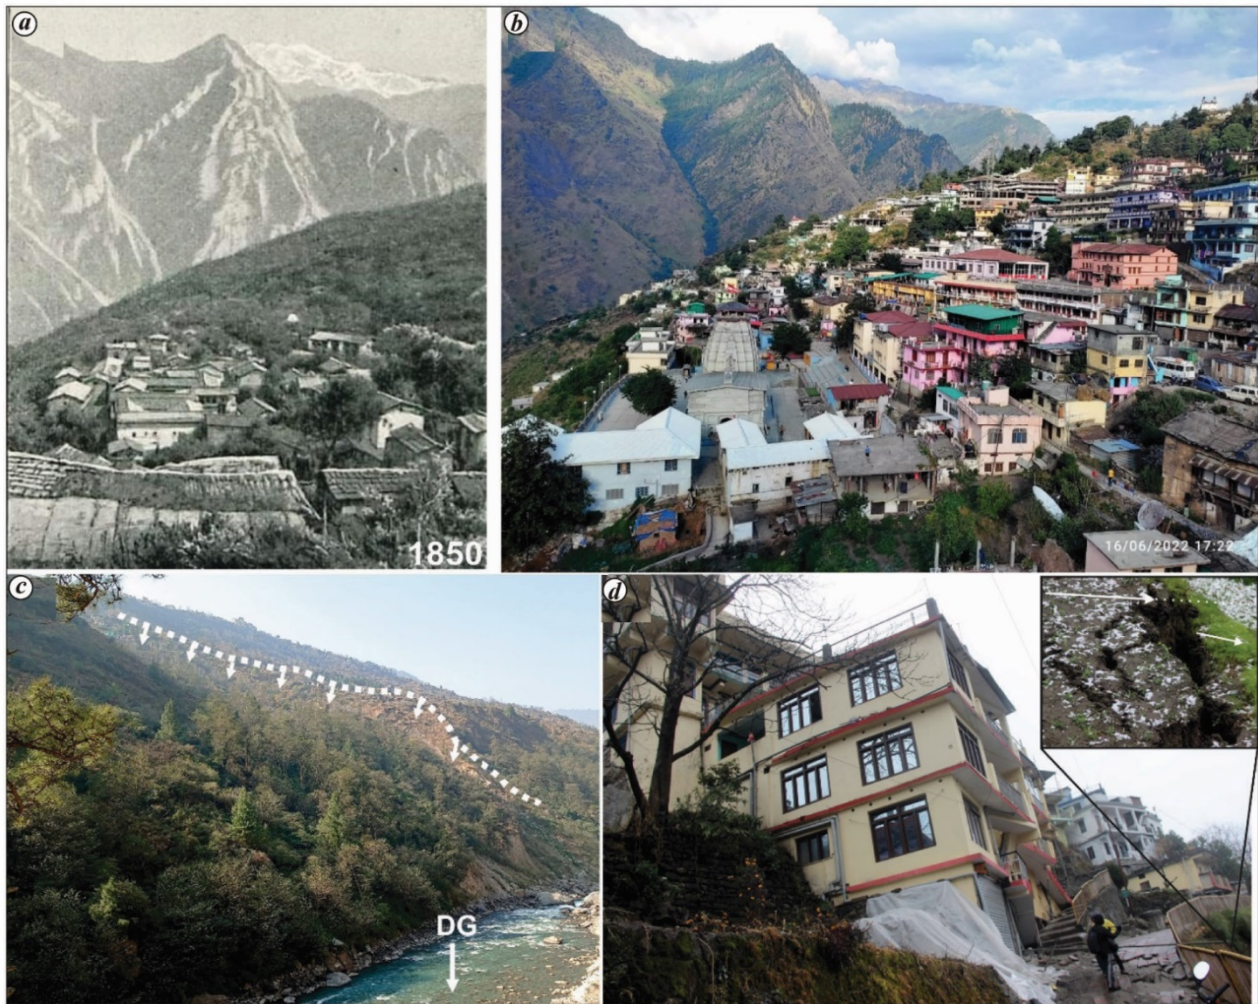
Figure 4. Joshimath town in (a) 1890 (photograph courtesy: Dr Kurt Boeck, Himalayan Album, 1894) and (b) May 2022 (photograph courtesy: Atul Sati). Note the change in the type of settlement from rural to urban, as thatched houses have been converted into dense and closely packed multi-storied concrete buildings. (c) The subsiding area east of Singhdhar. Note the *Alnus* forest at the bank of Dhaulti Ganga (DG) – an ecological indicator of old landslide deposits. (d) Close-up of the settlements located in the subsiding Singhdhar area. (Inset) Fissured ground located immediately below the road. The white arrows show the subsidence and direction of creep which is towards the north (picture taken after January 2023).

on the upper and lower unstable slopes (Figure 1 *d*), further accelerating the pace of instability (Figure 4). Additionally, more than 3 lakh pilgrims transit the town during summer on their way to Badrinath, requiring additional infrastructure. The nearby Auli skiing resort is also growing as a popular winter sports location in Uttarakhand. To sustain the stability of the terrain, there is a need to maintain a balance between the economy and ecology.

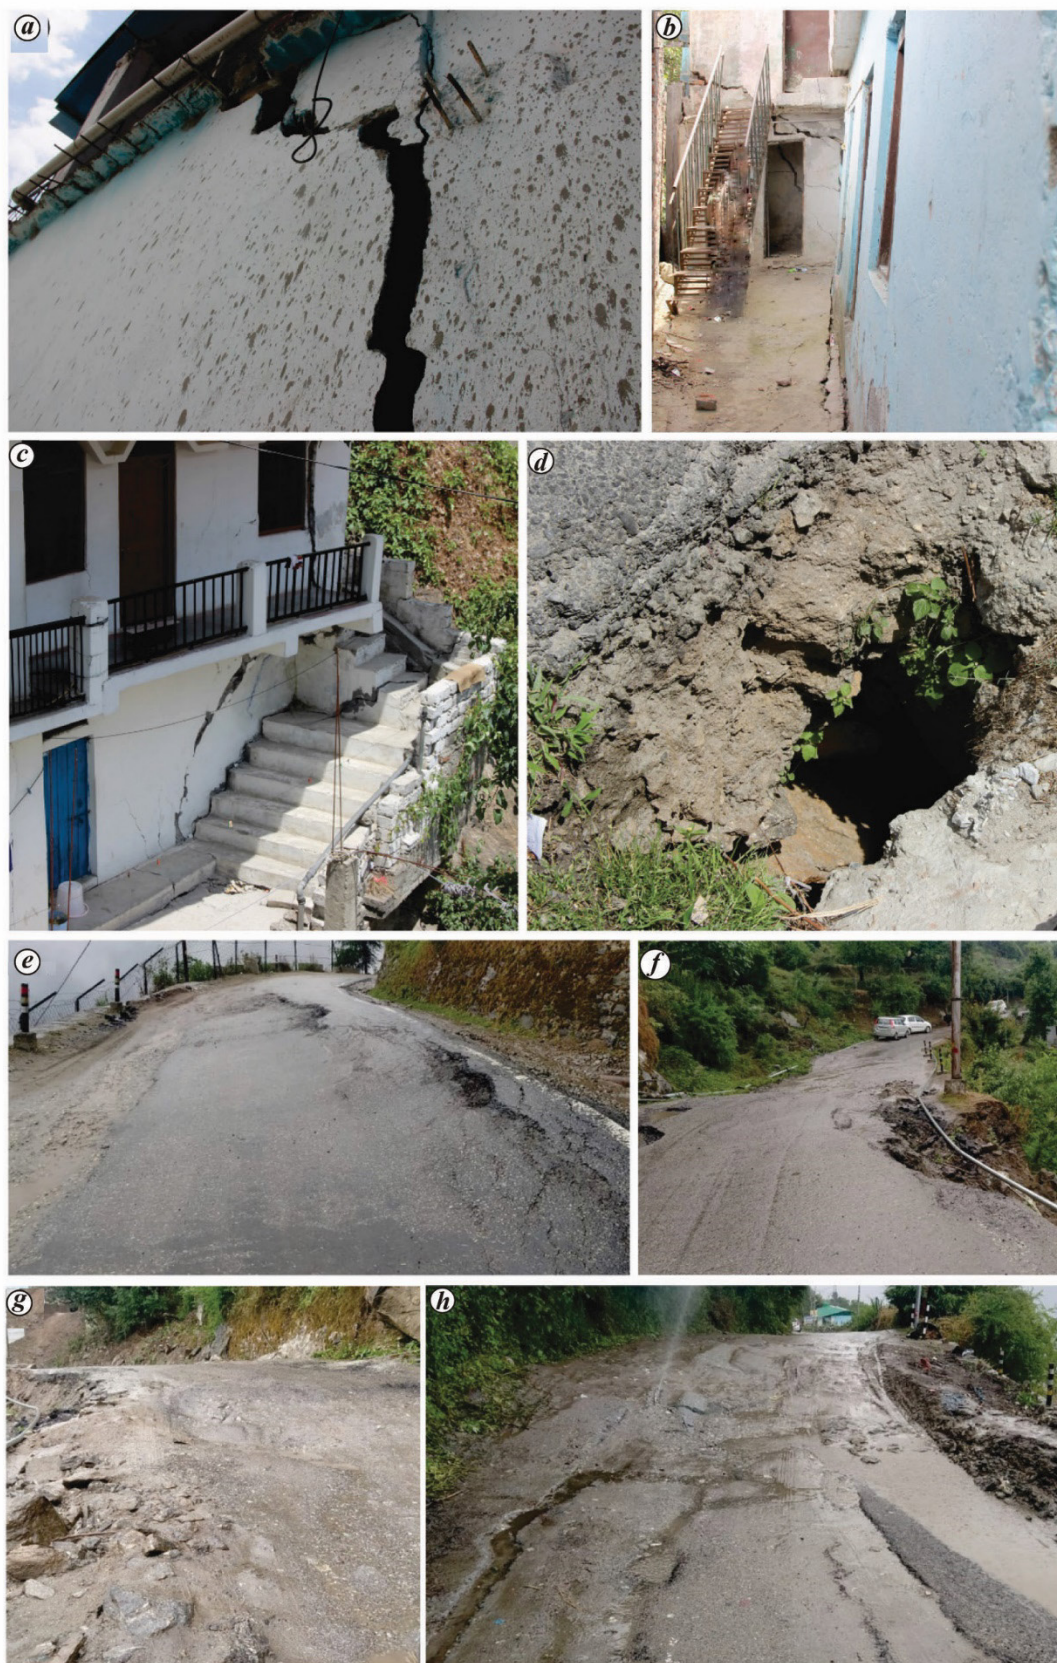
Figure 5. *a–c*, Damage caused to houses in the Chawani Bazar area (Badrinath road) due to continuous soil creeping. *d*, Potholes on the alluvium have become a regular feature, and are one of the reasons for eroding and transporting the fine matrix of the landslide deposits, thus creating caverns. *e–h*, Few segments of Joshimath–Auli road which are undergoing subsidence (photograph courtesy: Atul Sati).

The presence of potholes and fissures in Joshimath town indicates unstable slope conditions due to the selective removal of fine sediments, which could be one of the reasons for observed subsidence and the development of cracks/fissures in the houses (Figure 5). According to the locals, subsidence and slope destabilization which was going on for the last few decades was exacerbated post-November 2021 (after the Rishi Ganga disaster). Prior to February

(iv) The roads in the periglacial zones, such as between Joshimath town and Tapovan, is undergoing subsidence at multiple places (Figure 5 *e-h*). This is because the slopes (20°–40°) are drained by the snow/groundwater-fed streams (Figure 1 *d* and *e*) and are subjected to winter snowing and summer thawing. This leads to solifluction (gradual downslope movement of the surface soil). Therefore, such areas require special engineering skills while excavating the slopes for road construction, which are currently lacking. Consequently, our response to maintaining the roads in such areas is reactive (repair following subsidence) and not proactive (providing long-term slope stability). One of the ways to circumvent this chronic problem of continuous creeping and subsidence is by making elevated corridors with pillars deeply anchored on hard rock substratum, as done for the ropeway in Joshimath town.
