The ‘mystic’ sand dune-covered temples of Talakad, Mysore district, Karnataka: evidence of earthquake-related destruction

A. B. Roy^{1,*} and M. S. Sethumadhav²

Keywords: Ancient temples, disaster archaeology, neotectonic landform changes, palaeoseismicity, sand dunes.

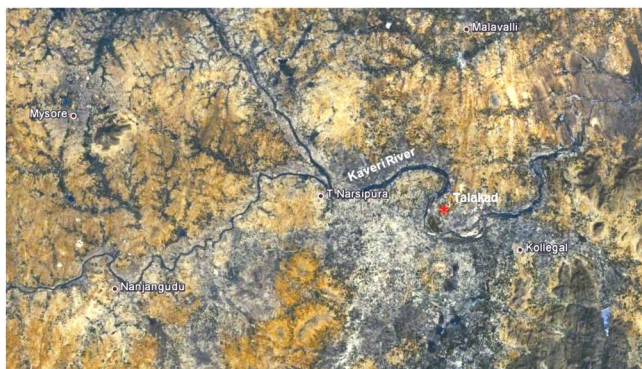
Figure 1. Google satellite imagery showing the nature of the terrain through which the Kaveri flows. The bluish-grey colour shows the extent of flood plain of the Kaveri Basin amidst hilly tracks (brown shaded areas).

setting of the area. This was followed by field investigations mainly around the excavated sites. An important aspect of our study involved determination of spot heights using GPS as well as satellite imagery to find out the relief pattern in and around Talakad. Regionally, the area around Talakad has a wider spread of flat alluvial ground of the Kaveri Basin (bluish-grey colour in Figure 1) than that in the surrounding hilly tracks (in brown shaded areas in Figure 1) through which the Kaveri River flows. Because of this, the region is also nicknamed as Mysore ditch².

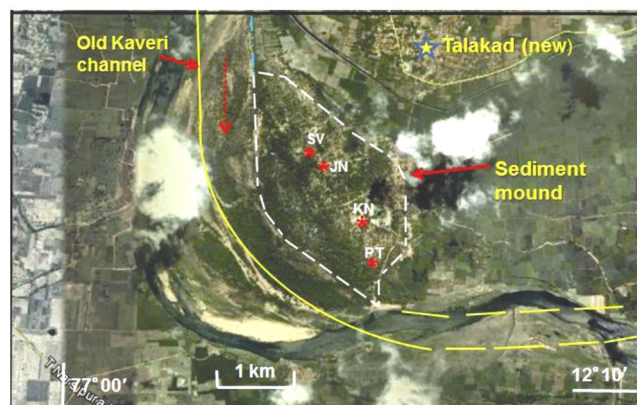
Figure 2. Google satellite imagery indicating the lens-shaped outcrop of the sediment ‘heap’ (marked by discontinuous white line) in the Talakad region. Location of some ancient temples exhumed from sediment cover is shown: PT, Pataleshwara temple; KN, Kirtinarayana temple; JN, Jain temple and SV, Shiva temple. Discontinuous blue line marks a fault.

The Talakad sediment mound is sharply divided into two parts marked by straight-running tree line, which marks the trace of a fault⁷. The sand-covered area lies on the eastern half, which can be identified in the satellite imagery by the dominance of the light yellow-brown shades wherever the vegetation cover is sparse. The western half is dominantly a tree-covered zone. From the arc-shaped outline of the western ridge-boundary and the nature of vegetation cover, the half-lens shaped outcrop of the ridge looks like a slice of an older flood plain of the Kaveri meander.

because the sand cover over the temples close to the top of the mound (Jain and Shiva temples, for example, Figure 2) is either lacking or forms only a thin veneer (Figure 4 *a* and *b*). Even at places where the sand cover is present, it occurs above the debris of the already destroyed temples. Evidently the destruction noted in these temples cannot be attributed to the load of the sand cover.

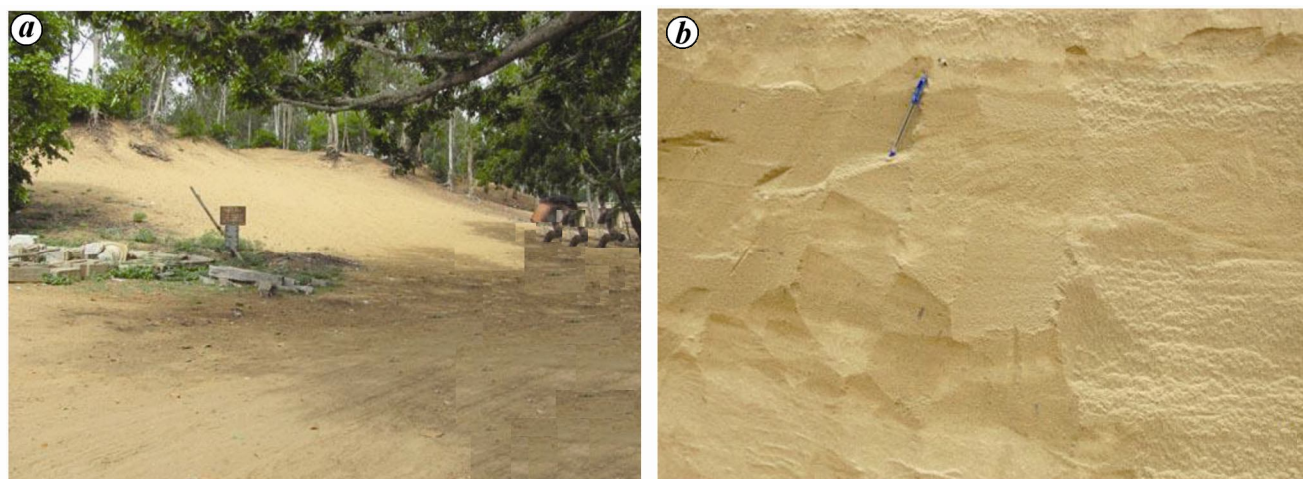
Figure 3. *a*, Spread of dune sand at old Talakad. *b*, Close-up view of the uniform, fine-grained sand materials exposed in a section cut at the Kirtinarayan temple.

Not much information is available about the lithological character of the Talakad sediment mound, except the general belief that it is made of riverine sand dunes. It is thought to have originated due to an ‘eco-disaster’ that lashed the region during the 17th century⁸. That was the time when the normal flow of the Kaveri River was impeded because of the construction of a dam on the upstream side, north of Talakad and subsequent diversion of water in a different direction. As a result, the water level at the point bar on the concave side of the Kaveri meander southwest of Talakad was significantly lowered leading to the buildup of sand at this place. The accumulated sand was then actively reworked and carried by the northeasterly monsoon winds, which were subsequently deposited around Talakad engulfing the temples and other settlements in the region³. The yellow coloured, uniformly fine-grained and homogeneous nature of the sand without any clay material in it provides further proof that the air-borne sand deposited as dunes (Figure 3 *a* and *b*).

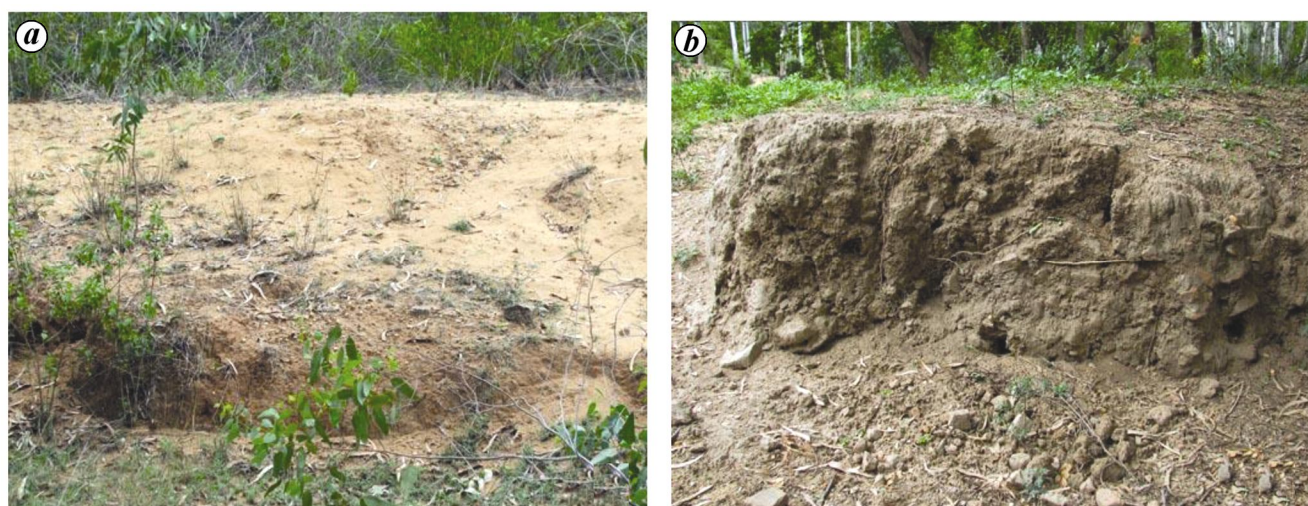
Figure 4. *a*, Thin (about 1 m) envelop of yellow coloured dune sand overlying the reddish-brown coloured rock at an excavation site. *b*, Exposed rock without any sand cover.

mound, the sands constitute only a thin envelop covering the rocks below (Figure 4 *a*). The sand cover is virtually absent at several places near the top close to the excavation site of an ancient Jain temple². Instead some harder, grey to brownish-red coloured rock masses made of clay–silt mixture containing broken fragments of rocks and bricks are seen in that part of the sediment mound (Figure 4 *b*).

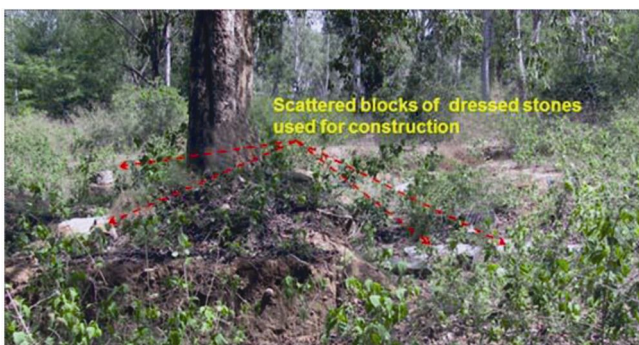
Figure 5. Large blocks of dressed rocks lying scattered on the ground at the Jain temple site.

Reporting the tumbledown condition, especially of the Jain temple and the surrounding 'basadi' areas (Figure 5), the archaeologists advocated possibility of 'ransacking' of the temple site inferring possible inter-religious rivalry². However, considering the fact that all the temples in the sand-covered area belonging to different sects are in dilapidated condition, we may also exclude the possibility of anthropogenic vandalism as the cause of destruction of the temples.

Tell-tale evidence of earthquake-induced destruction of the temples and other construction structures is visible on the surface. In case of the Jain ‘basadi’, scattered dressed stones of plinth are seen lying on the ground (Figure 5). A similar situation is noted in the case of the Shiva temple situated nearby, where the entire top part of the temple has collapsed and the wrecked materials have piled up over the basement (Figure 9). Severe damage caused by earthquakes are also observed in a stone structure (possibly forming a part of an annexe temple) and brick structure within the compound of the Kirtinarayana temple (Figure 10 a and b).

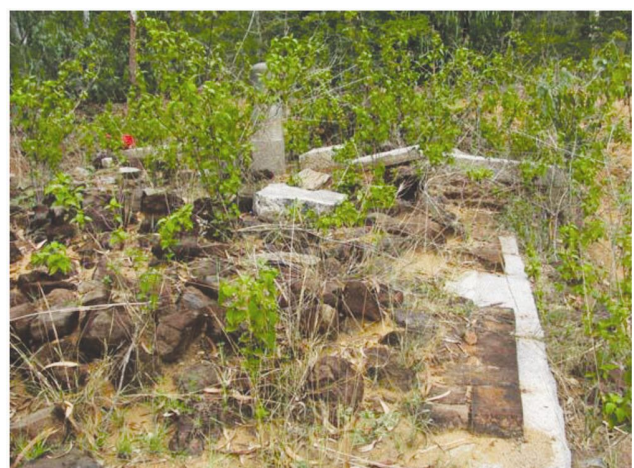
Figure 9. Completely ravaged Shiva temple showing fragmented bricks and some dumped stone slabs showing minor deposition of Aeolian sand at the plinth level.

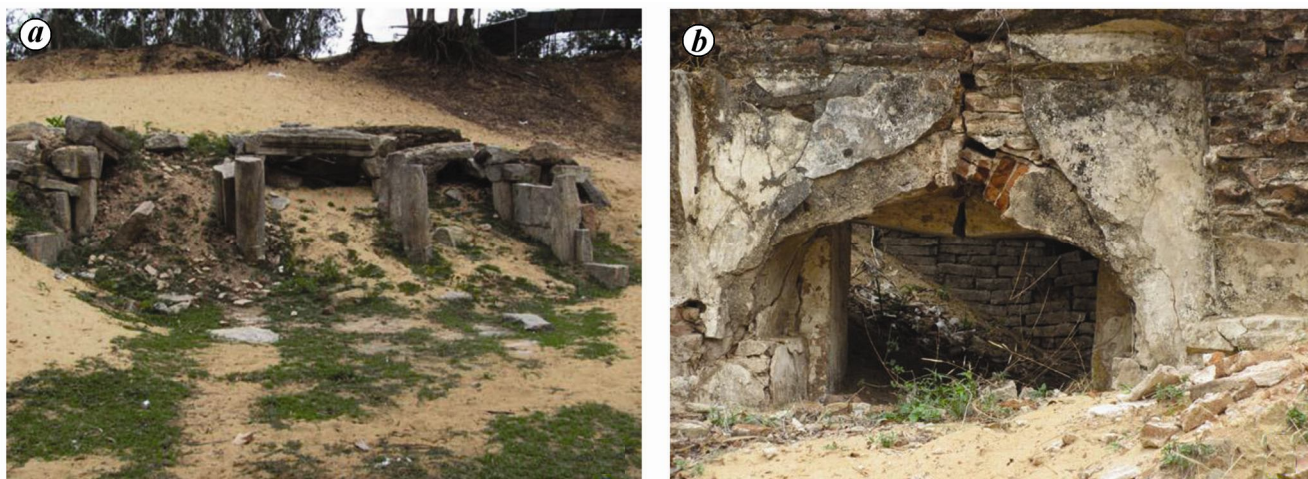
Figure 10. *a*, Dilapidated stone structure (possibly forming a part of an annexe temple) recovered from under the sand dune. *b*, Fractured and sagged gate-like structure made of brick. Both the structures are located within the compound of Kirtinarayan temple.

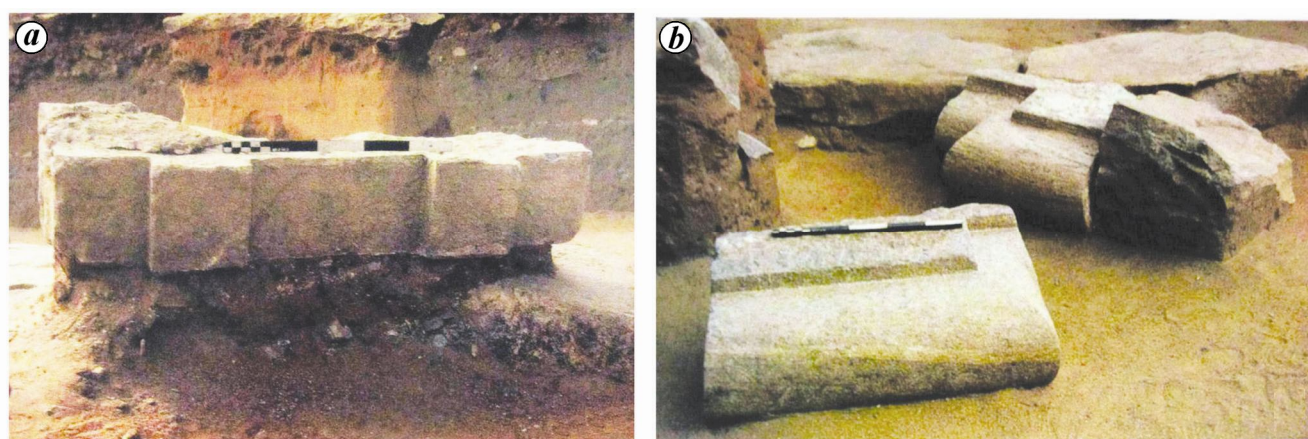
Figure 11 *a, b*. Tumbled-down pieces of plinth stones of destroyed temples lying on the (post-excavation) sand-filled smooth surfaces (reproduced from Devaraj *et al.*²).

report says that the foundation stone of the temple was either disturbed or lost (Figure 11 *a* and *b*). Layer-4 in this trench provides a striking example of earthquake-induced destruction. A vivid description like ‘Materials such as river sand..., brick-bats (broken pieces of bricks and stones), small, tiny river pebbles, dressed granite pieces, and fine river clay (greenish yellow in colour) are found in lumps intermixed with each other’, clearly informing about the interspersing of earthquake-derived debris with flood water. Similar picture of damages has also been recorded in other trenches at different excavations sites in the sand-covered mound.

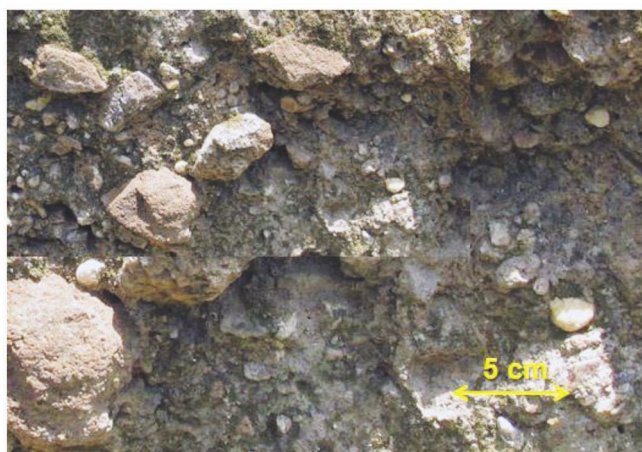
Figure 12. Soil profile section at a trench near Jain ‘basadi’ showing cluster of materials, including broken fragments of bricks and stones of different sizes and shapes as well as well-rounded, small-sized pebbles of quartz of varying sizes embedded in fine-grained mixture of silt and clay.

Clinching evidence of earthquake-induced destruction is observed in the sedimentary formations that have been deposited over the damaged temple sites and other places. On close examination we find that the deposited sediment contains significant quantity of broken fragments of construction materials like bricks and stones of different

sizes and shapes embedded in fine-grained mixture of silt and clay, which also contain a few well-rounded quartz pebbles (Figure 12). Similar rock formations containing fragmented construction materials along with small river-worn, well-rounded quartz pebbles embedded in clay-silt matrix have also been reported from a number of excavated trenches². We interpret these as ‘erratics’ formed due to intermixing of earthquake debris (Figure 13 *a*) with sediments carried by river water. The deposition of these mixed rocks containing materials drawn from different sources took place in the flood plains, where the flow of water was greatly reduced because of the presence of some blockages which could be the earthquake-damaged temples and other structures. Movement of floodwater was greatly impeded because of these blockages leading to the deposition of the mixed sediment load. Not uncommonly, broken pieces of plinth and other stone structures are observed scattered over such materials (Figure 13 *b*).

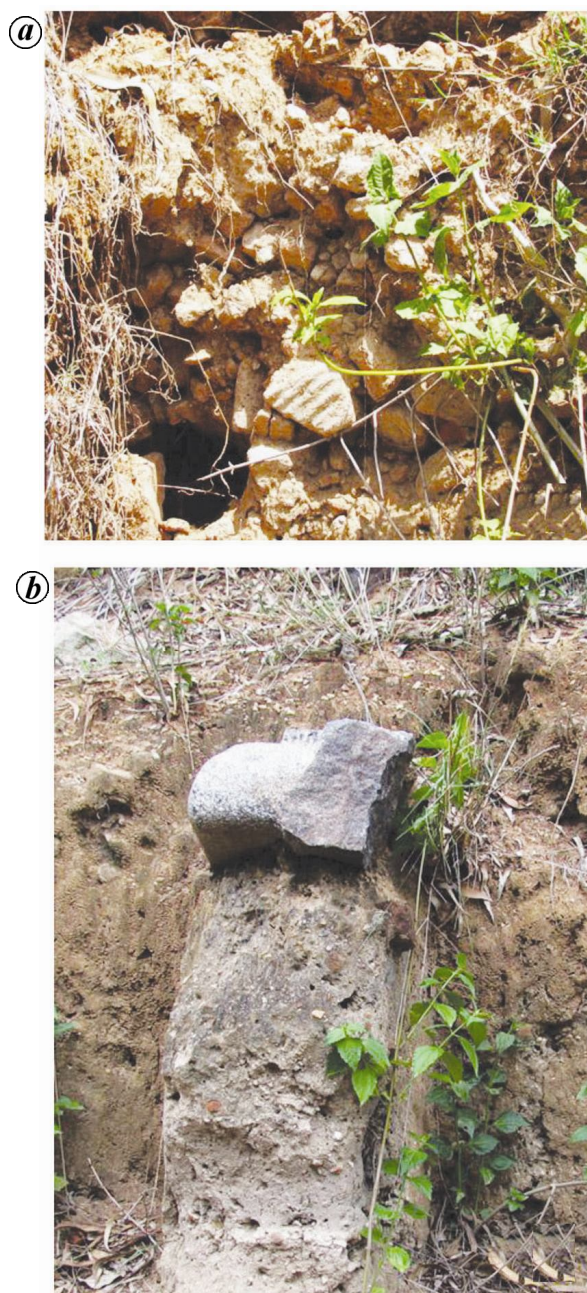
Figure 13. *a*, Earthquake debris mixed with soil. *b*, A broken piece of plinth lying over flood plain deposit mixed with earthquake debris.
