# Status of soil degradation in an irrigated command area in Chikkarasinakere Hobli, Mandya district, Karnataka

<sup>1</sup>National Bureau of Soil Survey and Land Use Planning (ICAR), Hebbal, Bengaluru 560 024, India

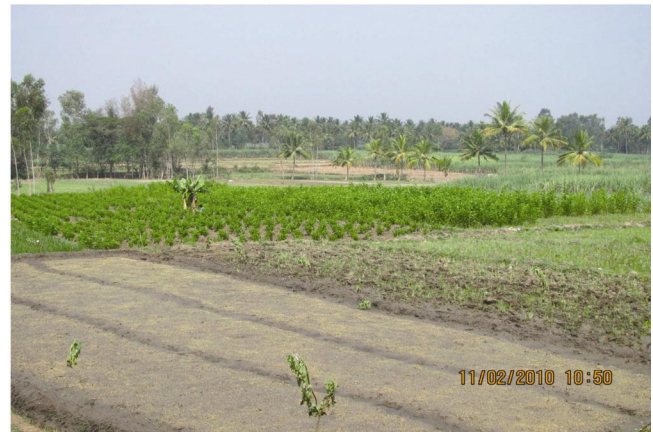
**Figure 2.** Typical landscape of irrigated gently sloping uplands merging with narrow valleys, Arechakkanahalli.

After establishing the soil–landform relationship for the block, detailed characterization of soil, site and other parameters was carried out for each village separately. In each village, the field boundaries and survey numbers given on the cadastral sheets were located on ground by following permanent features like roads, railway lines, creeks, streams, rivers, tanks, ponds, burial ground, etc. and wherever changes were noticed, they were incorporated on the cadastral maps. After this, intensive traversing was carried out for each physiographic unit like ridges, uplands, lowlands/valleys, etc. by involving all the soil survey party members. Based on the variability observed on the surface, transects were selected across the slope, covering all the physiographic units occurring in each village (Figure 2).

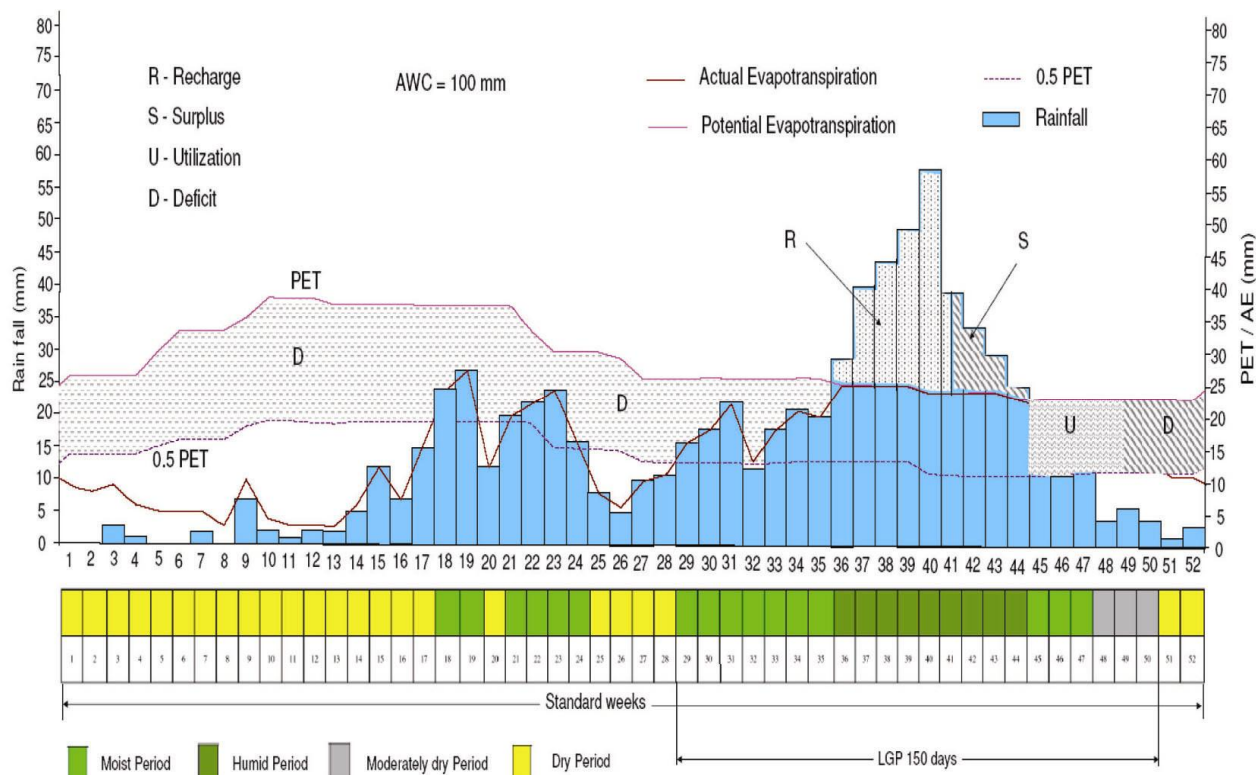
**Figure 4.** Rainfall, PET and growing period of Chikkarasinakere hobli.

The normal rainfall received in the area is about 770 mm. Out of this, about 50% is received during the SW monsoon, 20% during the northeast monsoon and 30% during summer. The rainfall distribution is fairly widespread and except during the winter months, fairly good amount of rainfall is received in the area for almost eight months (April to November) in a year. It is bimodal in nature with one peak occurring during May and another during October. The average number of rainy days during this eight-month period is about 43 (Figure 4).

The total potential evapotranspiration (PET) of the area is about 1794 mm, which is higher than the amount of rainfall received in the area. Only during September and October, the precipitation is more than the PET. During May, the rainfall received in the area crosses the 1/2 PET, which is considered sufficient for plant growth. However, rainfall becomes less and does not cross the 1/2 PET values from June to August and it crosses the 1/2 PET values again during the period from September to the middle of November. Whenever the rainfall reaches close to the 1/2 PET values, that period is considered favourable for plant growth. This period gets extended to one or two weeks more, if the soil conditions are favourable (soil depth, texture, structure, high organic matter content, etc.) for plant growth. Accordingly, the growing period for the area is about 150 days, which starts from the middle of July (28th week to 50th week) and extends up to the middle of December.

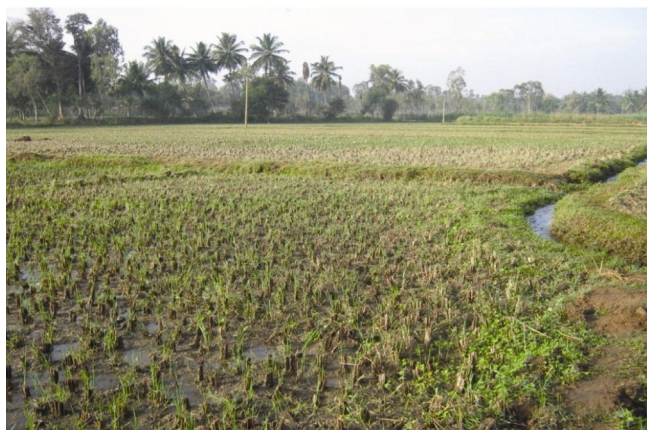
The study has revealed that waterlogging is a major problem, particularly in all the lowlands, and to some extent in the upland areas of the block (Figure 7). The lowlands occupy about 4706 ha (29% of the area) in the hobli. Normally, the lowlands are characterized by nearly level to flat topography and very deep, well-drained, fine-textured soils with good water-holding capacity. They are the most productive soils of the hobli. Even without any irrigation facility one assured crop under rainfed situation is possible and that was the scenario which prevailed in most parts of the hobli before the introduction of the KRS canal irrigation during the 1930s.

**Figure 7.** Very gently sloping canal irrigated midlands, S. No. 158, Kyathaghatta. Major part of the area in the village is affected by salinity and waterlogging.

lying between the uplands and lowlands. Apart from the general trend, in many villages salinity has become a major problem seriously affecting the productivity. For example, in Kyathaghatta village, except Aravanahalli soil which is not brought under irrigation, other soils have severe salinity/sodicity problem. Out of the 537 ha area in the village, more than 500 ha has serious salinity problem. In this village, all lowland and midland soils, particularly Kyathaghatta, Chikkarasinakere and Doddarasinakere series have severe sodicity problem (Figure 8).

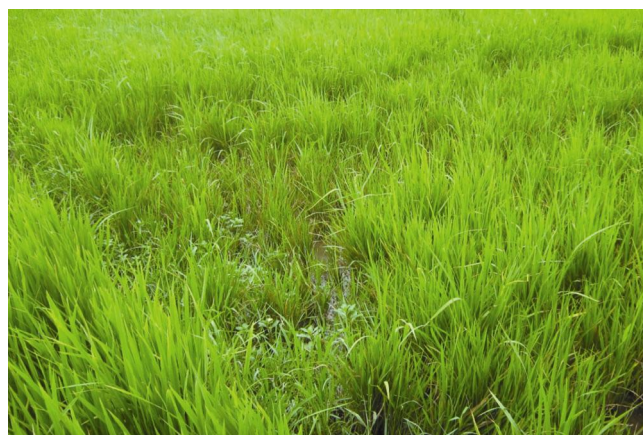
**Figure 10.** Impact of salinity on paddy: stunted growth in Doddarasinakere.
