Development of Stability Criteria for Risk Reduction in the Sianok Canyon in Bukittinggi Indonesia

BAMBANG ISTIJONO AND ABDUL HAKAM

Abstract: The development of Sianok Canyon area as a tourist destination in Bukittinggi - Indonesia also needs a disaster risk reduction to be included in. The city already has land use plan that restricts the development around the upper part of the Canyon. This restriction is not equally effective because it has no consideration based on the actual thinking. The study that provides a scientific consideration is needed since the city has limited land. Then, the geological study and geotechnical investigation was done to obtain required data. It is followed by the potential landslide analyses of the Canyon area. Furthermore, based on the results of the analyses the safety factor and safe distance criteria are proposed for consideration in the development plan of the city as well as to reduce the disaster risk.

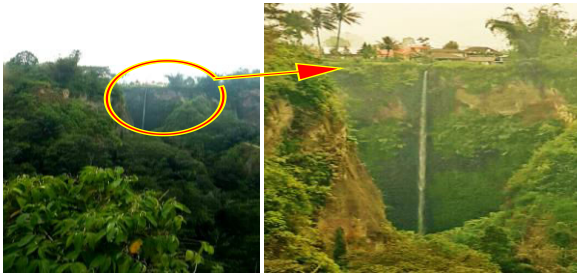
Figure 2 Township on the edge of the canyon

building with the edge of top side of the Canyon wall just in a matter of less than 5 meters. The investigation on this area is needed to reduce the disaster risk as it has happen in the other place (Hakam et al, 2013).

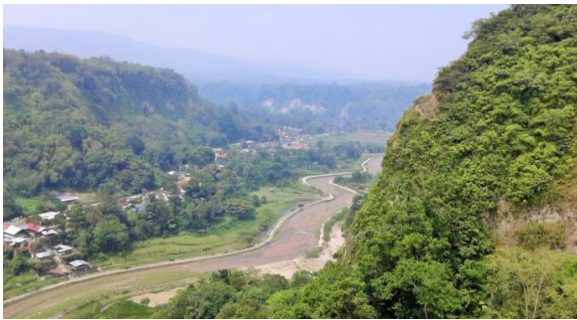
Figure 3 Houses and business building development under the canyon
