## Wear Rate Analysis of Ceramic Coated Brake Lining Material

Dept. of Automobile Engg., Sathyabama University, Chennai, India

K.R. Kavitha and S. Prakash. 2017. Wear Rate Analysis of Ceramic Coated Brake Lining Material, *Int. J. Vehicle Structures & Systems*, 9(4), 238-240. doi:10.4273/ijvss.9.4.08.

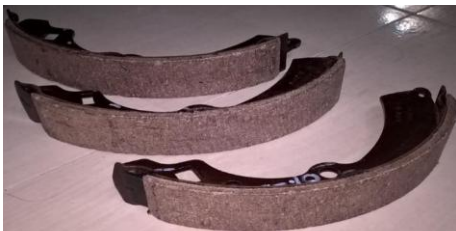
**Fig. 1: Asbestos Brake lining Samples purchased for experiment**

An original sample of brake lining was purchased (Autotech Manufacturing & Marketing Co.) from the manufacturer. This brake lining material (Asbestos brake lining) is referred to as sample A and used as standard reference sample to compare with ceramic coated brake lining materials on the surface of abrasive brake lining sample. The ceramic coating sample was prepared by coating the Aluminium oxide and Zirconium oxide on the surface of Asbestos brake lining of various thicknesses. Three different thicknesses of 25µ, 35µ, and 45µ were chosen for the experiment. The coating was done with plasma coating with the addition of epoxy resin as binder. Table 1 gives the detailed structure of the samples prepared for different thickness of coating of Alumina and Zirconium Oxide on the surfaces of asbestos brake lining as base material. Fig. 1 shows the samples of brake lining used for the experiment which is made of purely asbestos material. Figs. 2 and 3 shows the brake lining coated with Aluminium Oxide and Zirconium Oxide respectively on the surface of asbestos brake lining.

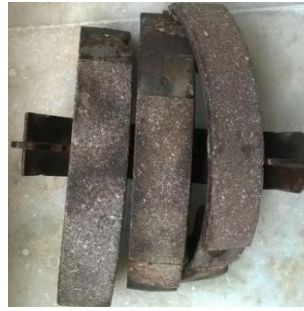
**Fig. 3: Zirconium oxide coated samples**
