Examining Fundamental Problems of APC Canal Concrete Lining and Strategies to Solve them

Background/Objectives: In this research, various reasons of creation of crack irrigation canals, uplift, and failure of concrete lining, and coping strategies with these problems were investigated. **Methods/Statistical Analysis:** In the main APC canal, the primary type of the canal trapezoid section includes executing a filter at the bottom of the canal, executing soil-cement mixture, and then executing a concrete lining at the walls of the canal. The final type of the canal trapezoid section reformed executing a filter in the bottom and walls of the canal, executing a lean concrete, and then executing the main concrete lining at the bottom and walls of the canal, and also executing a one-sided valve at the bottom of the canal.

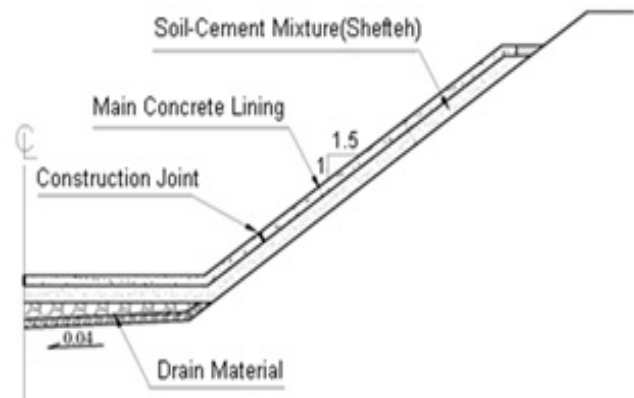
Figure 1. The primary section type of the canal.

In the main APC canal, various types of materials were applied for concrete lining and its bed layer in the canal section. The primary type of the canal section includes execution of filter in the bottom of the canal, execution of the soil-cement mixture (Shefteh), and execution of the concrete lining in the canal wall according to Figure 1. After executing the canal, based on properties of the primary canal section type (about 10 kilometers from the beginning of the path) and before starting operation

According to Figure 1, in the primary section of the canal, the drainage material was only predicted to be executed in the canal bottom and under the soil-cement mixture which had two main problems. Firstly, in rainfall time, according to the regional conditions, the groundwater level increases noticeably. The hydraulic pressure exerted the canal bottom, as a result of increase of the groundwater level, will be accumulated in the canal bottom because of water drainage by use of filter. Hence, because of not predicting an appropriate conduct for exit of the canal bottom water, this pressure will not be depreciated. To cope with this phenomenon, we used one-sided valves (Barbakan) and executed them in the said regions, also in the modified section type of the canal, in order to depreciate the pressure, besides applying Barbakan in the canal bottom, in the whole area of the canal and on the repair surface and under the lean concrete, a layer of filter is executed.

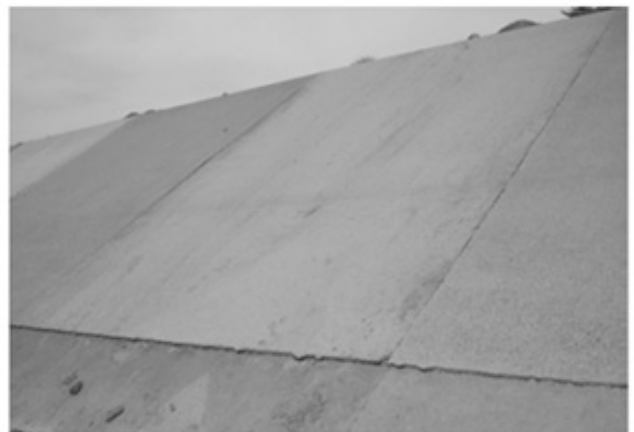
Figure 2. Crack, and uplift of concrete lining.

of the canal, crack, failure, and uplift of concrete lining parts were observed in the parts of the canal which were executed, according to Figure 2. Following creation of such cracks and in order to cope with this phenomenon, by applying some changes in the material of the bed layer and concrete lining, the executive section of the canal was modified and corrected.

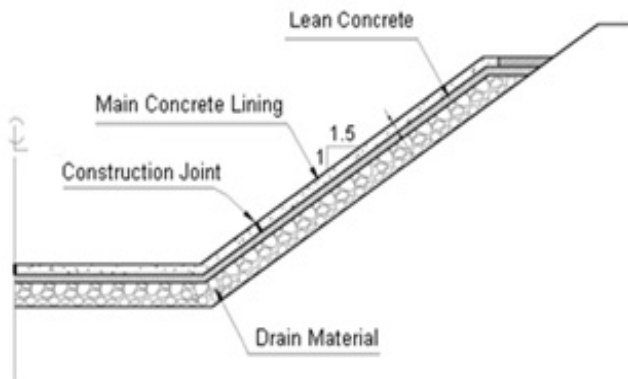
Figure 3. The final modified section type of the canal.

The final modified type of the canal section, according to Figure 3, includes execution of filter, lean concrete, and main concrete lining around the canal, together with construction of a one-sided valve (Barbakan) at the canal bottom.

After executing this section, no creation of crack and failure in the canal coverage has been observed so far. However, still some uplifts at the canal wall can be observed in some parts of the canal, but its intensity has been decreased. Of course, the behavior of the canal concrete lining against reasons of creation of cracks and uplifts will be determined after operation of the canal and

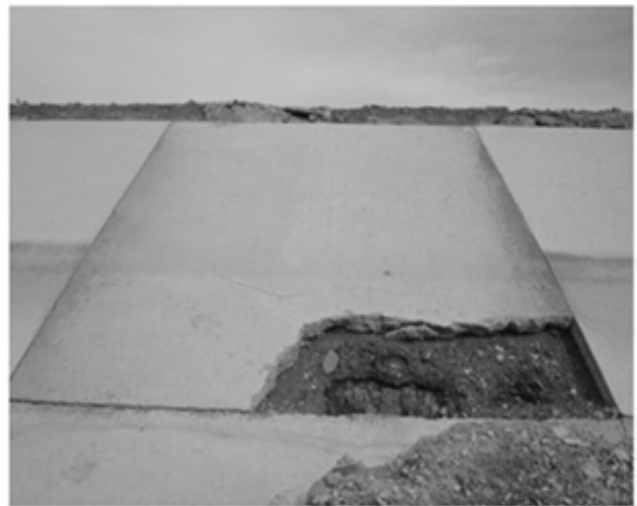
Figure 4. Failures in the concrete lining.

Therefore, it is resulted that not only the soil-cement mixture does not have a noticeable effect on bed stabilization, but regarding resistance aspect, it is not an appropriate material for substructure of the canal concrete lining and causes its especial executive problems. In some parts of the path that intensity of the cracks and failures in the concrete lining is higher and according to Figure 4, the shattered mortar under the coverage is exposed, it can be observed that the soil-cement mixture is very delicate and even can be damaged with hand pressure. Such materials, when executing the canal concrete lining, may absorb the concrete water and become inflated and cause reduction of strength of canal concrete lining.

Fortunately, after modifying and correcting canal concrete material properties, the soil-cement mixture is replaced with the lean concrete. First, the filter material is poured on the repaired surface and after regulating the filter, lean concrete is executed on it. Despite the lean concrete does not have an effective role in stabilization of the soil bed, it can act as a layer between filter and the main concrete and can be used as an appropriate bed layer (with appropriate compressive strength compared to soil-cement mixture) for execution of the canal concrete lining.

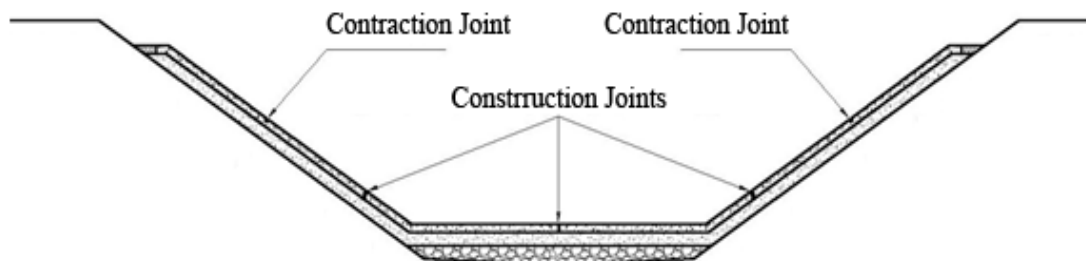
Figure 5. Contraction and construction joints.

Considering the reliance of the canal concrete lining and fulfillment of its substructure on non-homogenous soil material, existence of construction joints especially in walls cause that the canal concrete lining, according to Figures 5, 6 won't be resistant against uniform pressures and result in uplift of the canal lining wall panels.

By executing contraction joints instead of construction joints between bottom and wall panels, it is expected that uplift of panels would be removed and the probable cracks created due to exerted pressures to the contraction joint would be depreciated. Of course, in the primary section of the canal, because of weak substructure of the concrete lining, weakness due to lack of coherence of the
