Performance of residential buildings during the M 7.8 Gorkha (Nepal) earthquake of 25 April 2015

Durgesh C. Rai*, Vaibhav Singhal, S. Bhushan Raj and S. Lalit Sagar

Department of Civil Engineering, Indian Institute of Technology Kanpur, Kanpur, India

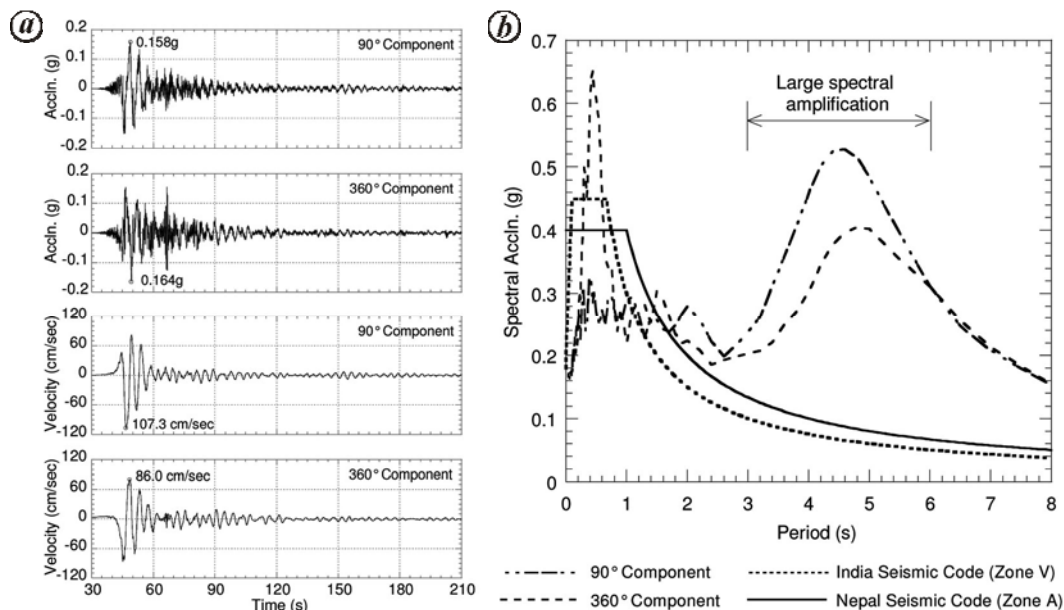
Figure 3. *a*, Acceleration time histories for the main shock of the 25 April 2015 event recorded at Kathmandu. *b*, Comparison of 5% damped acceleration response spectra of recorded ground motions with the Indian and Nepalese seismic code specified elastic design response spectrum for the design basis earthquake in soft-soil site.

noted that the peak ground velocity is much higher than typically expected for the observed PGA of 0.164 g (ref. 12). This is noteworthy as peak ground velocity is better correlated with the damage statistics of mid- to high-rise buildings and it could have played a significant role in the unexpected degree of damage to many structures¹³.

In Figure 3 *b*, acceleration response spectra of the recorded ground motions are compared with the code-prescribed elastic design response spectrum corresponding to zone A of the Nepal seismic code and zone V of the Indian seismic code, for the design basis earthquake (DBE) in soft-soil site. The USGS global V_{S30} server indicates that the central part of Kathmandu valley has soft-soil deposits which are typically NEHRP site class D (V_{S30} between 180 and 360 m/s)¹⁴. It is clear that in the acceleration-controlled regime (i.e. short-period range which is typical for low-rise unreinforced masonry and infilled RC-frame construction), the ground motion has higher acceleration demand than the code-expected demand in the most severe seismic zone. Geologic studies show that the Kathmandu valley is covered by thick semi-consolidated quaternary sediments with a maximum depth of 550 m in the central part of the valley¹⁵. An earlier study on local site amplifications due to unconsolidated quaternary sediments of Kathmandu valley has indicated that the resonant frequencies were in the range 0.5 to 8.9 Hz, with the maximum amplification occurring at 0.5 Hz (2 sec) in the central lacustrine area¹⁶. However, in addition to the amplification at 0.5 sec (2 Hz), unusual higher spectral amplification was observed in the range 3–6 sec (0.17 to 0.33 Hz), which could also be due to the complex influence of underlying unconsolidated quater-

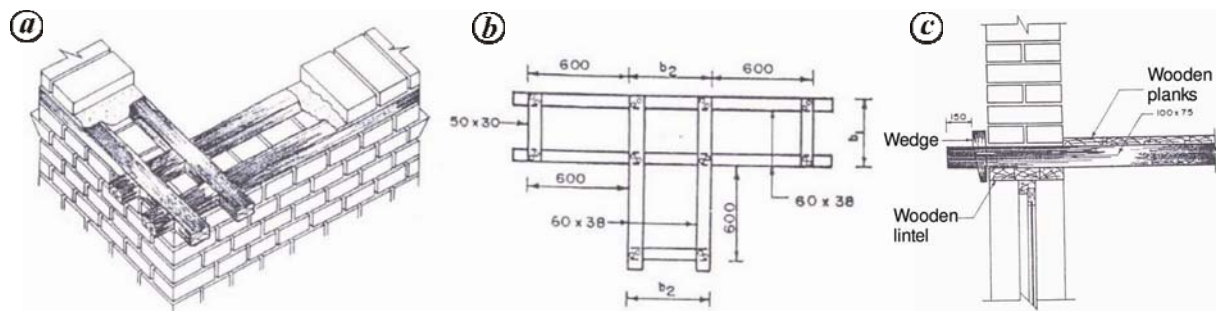
Figure 6. (a) Detailing of horizontal band with timber reinforcement at the corner. (b) detail of timber reinforcing at T-junction, and (c) example of use of wedge to anchor floor joist over lintel.

forcement in the form of timber or steel should be provided to integrate the box action for the peripheral walls (Figure 6). Due to the absence of positive connection between the walls at the corners and at T-junctions, these behave as free-standing slender walls subjected to large out-of-plane seismic forces due to their heavy mass which often exceeded their capacity. Thus these separated walls were vulnerable to out-of-plane collapse and many failed during the shaking (Figure 7).

The floor and roof diaphragms were made of timber joists with timber planks and were embedded in the masonry (Figure 7 a). Wooden pegs were generally used to prevent the dislodgement of the roof from the wall in the Newari buildings as shown in Figure 6 c. However, as observed in Figure 7 b, the timber joists were simply embedded into masonry walls without provision of pegs. Consequently, they were incapable of holding the walls together resulting in tall, free-standing wall sections vulnerable to out-of-plane collapse. Some old masonry buildings, especially heritage structures which survived during this earthquake, were provided with the continuous timber bands at each storey levels. In addition, wide timber bands were provided on the top of openings, which acted as lintels for carrying the loads from the upper storeys (Figure 8 a). The roof was connected to the walls by means of wooden pegs which enhanced the box action of the building (Figure 8 b). The sloping/overhanging timber roof was supported by aesthetically carved timber struts, which also acted as structural members enhancing the rigidity of the floor/roof (Figure 8 b). However, it seems that this knowledge of earthquake-resistant features in unreinforced masonry was somehow lost during the last few decades leading to the poor seismic performance of these unreinforced masonry buildings. The lack of earthquake-resistant features in these masonry structures could also be due to high cost and non-availability of structural timber in the Himalayan region. The use of materials other than timber, such as precast RC and steel members, for confining masonry should be investigated for wider application²².

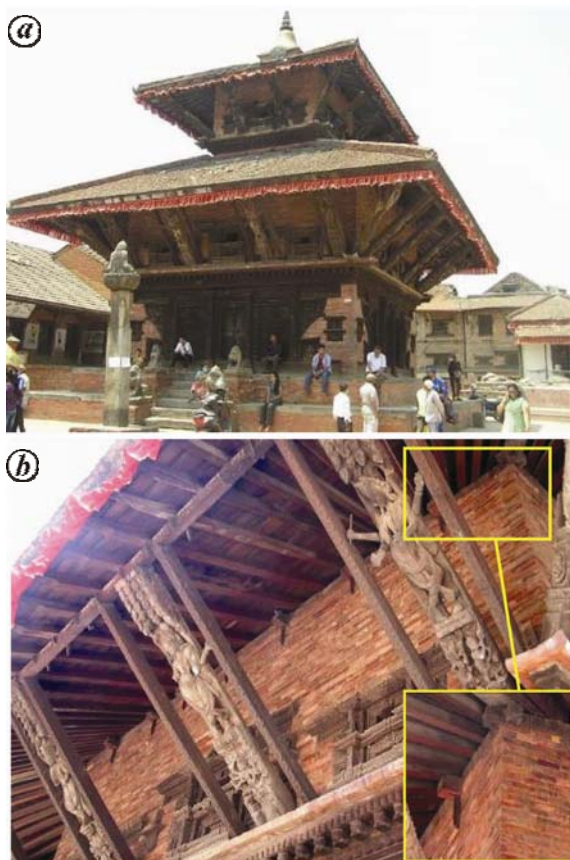
Figure 8. Good construction practice in traditional buildings of Bhaktapur Durbar Square ($27^{\circ}40'20''$, $85^{\circ}25'45''$): (a) Provision of wide timber bands over the top of openings, and (b) connection of floor/roof and walls using timber struts and wooden pegs.
