## Laboratory Investigation to Study Breach Behavior of Embankments

**Keywords:** Fuse plug, Dam breach, Breach characteristics, Temporal variation, Degree of compaction.

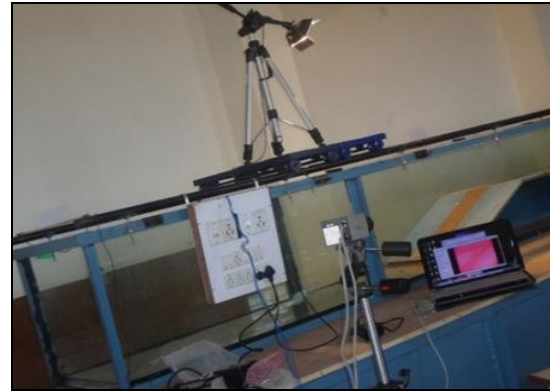
**Figure 4:** Complete set up for experimentation

upstream was increased and overtopping occurred. The breaching process of breach growth was videotaped with a high speed digital video camera (Fastec Imaging Inline Gigabyte Ethernet Camera) (Figure 4). The instant photographs were taken with two digital cameras. The procedure was repeated for different proportion of sand-silt-clay using two different fuse plug models.
